THE MAJOR CAUSE OF THE WANFO TEMPLE COLLAPSE IN THE 1999 JIJI EARTHQUAKE: SHEAR BANDING

Tse-Shan Hsu

Abstract

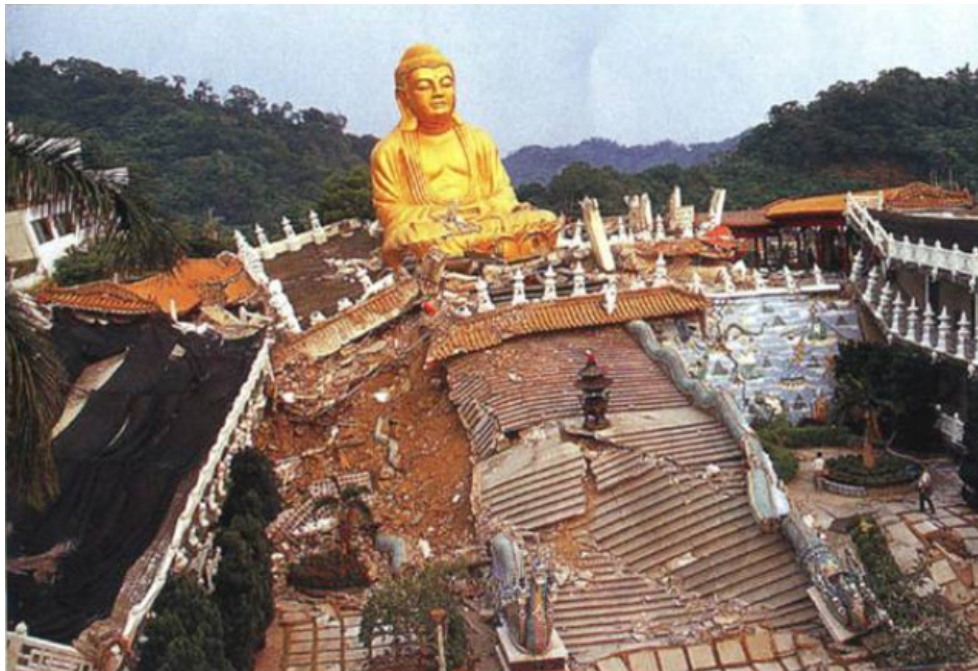
Figure 2. Collapse of the Wanfo Temple in the 921 Jiji earthquake (Wu, 1995).

1. The Major Cause of the Collapse of Temples during the 921 Jiji earthquake. The Wanfo Temple is located within the total width of a shear band. During the 921 Jiji earthquake, the faulting of the Chelungpu fault induced the principal deformation shear D , the thrust shear P , the Riedel shear R , the conjugate Riedel shear R' , and the compression texture S , which caused severe collapse of the Wanfo Temple (detailed in Figures 2 and 14).

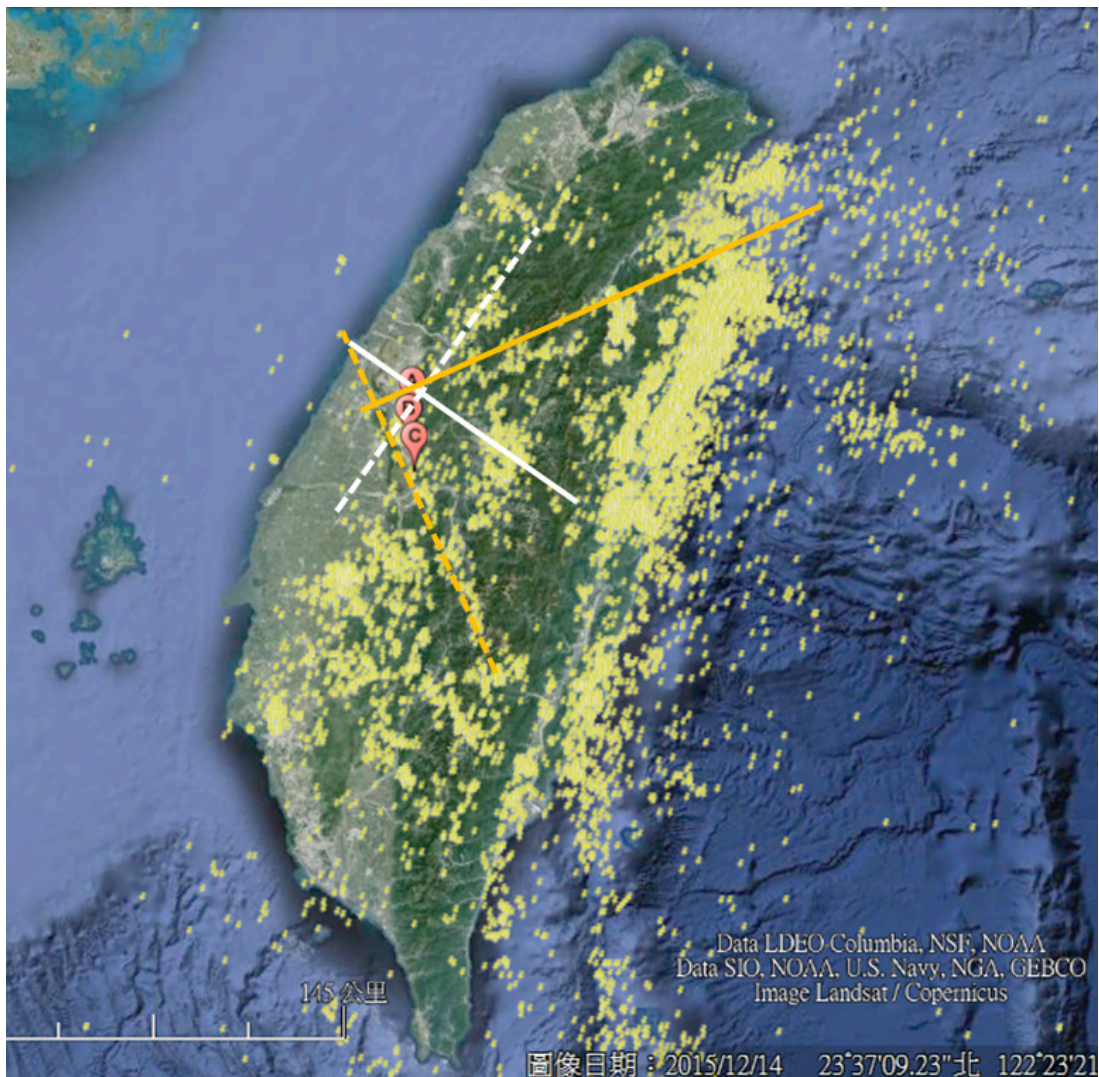
According to Figure 10, four groups of shear bands passing through the Wanfo Temple can be identified via the historical epicenter map. The four groups of shear bands are represented by the white solid line (N54°W), white dashed line (N36°E), orange solid line (N66°E), and orange dashed line (N24°W).

Note: The center point of Circle A is where the Wanfo Temple was located

Figure 10. Using the historical epicenter map to identify the shear bands that pass through the Wanfo Temple (background image is taken from Google Earth, 2019).

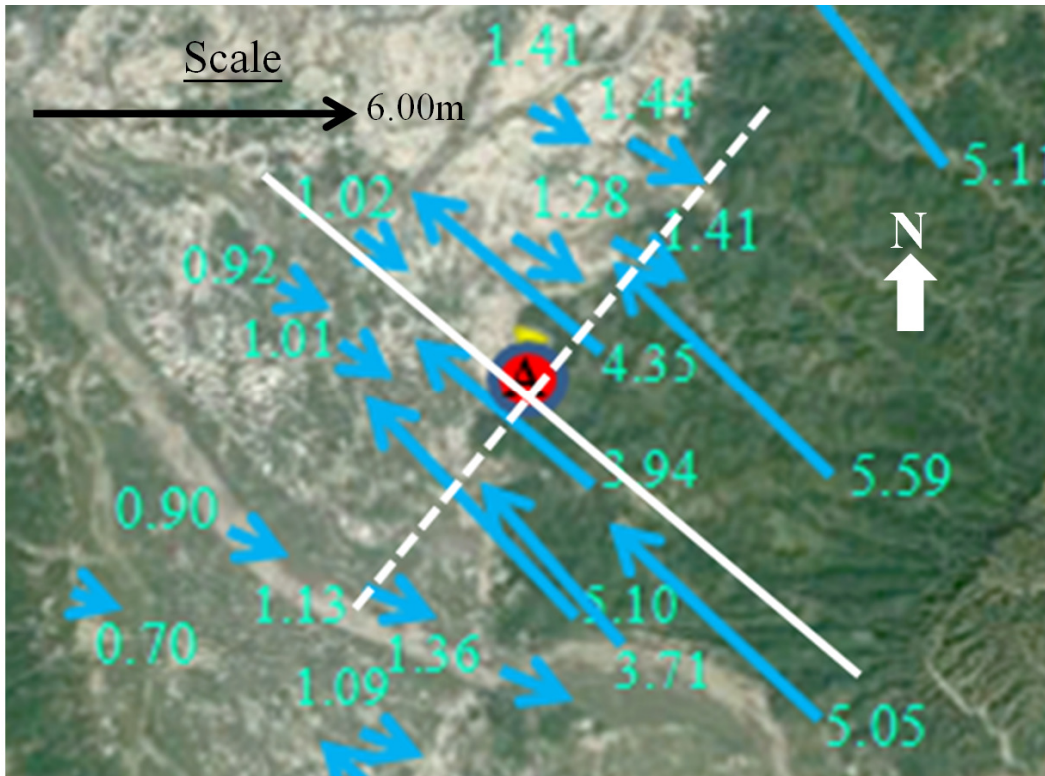
(a) 1999 Jiji Earthquake GPS velocity vector map (Google Earth, 2019;
GPS LAB, 2019).

Figure 11a shows the two groups of shear bands passing through the Wanfo Temple as obtained from the GPS velocity vector map of the 921 Jiji earthquake. The two groups of shear

bands are represented by the white solid line (N54°W) and white dashed line (N36°E). Figure 11b shows that the four sets of shear bands passing through the Wanfo Temple can be identified by the 2007 GPS velocity vector map. The four groups of shear bands are represented by the white solid line (N54°W), white

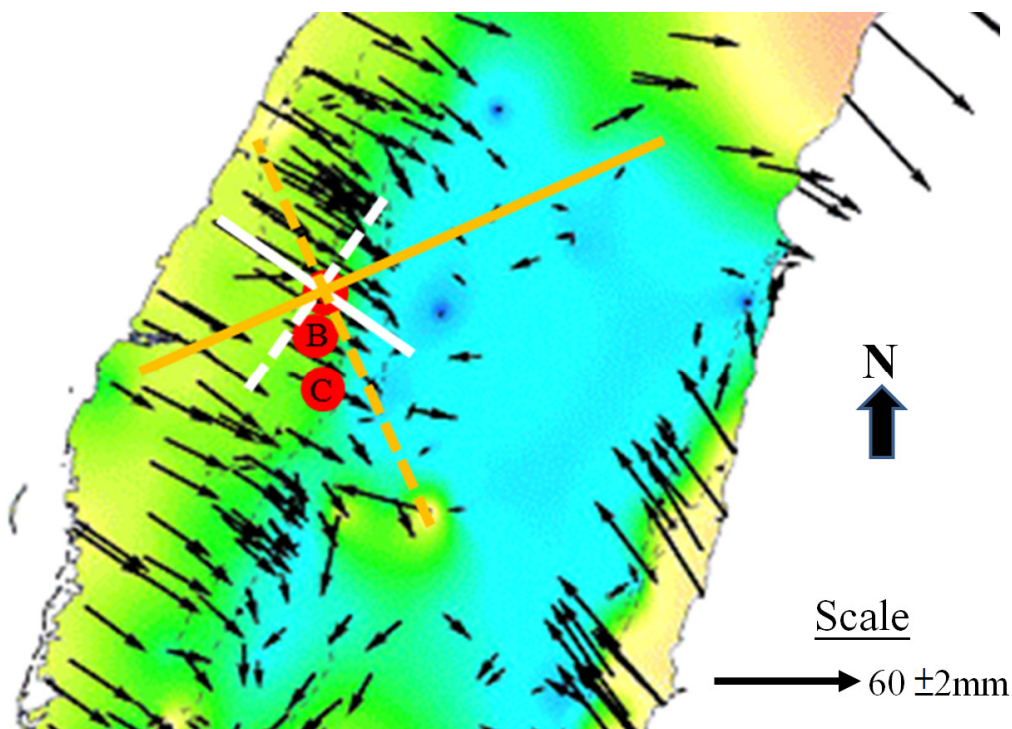
(b) 2007 GPS velocity vector map

dashed line (N36°E), orange solid line (N66°E), orange dashed line (N24°W).

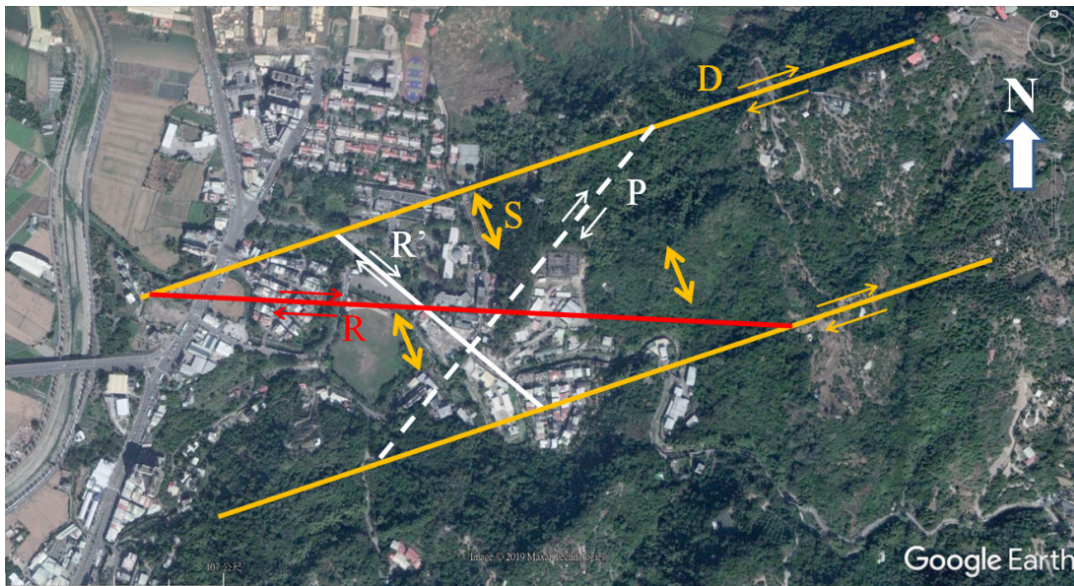
Figure 13 shows that the five groups of shear textures within the total width of a shear band can be identified by the features of displaced landform in satellite imagery of the vicinity of the

Wanfo Temple. The five groups of shear textures and their strikes are the principal deformation shear D (orange solid line) N66°E, the thrust shear P (white dashed line) N36°E, the Riedel shear R (red solid line N85°W), the conjugate Riedel shear R' (white solid line) N54°W, and the compression texture S (double arrow orange line) N24°W.

Figure 13. Shear textures obtained by satellite imagery identification in the vicinity of the Wanfo Temple (Background image is from Google Earth, 2019).

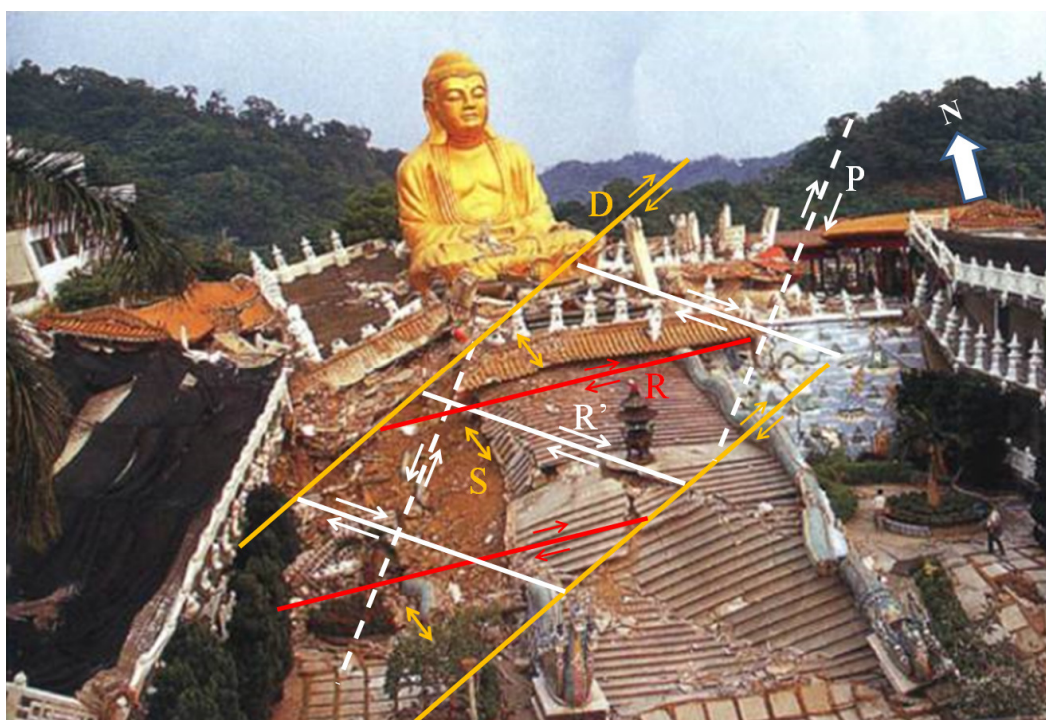
Figure 14 shows that the five groups of shear textures within the total width of a shear band can be identified by the features of displaced landform in local imagery of the vicinity of the

Wanfo Temple. The five groups of shear textures and their strikes are the principal deformation shear D (orange solid line) $N66^{\circ}E$, the thrust shear P (white dashed line) $N36^{\circ}E$, the Riedel shear R (red solid line) $N85^{\circ}W$, the conjugate Riedel shear R' (white solid line) $N54^{\circ}W$, and the compression texture S (double arrow orange line) $N24^{\circ}W$.

Figure 14. Shear textures obtained by local imagery identification in the vicinity of the Wanfo Temple (Background image is from Wu, 1995).

14, after the completion of the Wanfo Temple, the foundation spanned the shear banding zone. During the 921 Jiji earthquake, various shear textures with different strikes existing in the total width of a shear band caused uneven uplifts of the ground, which in turn caused the foundation to break. Then, the columns were broken during being uplifted, and the beams and the adjacent floor were ruptured after the beam-column joints were broken. As a result, the temple collapsed randomly.

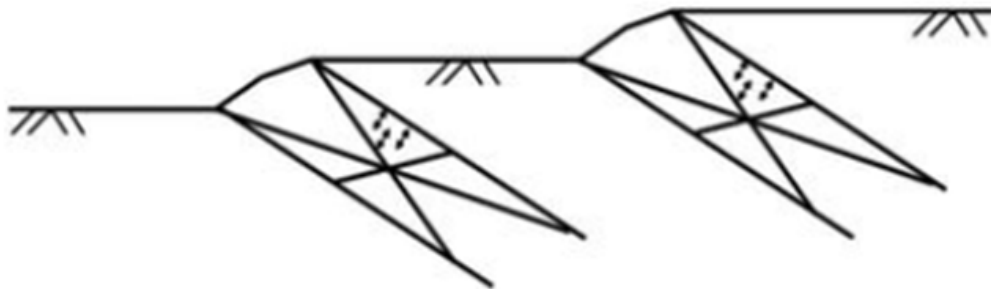
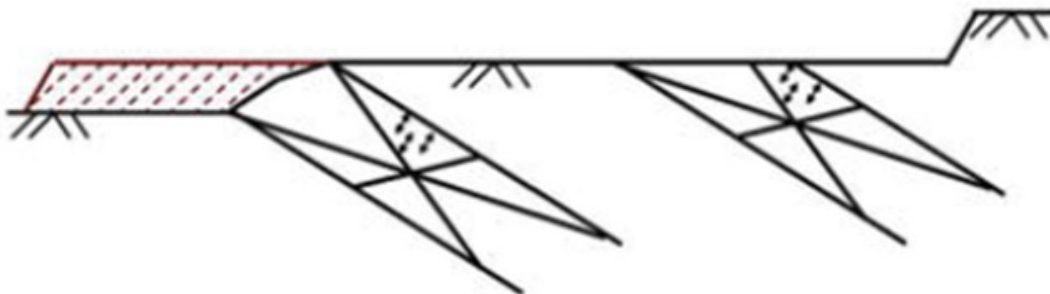
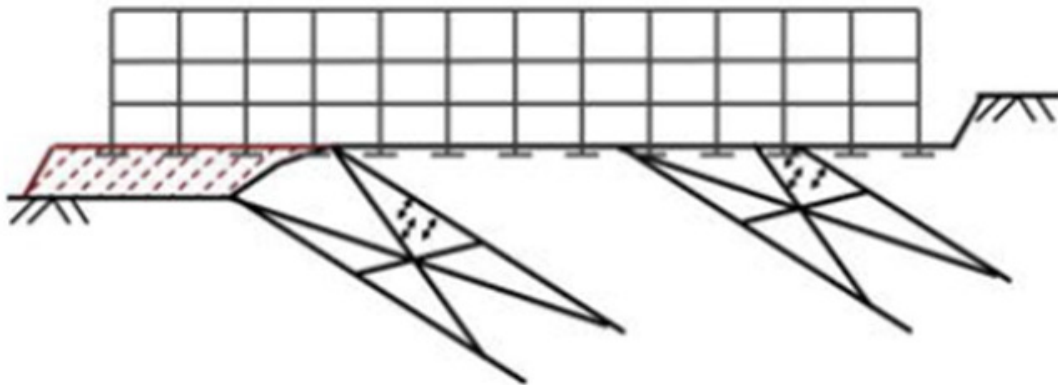
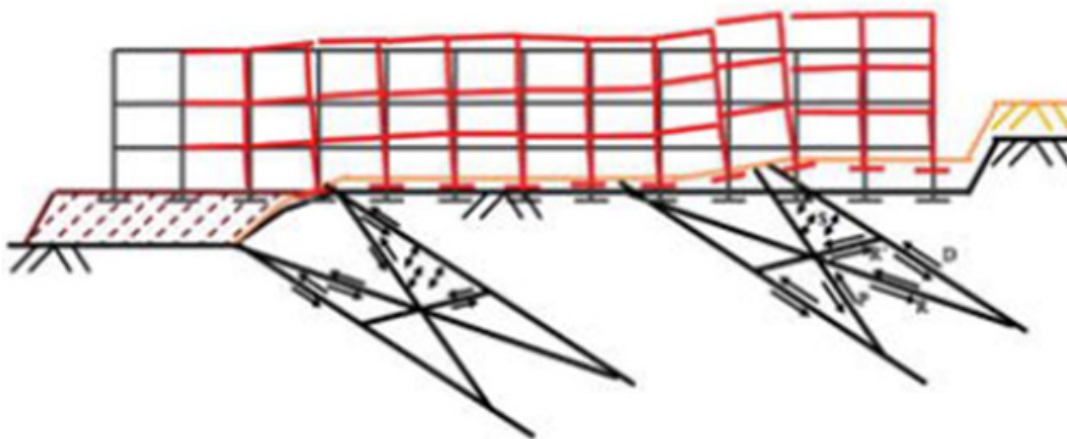
Figure 16. Mechanism of temple failure induced by shear banding (Hsu, 2018).

2. Model of Damaged Temple Induced by Shear Banding. Figure 16 shows that when the temple is built on a

shear banding tilted slope (Figure 16a), the whole site of the temple foundation needs to be leveled by balancing excavation and backfill (Figure 16b). Because of this, the shear banding tilted slope still partially remains below the foundation

of the temple after completion (Figure 16c). Consequently, during subsequent sensible tectonic earthquakes, the growing dislocation of the shear band will worsen damage caused to the temple (Figure 16d).
