## THE MAJOR CAUSE OF BRIDGE COLLAPSES ACROSS ROCK RIVERBEDS: SHEAR BANDING

### Abstract

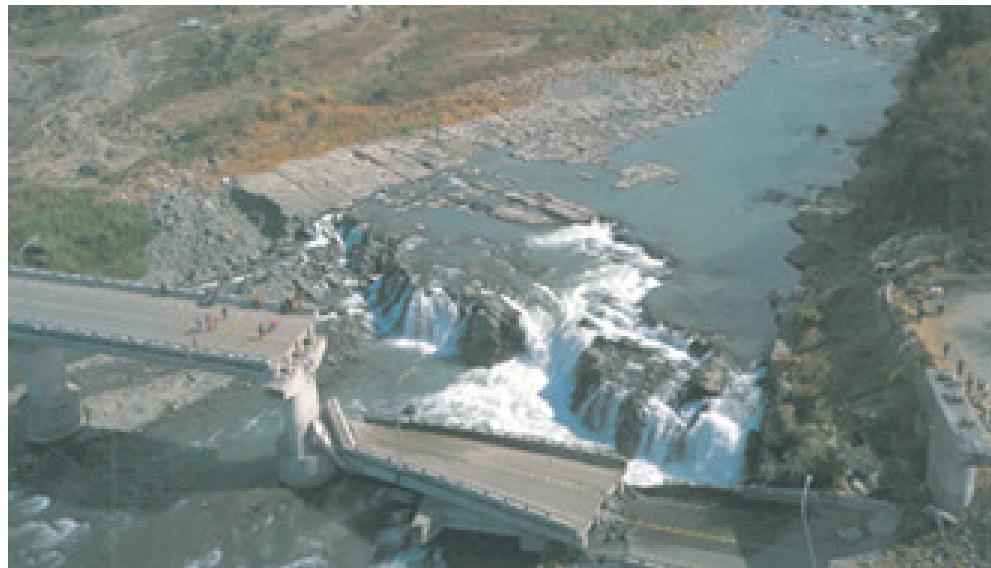
Figure 3. The collapse of Pifeng Bridge in Taichung, Taiwan, during the 1999 Jiji earthquake.

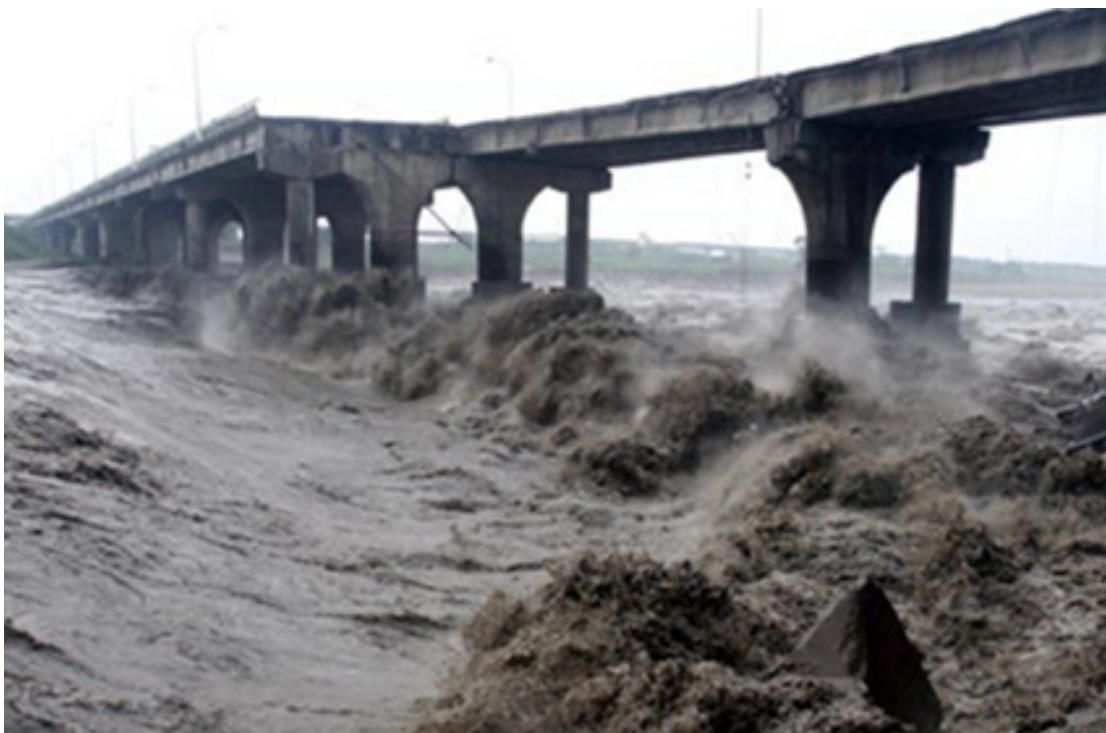
Figure 4. The collapse of Houfeng Bridge in Taichung, Taiwan, during Typhoon Sinlaku in 2008 (Jeng, 2008).

For Houfeng Bridge, shown in Figure 4 after its collapse during Typhoon Sinlaku, if riverbed scouring was the primary cause of its collapse, the peak flow of  $4,563 \text{ m}^3/\text{s}$  of the Dajiaxi Basin passing through Shi-

gangba station during the typhoon's transit should be the largest. However, Table 1 shows that the maximum peak flow was instead  $5,873 \text{ m}^3/\text{s}$  during the passage of Typhoon Mindulle. Based on the fact that the riverbed scouring failed to meet the three required conditions of disaster causes, Hsu and Hsieh (2009) found that riverbed scouring was not the major cause for the collapse of Houfeng Bridge.

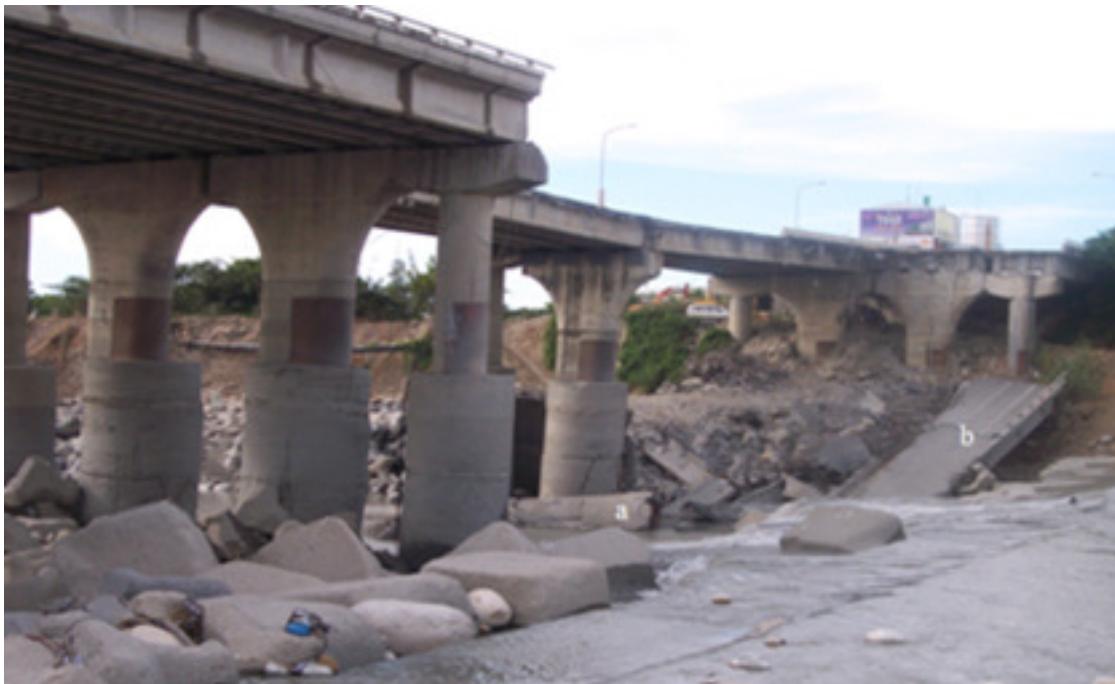
Note: In the figure above, a is the toppled caisson, and b is the fallen bridge deck.

Figure 5. The collapse of Houfeng Bridge during Typhoon Sinlaku.

Figure 4 shows the Houfeng Bridge collapse during Typhoon Sinlaku. Figure 5 shows the in-situ conditions of the exposed caissons, the toppled caissons, and the fallen bridge decks after Typhoon Sinlaku.

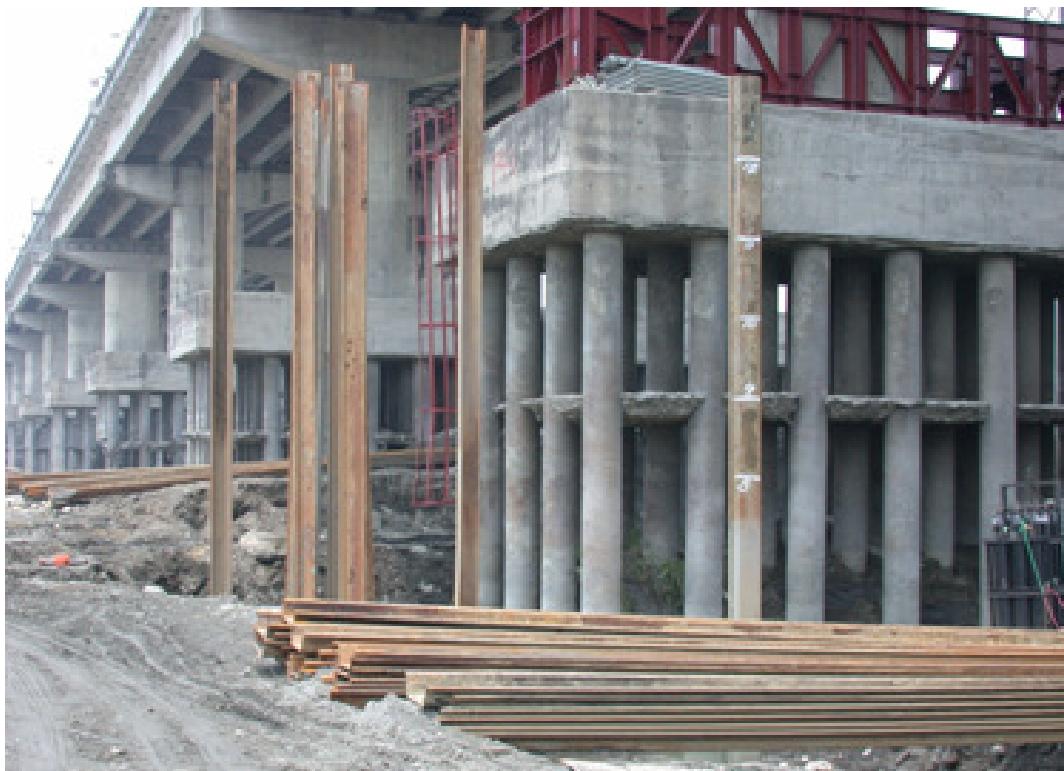
Figure 6. A bridge on a low shear strength soil riverbed that remained stable after group pile foundations were severely exposed (Sijhou Bridge, Changhua, Taiwan).

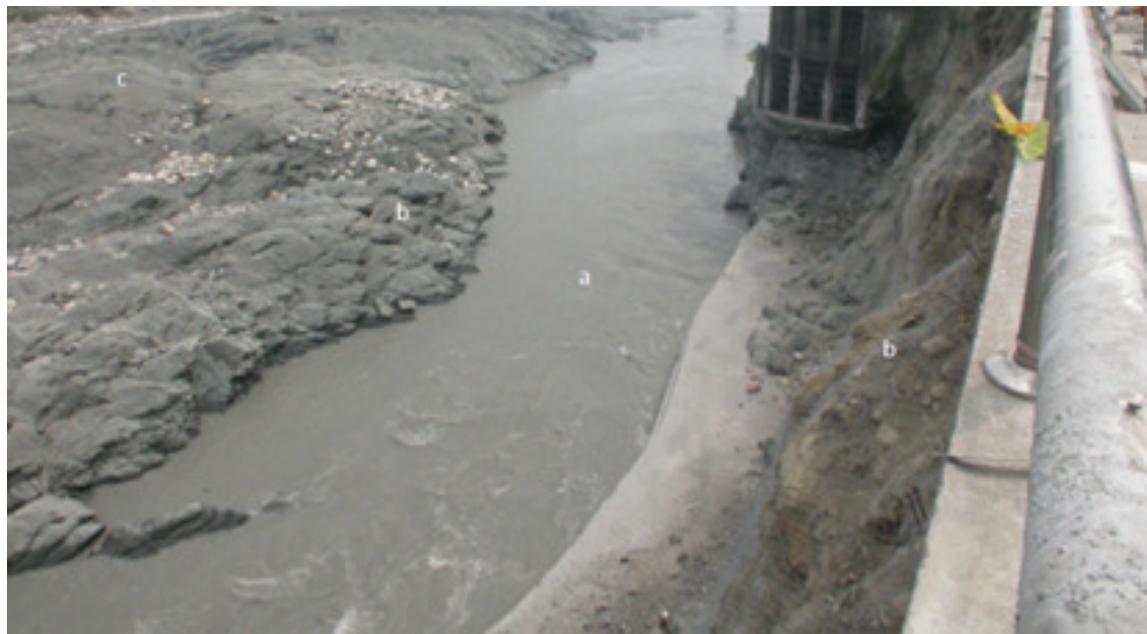
- 3) Figure 9 shows that the degree of brittle fracture of the rock riverbed in the shear band will continue to increase during tectonic earthquakes. The highly brittle-fractured shear-

band rocks will be lost in a flood, which will cause deep grooves to form in the riverbed. Furthermore, both sides of the deep groove are shear-banding tilted slopes.

Note: In the figure above, a denotes a deep groove, b denotes a shear-band tilted slope, and c denotes a non-shear-band rock riverbed.

Figure 9. The rock riverbed in the Dajiaxi Basin, in Taichung, Taiwan.

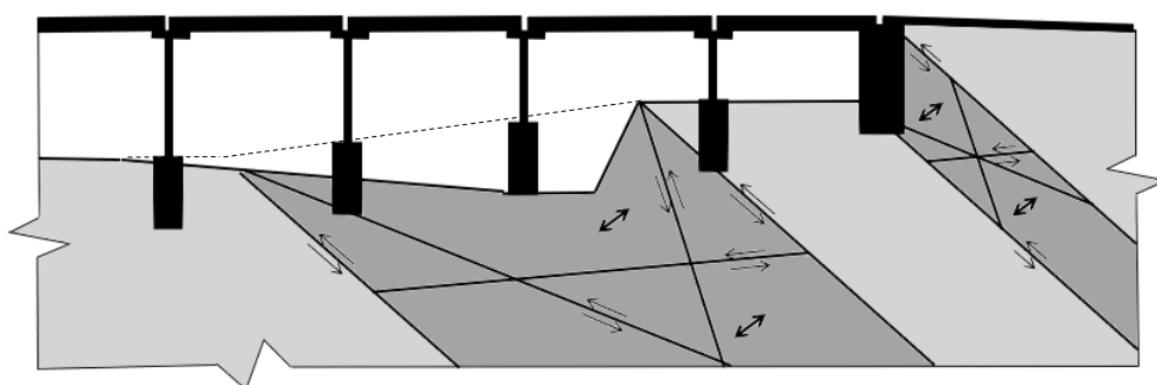
- 4) After the formation of the deep groove in the rock riverbed, its depth will increase as a result of the continuous loss of brittle-fractured shear-band rocks during flooding.

When all the shear-band rocks around a caisson or group piles are lost (see Figure 10), the bridge will collapse (Figures 4 and 5).

Figure 10. The loss of brittle-fractured shear-band rocks around caissons.

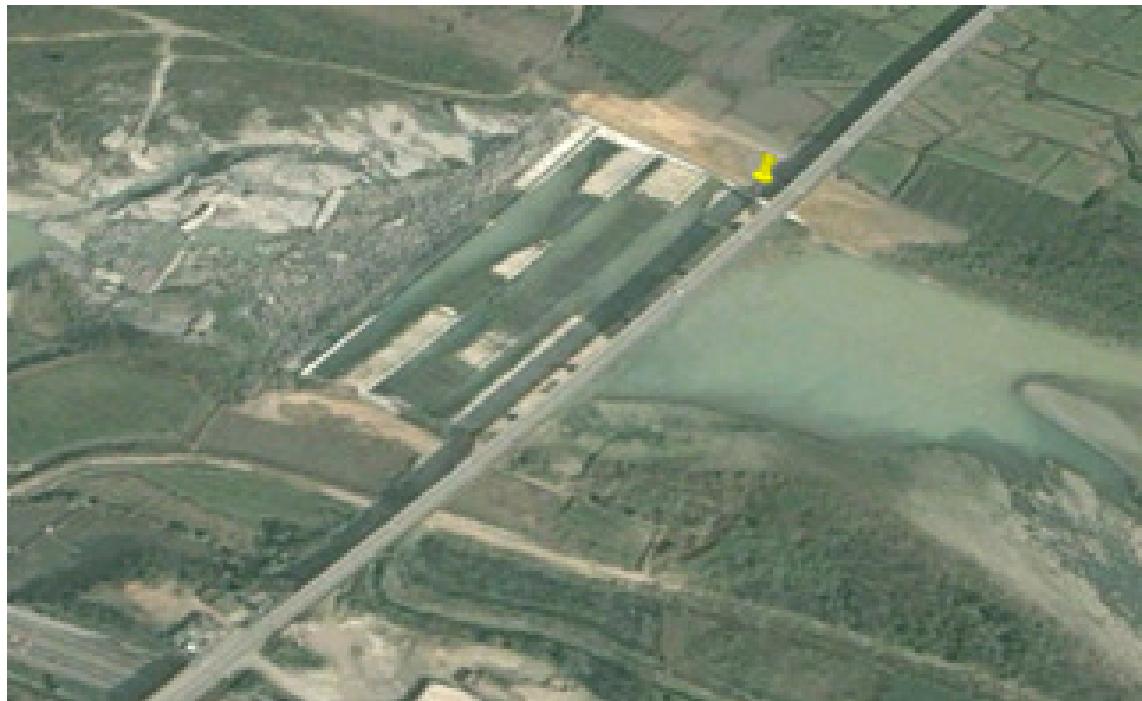
1981. Since the degree of brittle-fractured shear-band rocks continued to increase after construction, a concrete-groundsill was added in 2003 (see Figure 11).

Figure 11. The construction of a concrete-groundsill downstream of the Zhongzheng Bridge completed in 2003 (Google Earth, 2020).

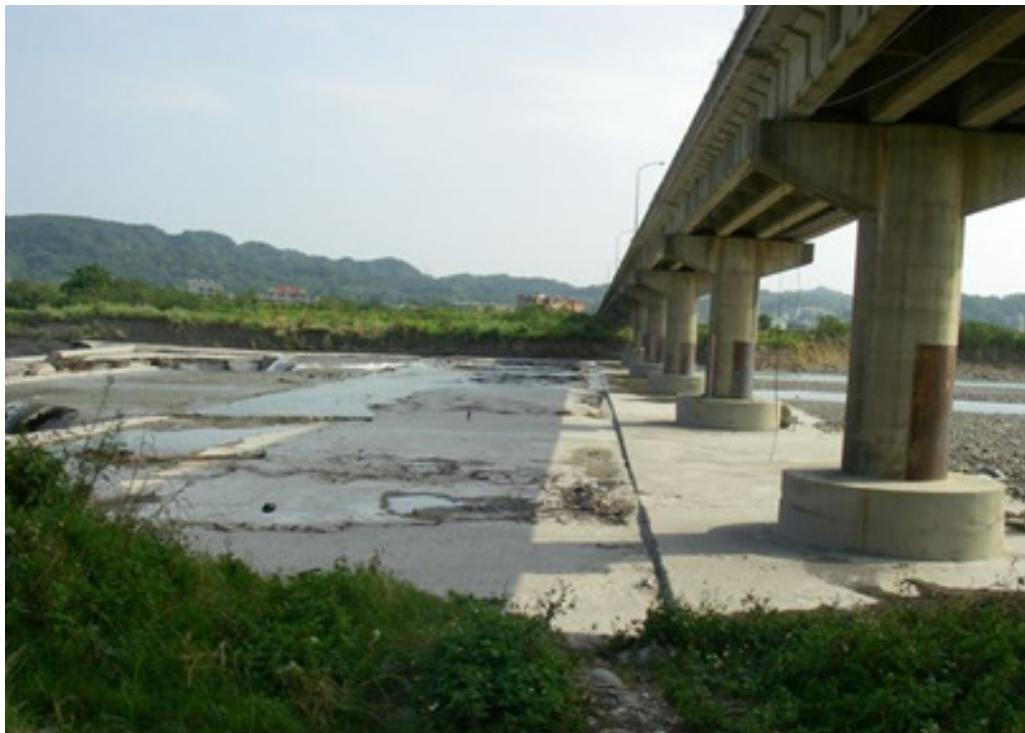
(a) In 2007 (Bicyclist, 2007)

The high shear strength concrete-groundsill started to fracture in 2007, and while the degree of brittle fracture gradually increased from the left bank to the right bank of the deep groove downstream of the bridge, the situation was not serious (see Figure 12). During Typhoon Saola in August 2012, the deep grooving effect of the shear-band rock riverbed intensified. The caissons

Figure 12. The degree of brittle fracture of the concrete-groundsill within the shear-band rock riverbed continued to increase before the collapse of the Zhongzheng Bridge.

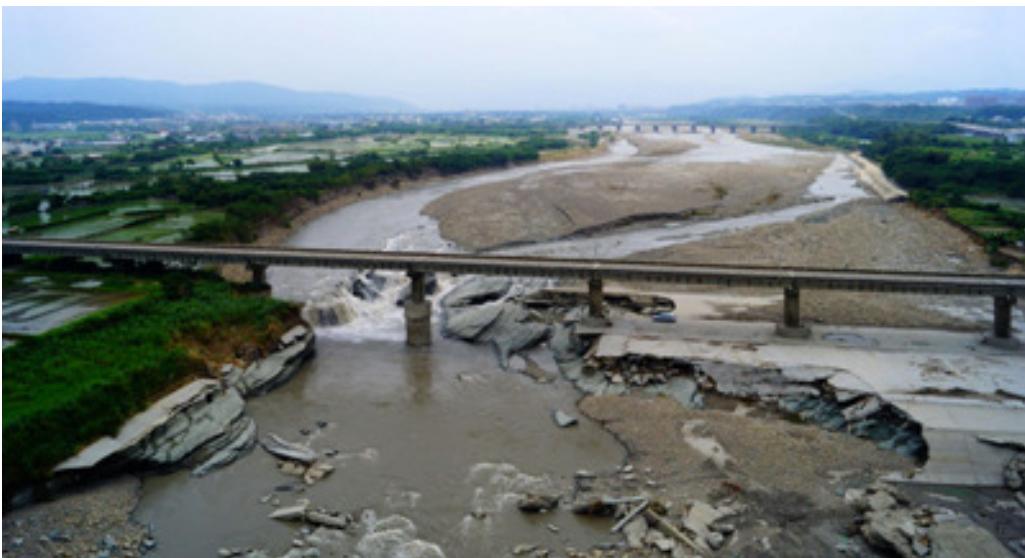
(b) After Typhoon Saola in August 2012 (Lian, 2013)

embedded in the shear bands were severely exposed, and the concrete-groundsill in the deep groove failed and was lost. In addition to extending towards the left bank downstream of the Zhongzheng Bridge, the range of loss also extended toward the upstream shear-band rock riverbed (see Figure 12(b)).

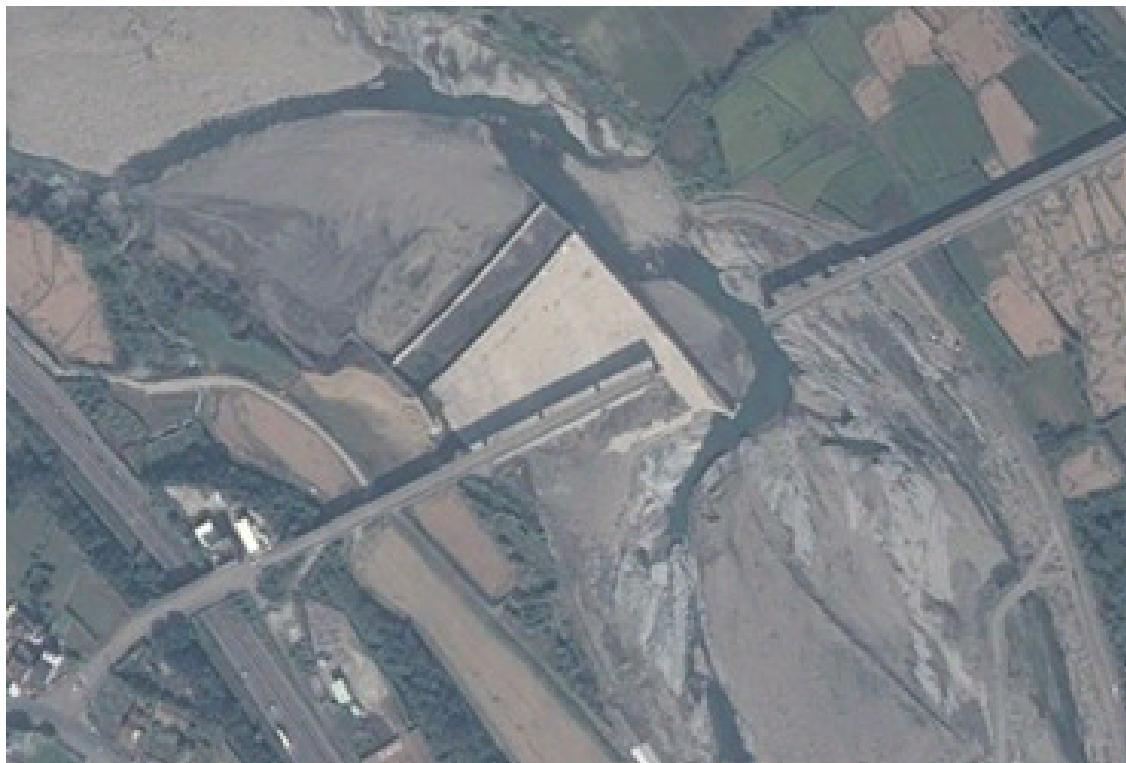
After Typhoon Saola in 2012, the reconstruction of a concrete-groundsill on the left bank of the deep groove was completed quickly, as shown in Figure 13. However, during Typhoon Soulik in 2013, a caisson was completely exposed, so the Zhongzheng Bridge collapsed. The pier, cap beam, and bridge decks on both sides of the caisson fell

onto the riverbed. Figure 13 further shows that, after the collapse of the Zhongzheng Bridge, the concrete-groundsill on the left bank of the deep groove of the rock riverbed was slightly damaged, while the deep groove of the rock riverbed extended to the riverbed outside the concrete-groundsill.

Figure 13. Satellite image of the partial drop of the Zhongzheng Bridge in 2013 (Google Earth, 2020).

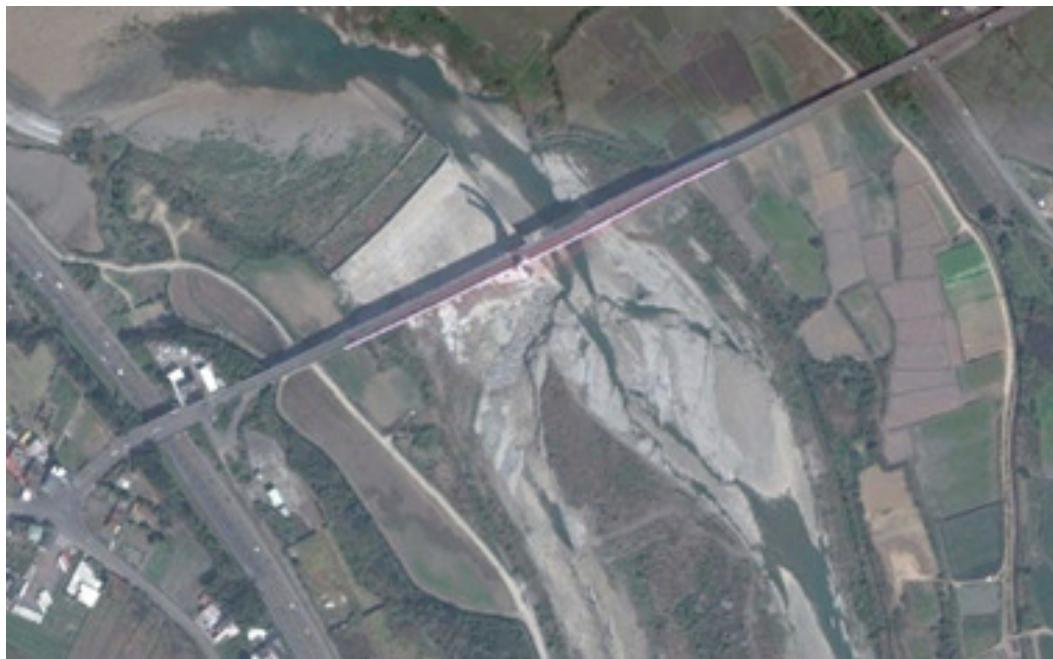
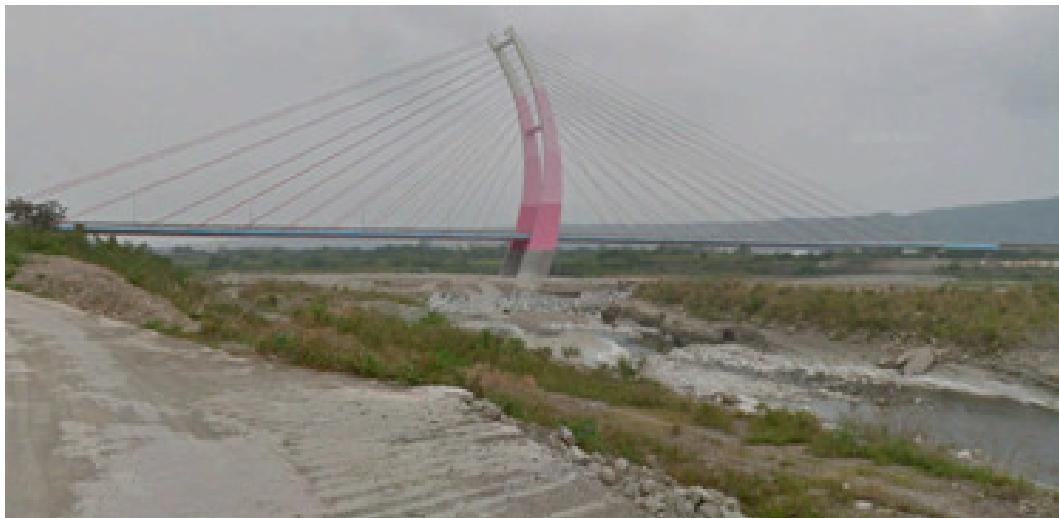
Figure 14. The Zhongzheng Bridge after reconstruction in 2015 (Google Earth, 2020).

The reconstruction of the Zhongzheng Bridge was completed in 2015, with the type of the bridge changed from a PCI-girder bridge to a cable-stayed bridge with a total length of 855.3 m, a width of 30 m, a main

tower height of 83.5 m, and a foundation depth of 28 m, as shown in Figure 14. The main purpose of this change was to reduce the contraction scour via a substantial reduction in the number of piers.

band, then the degree of brittle fracture of the shear-band rock riverbed will continue to increase during tectonic earthquakes, which will cause a significant decrease in strength and a significant increase in compressibility. If the bearing capacity is insufficient or the compressibility is too large for the shear-band rock riverbed, the Zhongzheng Bridge will collapse again.

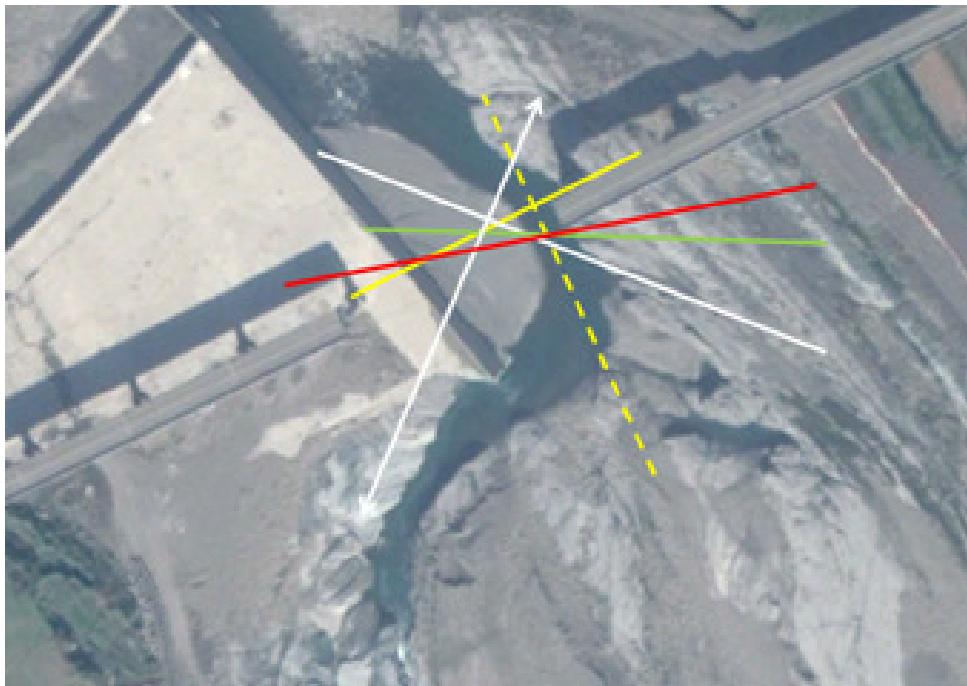
Based on the above-mentioned identification results, it is known that there are six different shear bands (or shear textures) in the rock riverbed for the Zhongzheng Bridge (see Figure 22). As shown in Figure 23(a), owing to the continuous displacement of these six shear bands (or shear textures), the brittle-fractured rocks surrounding the C1 and C2 caissons were partially lost during the 2012 Typhoon Saola, causing the C1 and C2 caissons to be exposed, with the C1 caisson more exposed than the C2 caisson. Furthermore, as shown in Figure 23(b), a stepped deep grooving appears in the shear-

Figure 22. Shear bands that induced the collapse of the Zhongzheng Bridge (background image from Google Earth, 2020).

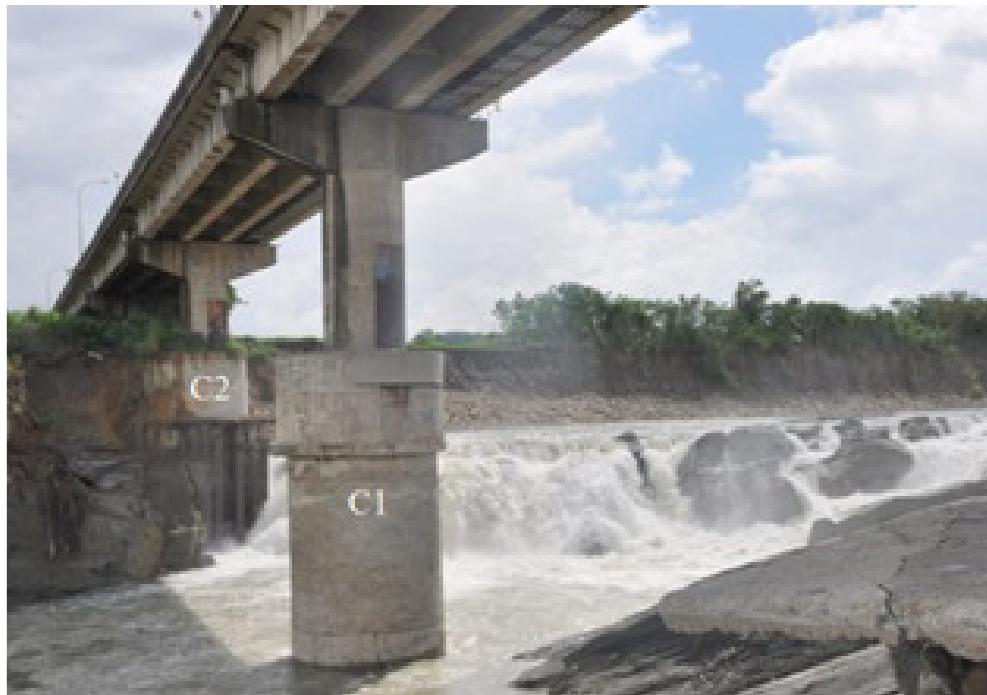
(a) During Typhoon Saola in August 2012

Figure 23. Caissons exposed as a result of deep grooving of the rock riverbed and the loss of brittle-fractured shear-band rocks.

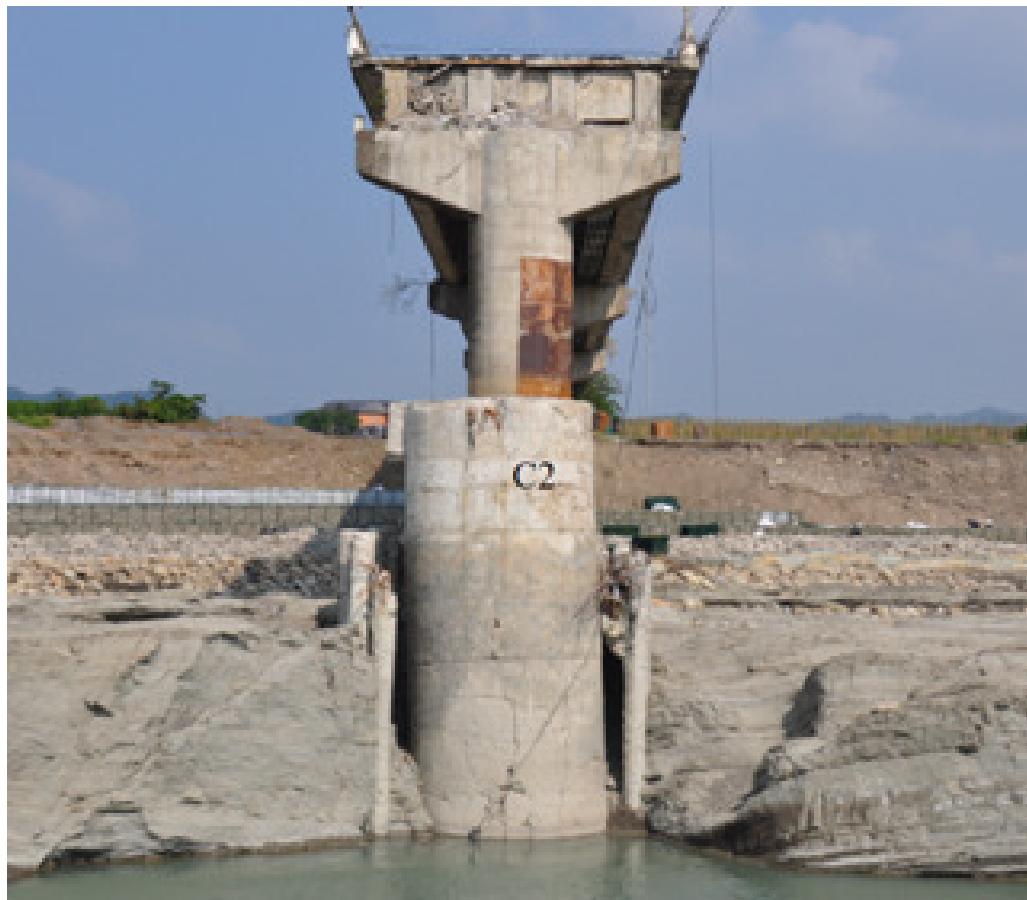
band rock riverbed when the bridge collapses. The first-stage deep groove's surface dropped to a depth of 2.5m below the top of the caisson, and the second-stage deep groove's surface dropped below the bottom surface of the C1 caisson, with the C1 caisson toppling because it lost all its bearing capacity. Secondly, a ring-shaped empty space of approximately 70cm in width (see Figure 23(c)) appeared in the C2 caisson, owing to the loss of brittle-fractured shear-band rocks. This phenomenon shows that, once the caisson is embedded in the shear band, the surrounding brittle-fractured shear-band rocks are easily lost.

(c) Stepped deep grooving of shear-band rock riverbed  
after Typhoon Soulik in 2013

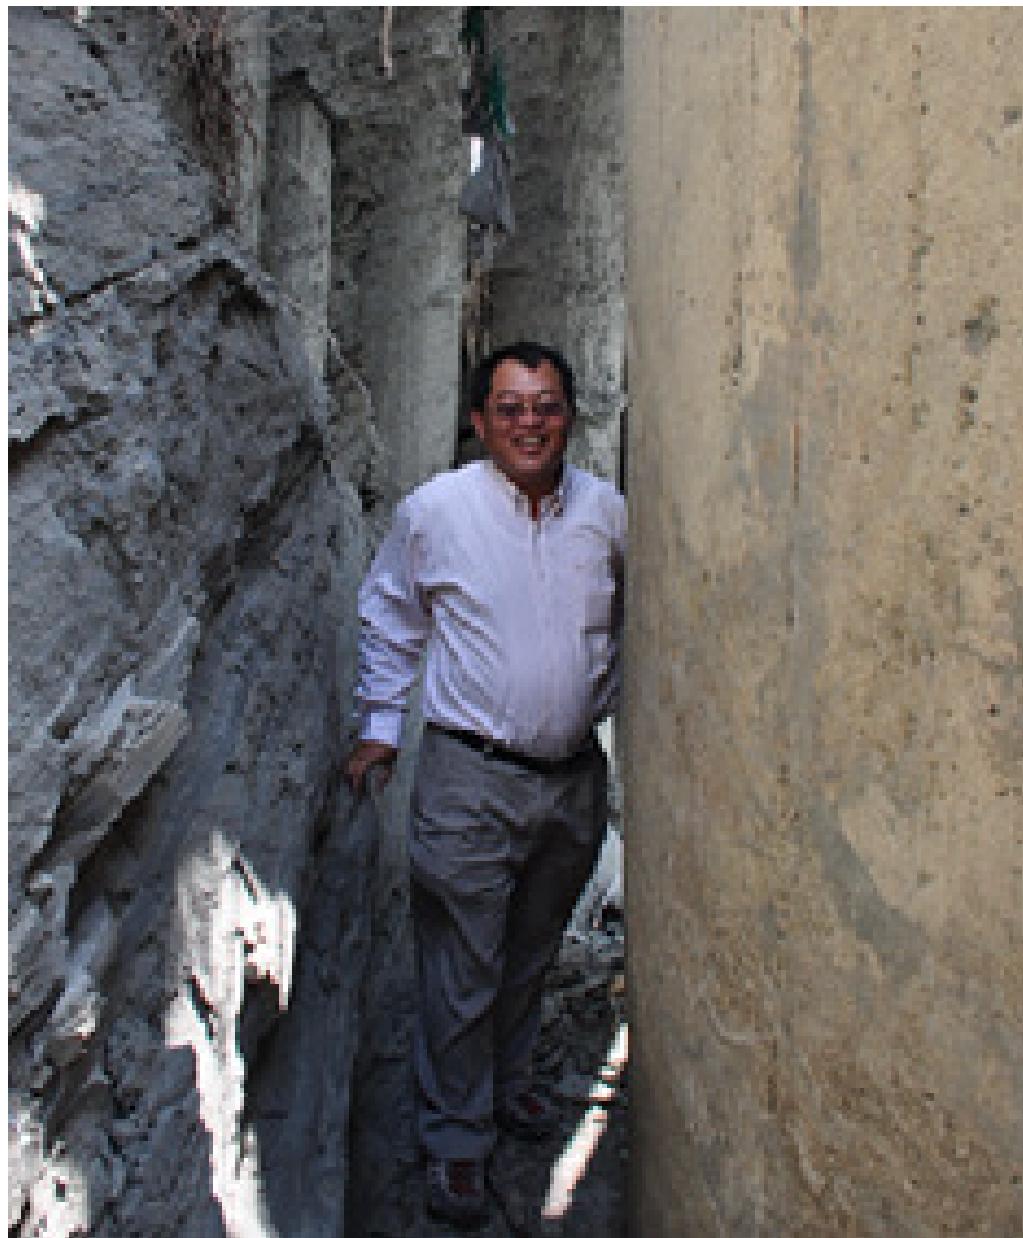
(d) The annular empty space that appeared after the loss of shear-band rocks that bounded the C2 caisson in Figure 23(b)
