## THE MAJOR CAUSE OF ANCHOR BLOCK SLOPE FAILURES

Currently, a large number of anchors are used in Taiwan to stabilize slopes. The design specifications have been continuously revised after the occurrence of anchor block slope disasters. However, disasters at anchor block slope that meet design specifications have become more and more serious, even in the absence of wind, rain, and earthquakes. This proves that the current design specifications do not include the major cause that induces anchor block slope failures. In view of this, this paper takes the anchor block slope disaster happened at 3.1km mark of the Formosa Freeway as an example. By comparing the endoscope inspection results and those

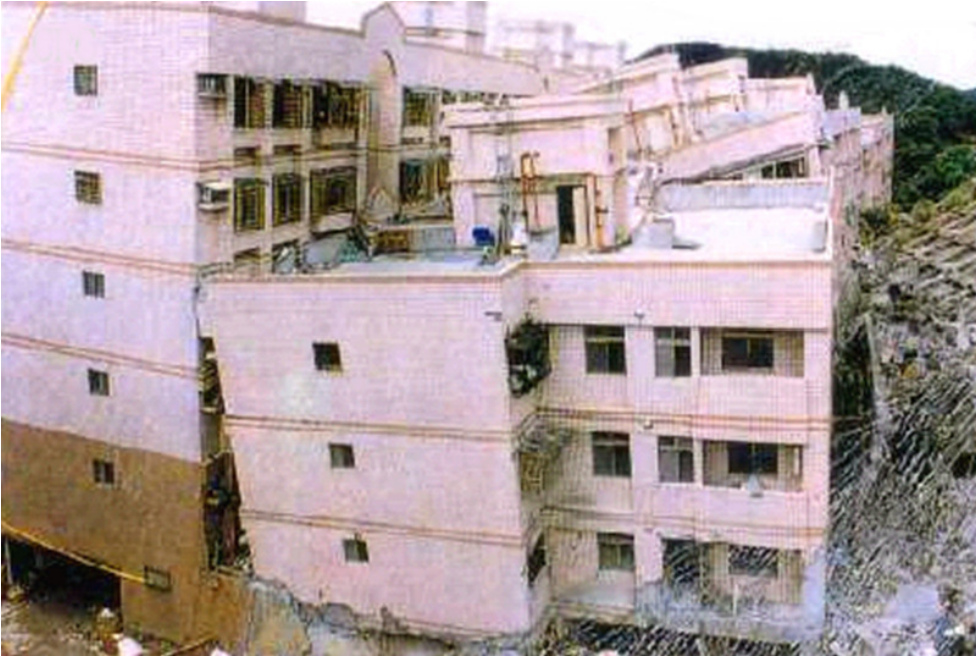
Figure 1. Lincoln County anchor block slope disaster (New Taipei City Government, 1997)

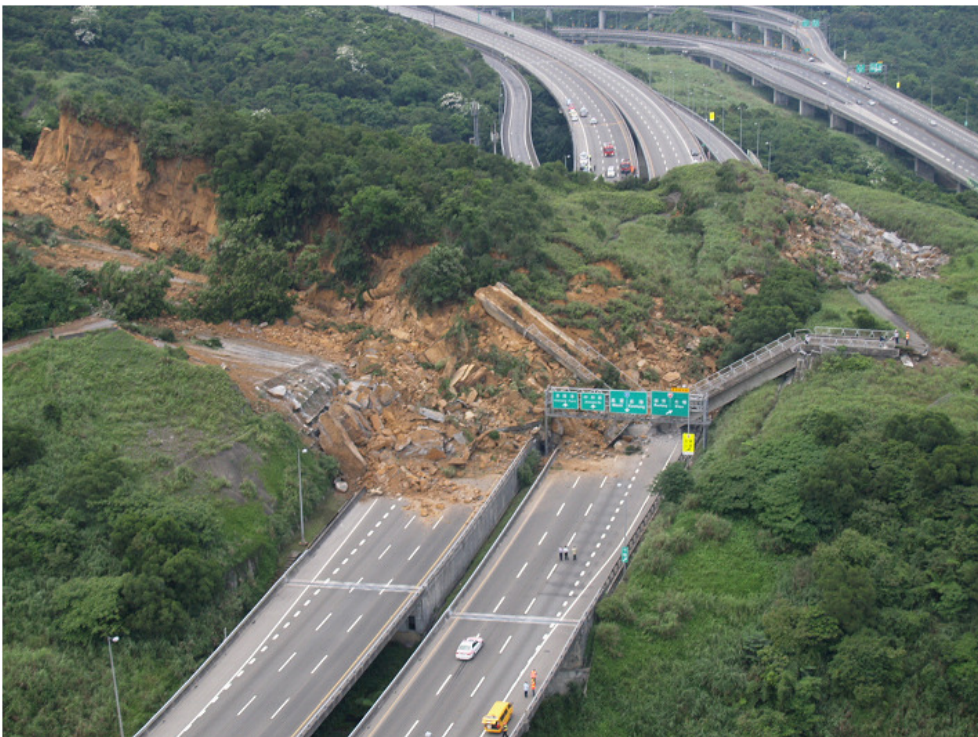
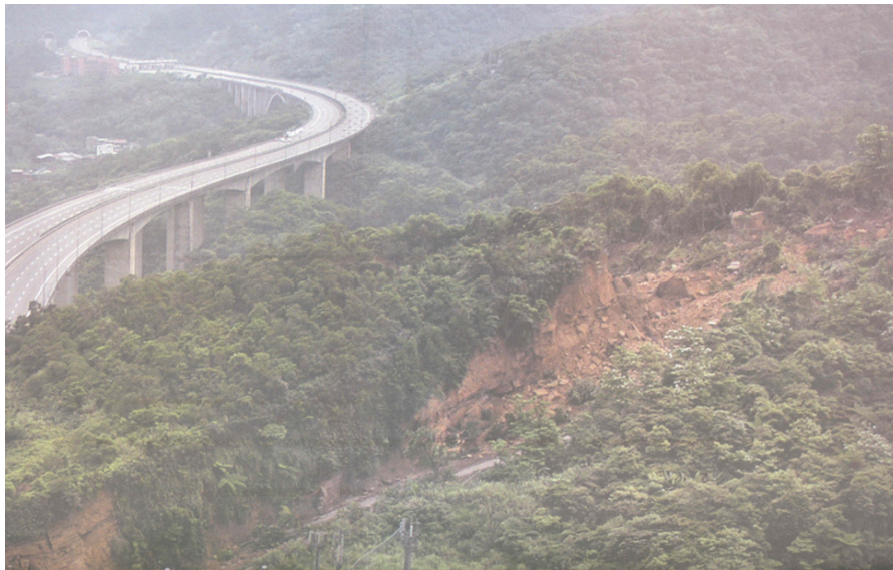
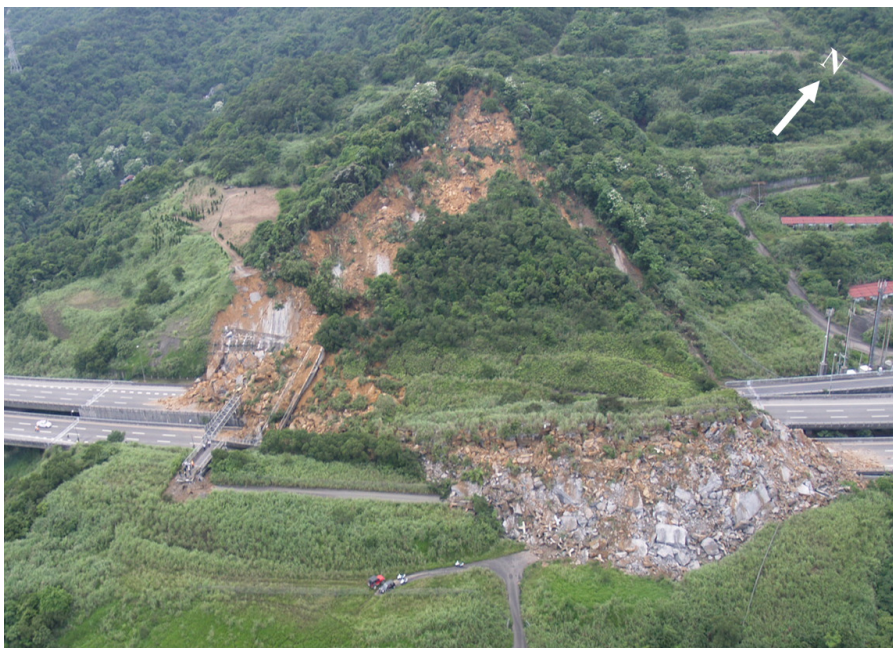
Figure 2. Anchor block slope disaster happened at the 3.1km mark of the Formosa Freeway

anchor block slope disaster occurred at the 3.1km mark of the Formosa Freeway (detailed in Figure 2), even though the site was absent of wind, rain and earthquakes, the disaster still occurred, causing all the lanes to be buried by falling rocks, and burying 4 people alive.

(a) Photographed from the southwest to the northeast (Water Resources Department Newsletter, 2018)

(b) Photographed from the northeast side to the southwest (Taiwan Geotechnical Society, 2011)

(c) Photographed from the southeast to the northwest (Taiwan Geotechnical Society, 2011)

However, it can be seen from Figure 2 that the sliding failure of the anchor block slope was caused by a yellow sandstone block slid on the top surface of grey shale. After the failure sandstone was cleared, Figure 5 shows that the entire sliding failure plane could be divided into upper and lower parts. The upper part of the sliding failure plane was not equipped with anchors, while the lower part was equipped with anchors. Figure 5a shows that the cracking was not severe on the surface of the shale for the upper part of the sliding failure plane. Figure

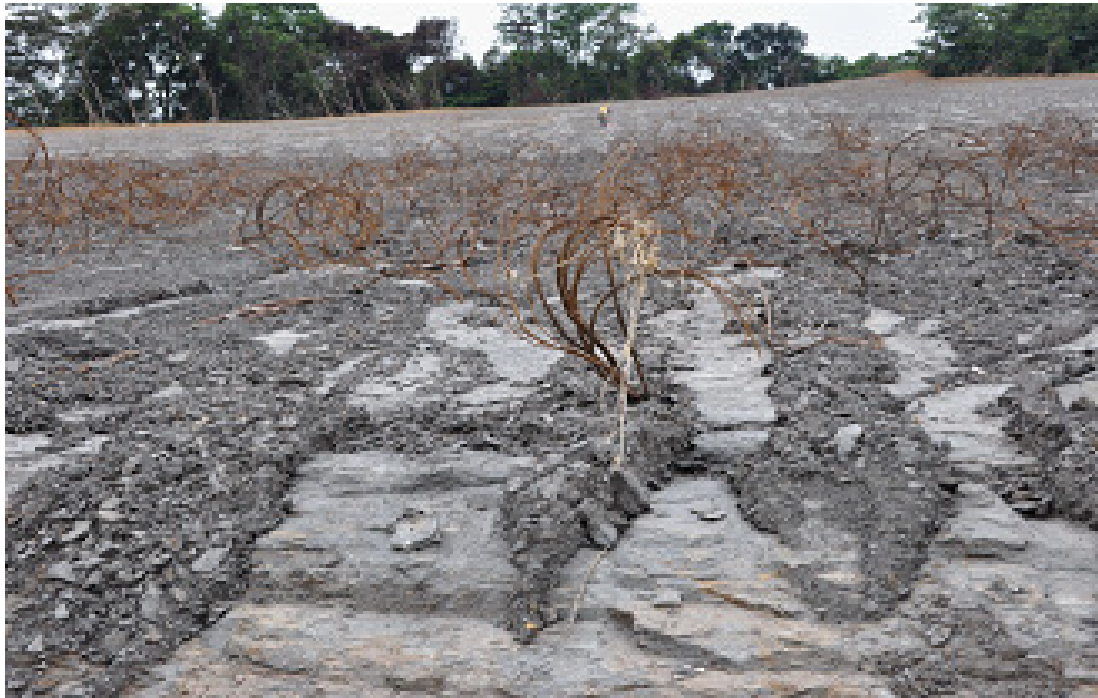
Figure 3. The rusted snapped anchors remaining on the sliding failure plane

For the snapped anchor remaining on the sliding failure plane as shown in Figure 3 or Figure 5b, since the block sliding on the potential sliding plane, shown in Figure 16a①, is disappeared, all shearing textures located within the total shear band width No. 1 no longer exist. Therefore, the anchor (Figure 16b②) remaining on the sliding failure plane shown in Figure 16b① is actually not affected by the total shear band width No. 1. In

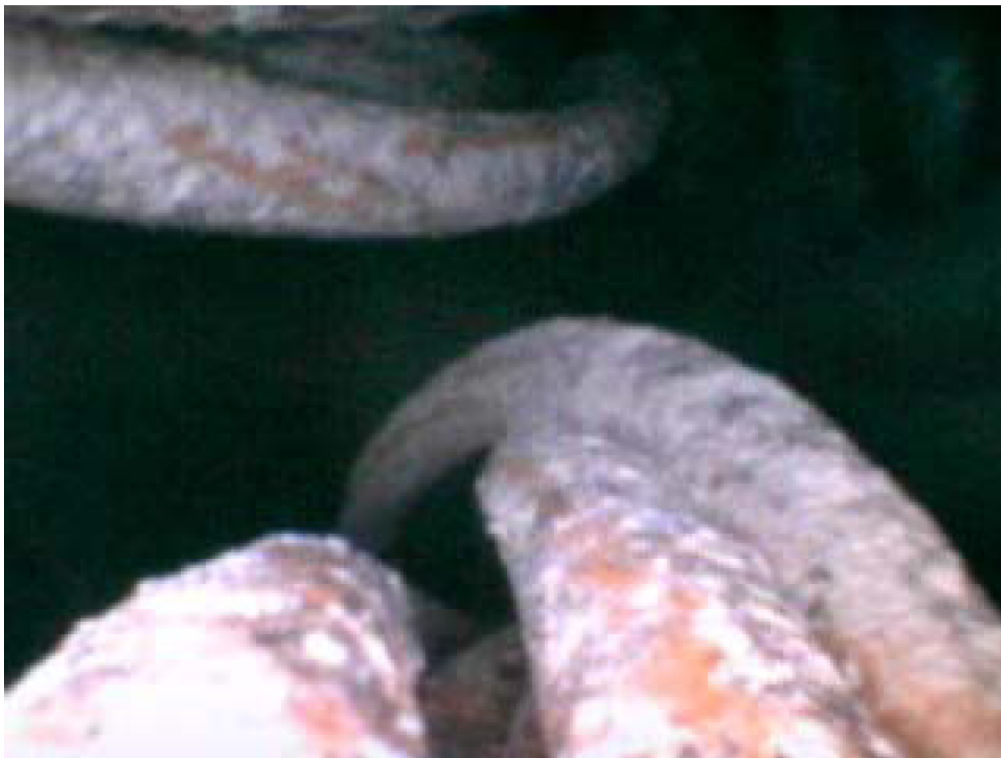
(a) The snapped anchor

(b) The unsnapped anchor

(c) The anchor affected by groundwater

Figure 4. Endoscopic inspection results for the corrosion conditions of the anchors remaining in the anchor block slope below the sliding failure plane (Taiwan Geotechnical Society, 2011)

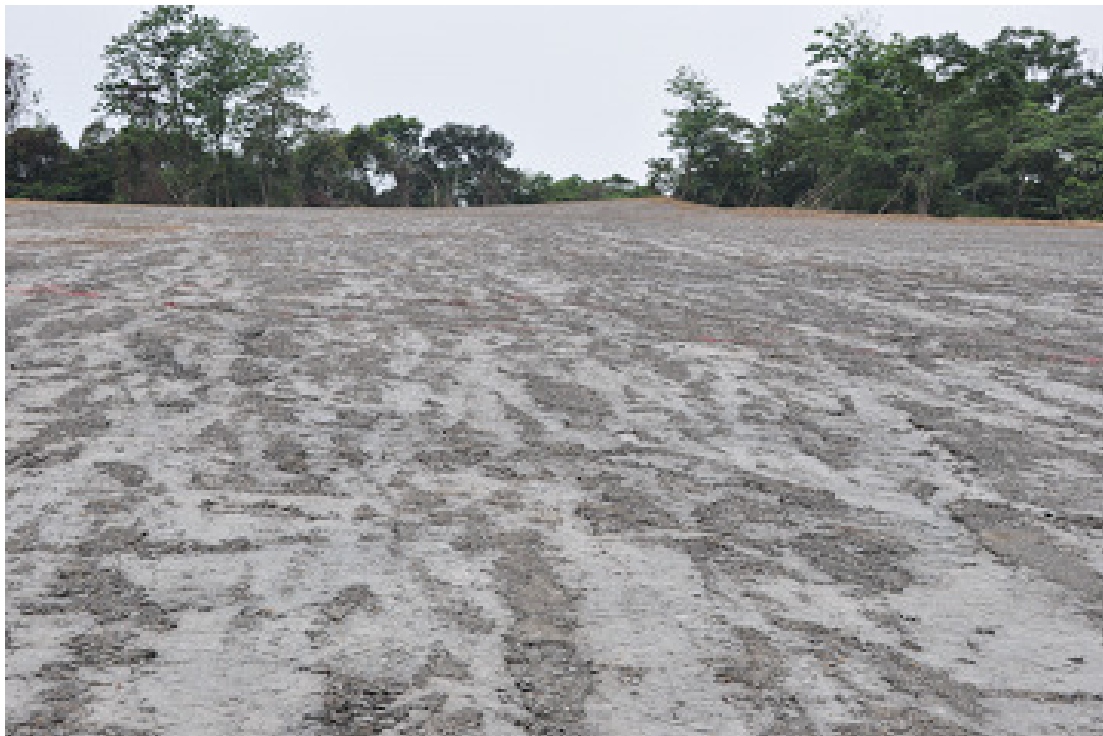
(a) Upper part of the sliding failure plane (no anchor deployed)

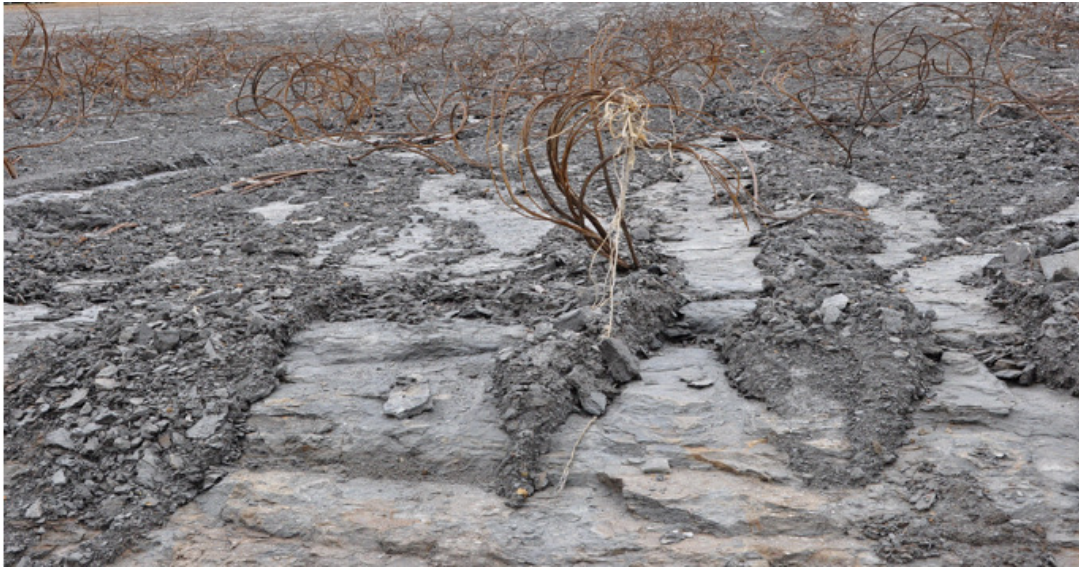
5b shows that the cracking was very serious on the surface of the shale for the lower part. A comparison of Figure 5a and Figure 5b shows that the anchors remaining on the sliding failure plane were rusted, but the tensile strength was still high, causing the surface of the shale adjacent to the anchors to be seriously cracked when the anchors were pulled off. In addition, the in-situ tensile strength test results of the anchors can also be used to prove that the anchors were rusty, but their tensile strengths were still high.

(b) Lower part of the sliding failure plane (the deployed anchors have been pulled off)

Figure 5b shows that the snapped anchors remaining after the disaster including steel strands of the free length on the sliding failure plane and the fixed length embedded below the sliding failure plane.

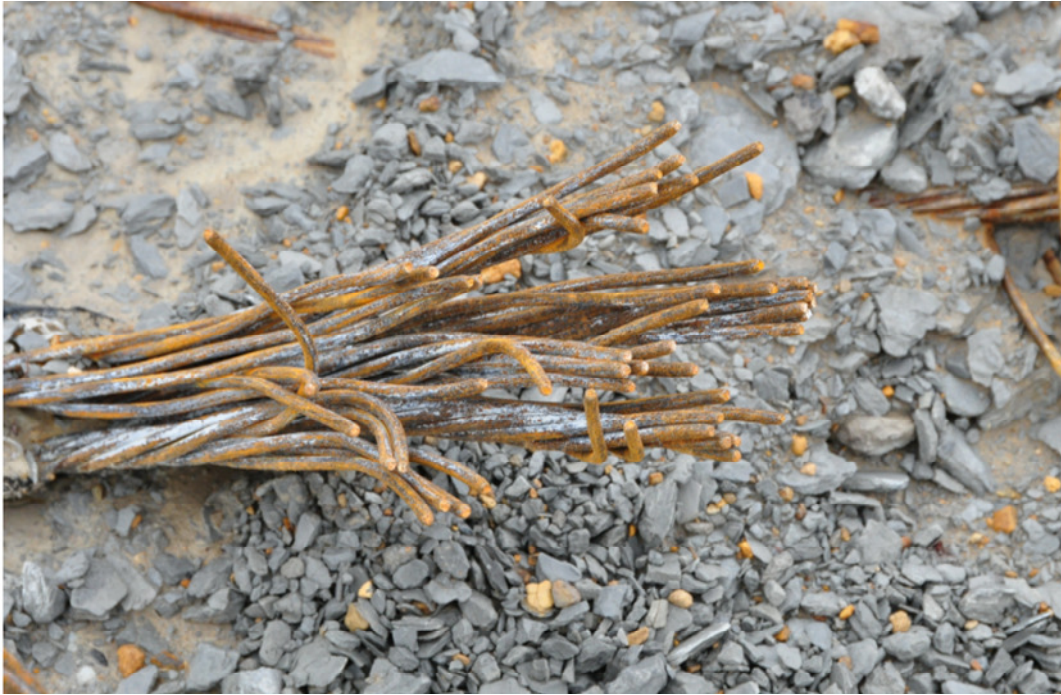
Before conducting the tensile strength test on the first set of anchors, five anchors were randomly selected; the steel strands were cut and prepared as test samples (detailed in Figure 6). Afterwards, the tensile strength test of the anchors was carried out separately, and the test results are shown in detail in Table 1.

Figure 6. Test anchors remaining on the sliding failure plane

The first set tensile strength test results of anchors in Table 1 show that: (1) when the tensile force applied reached 1098kN, all five test anchors did not snap; in other words, the tensile strength of all the test anchors was greater than 1098kN; and (2) since the initial tensile strength of this type of anchor was 1285kN (Taiwan Geotechnical Society, 2011), it is known that the influence of corrosion on the tensile strength of the anchor is not large.

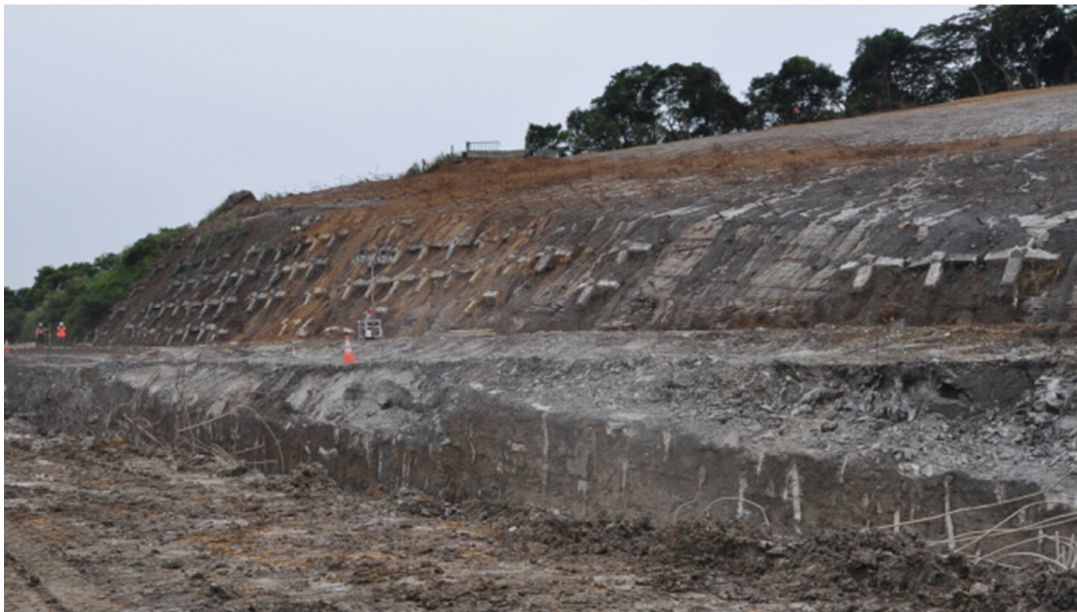
For the second set of anchor tensile strength tests, five test anchors were randomly selected from the remaining anchors shown in Figure 7. Since the 5 test anchors were located below the sliding failure plane, they were retained intact after the disaster. Figure 8 shows the strength test of the second set of anchors in the field; the test results are shown in detail in Table 2.

Figure 7. Anchors that were completely intact below the sliding failure plane

For the anchor in the residual anchor block slope below the sliding failure plane after the disaster shown in Figure 7 and Figure 16b④, the effect of the total shear band width No. 2 on all five anchors are shown in Figure 12, Figure 13, and Figure 16. In other

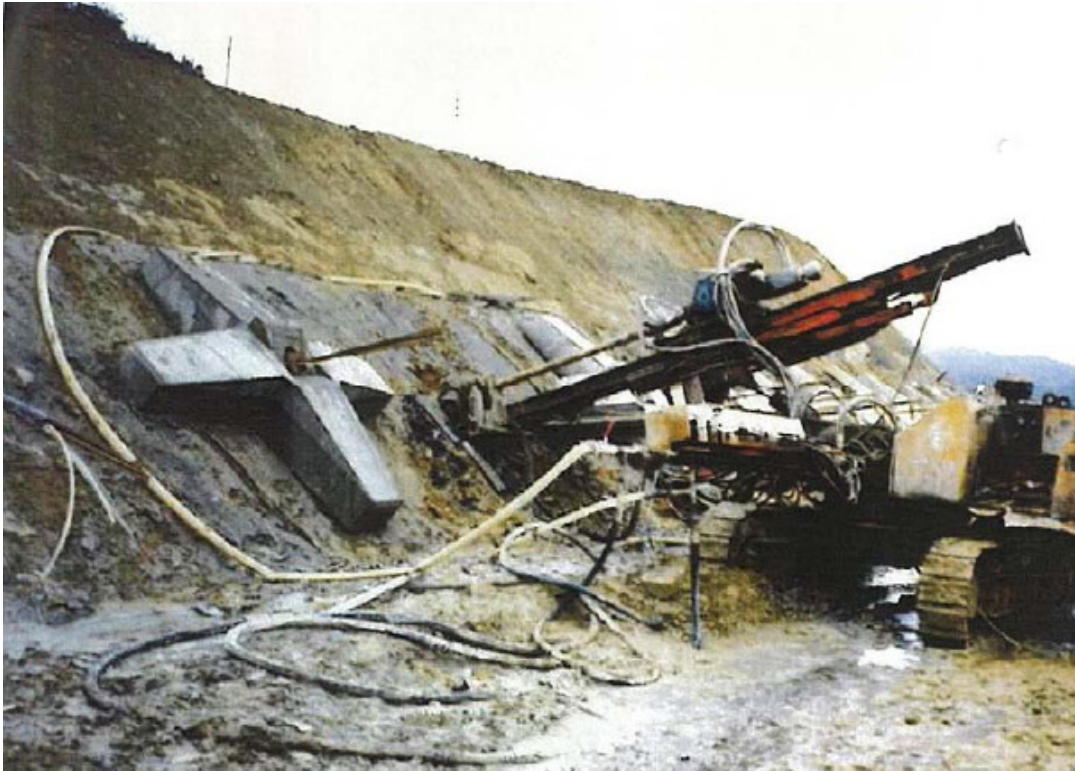
Figure 8. Tensile strength tests for the second set of anchors (Taiwan Geotechnical Society, 2011)

For the 5 test anchors that were completely intact on the remaining anchor block slope after the disaster occurred, according to Table 2: (1) among all 5 test anchors, only one test anchor had a lower tensile strength than the designed tensile strength; and (2) since the initial tensile strength of this anchor was 1285kN (Taiwan Geotechnical Society, 2011), it is known that the tensile strength reduction of these 5 experimental anchors were 28.4%, 31.3%, 51.9%, 54.2%, and 61.9%.

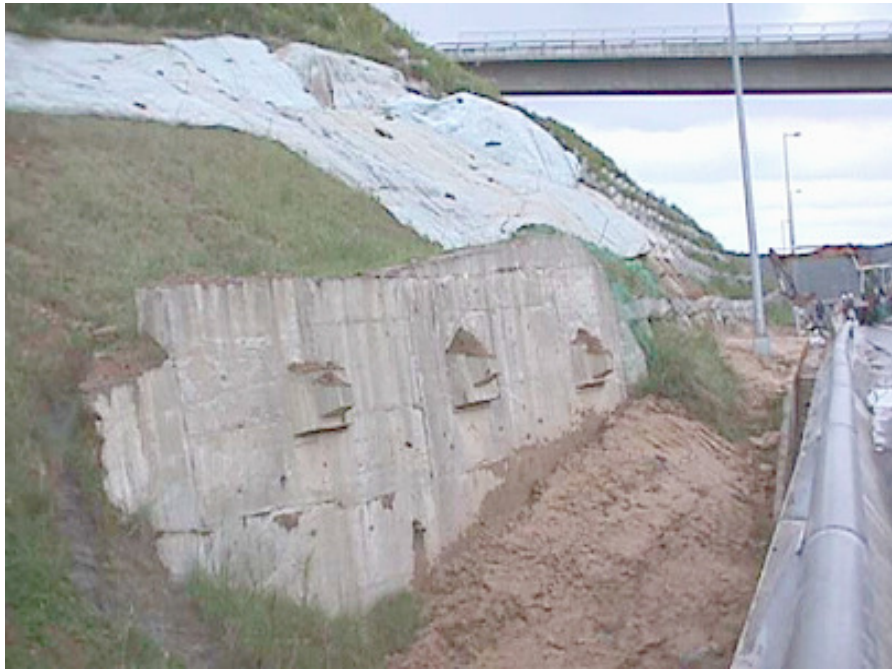
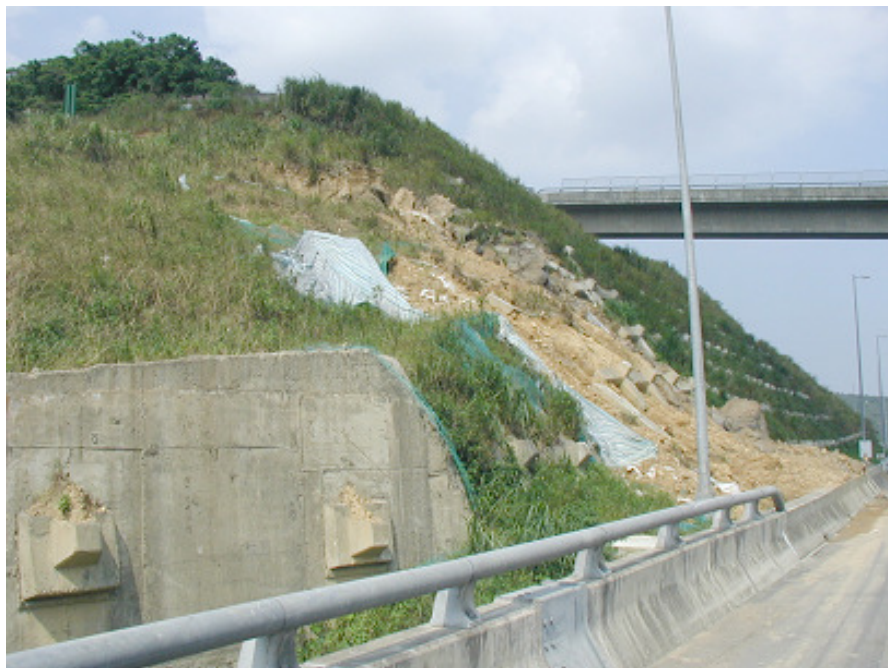
1. During Typhoon Xangsane in 2000 and Typhoon Nari in 2001, slope failures occurred locally on the southwest side of the sliding block (detailed in Figure 9).
2. With the shear banding of the block, the pier of the elevated land bridge, as shown in Figure 10, was squeezed, causing bending deformation and cracking phenomena to appear locally.
3. The anchor block slope induced shear textures of various strikes, as shown in Figure 1, with slow sliding.
4. The cementitious materials of the shear band rocks exuded onto the retaining wall (detailed in Figure 12a).
5. Due to the excessive amount of shear banding, local abrupt cracking occurred on the abutment of the expressway (detailed in Figure 12b).

(a) During Typhoon Xangsane

(b) During Typhoon Nari

Figure 9. Local slope failures appearing on the southwest side of the sliding block  
(Taiwan Geotechnical Society, 2011)

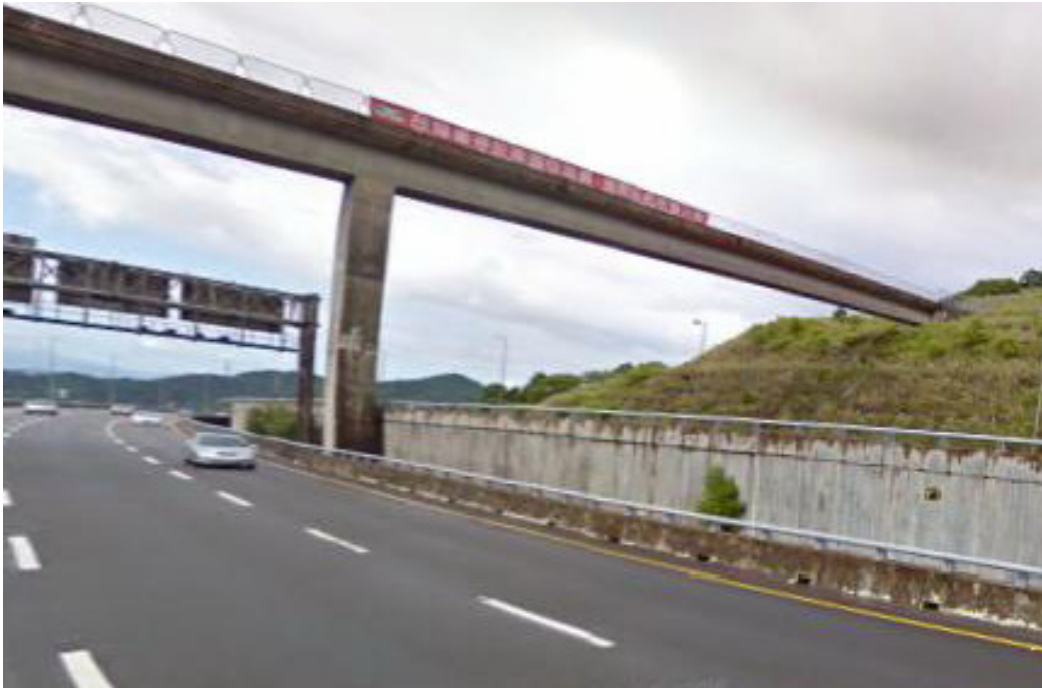
Figure 10. Bending deformation and cracking on the pier (Google Earth, 2010)

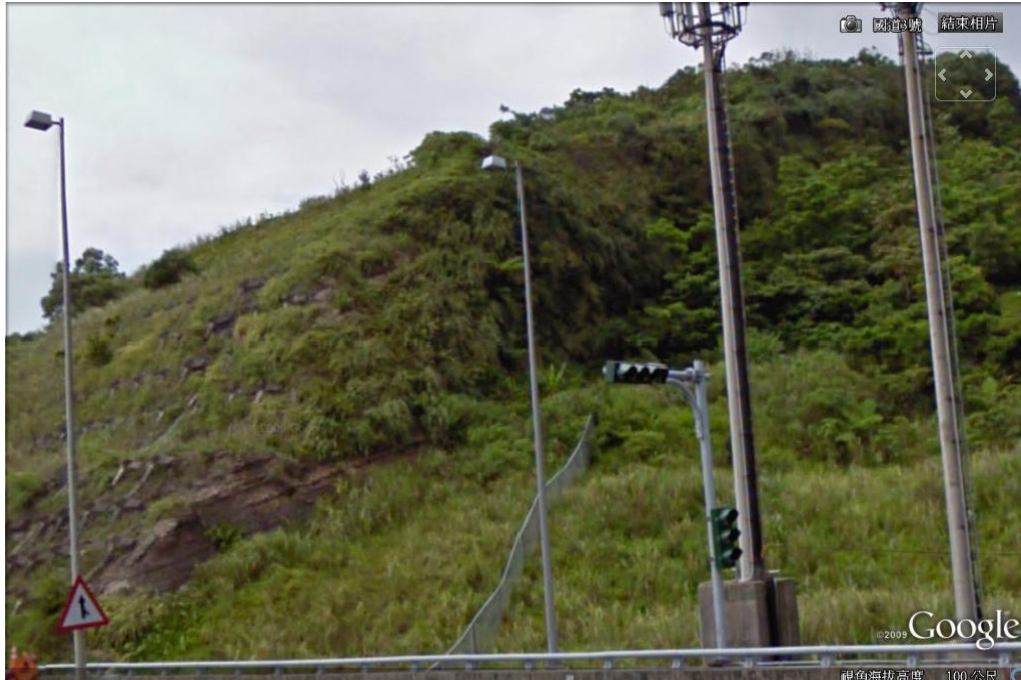
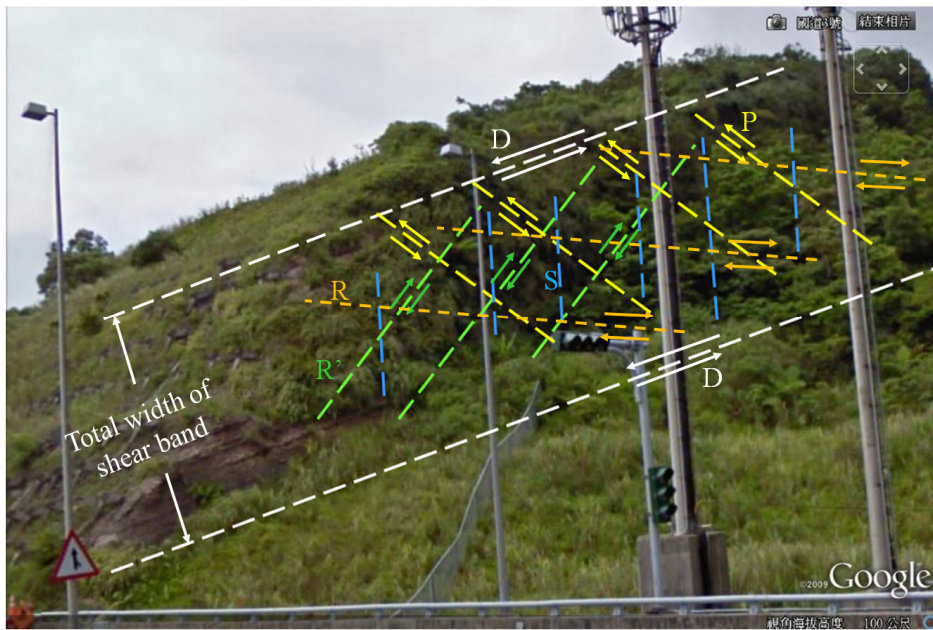
Figure 11. Shear band and various shear textures existing in the sliding block  
(background image from Google Earth, 2010)

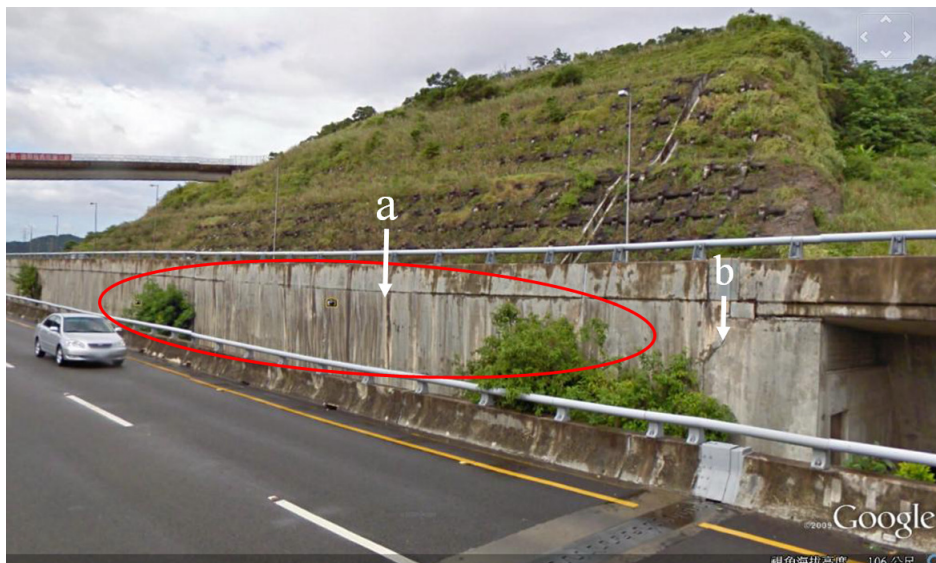
Figure 12. The a in the figure is the cementitious materials exuded from the shear band rock to the retaining wall, and b is the local fracture of the abutment induced by shear banding (background image from Google Earth, 2010)

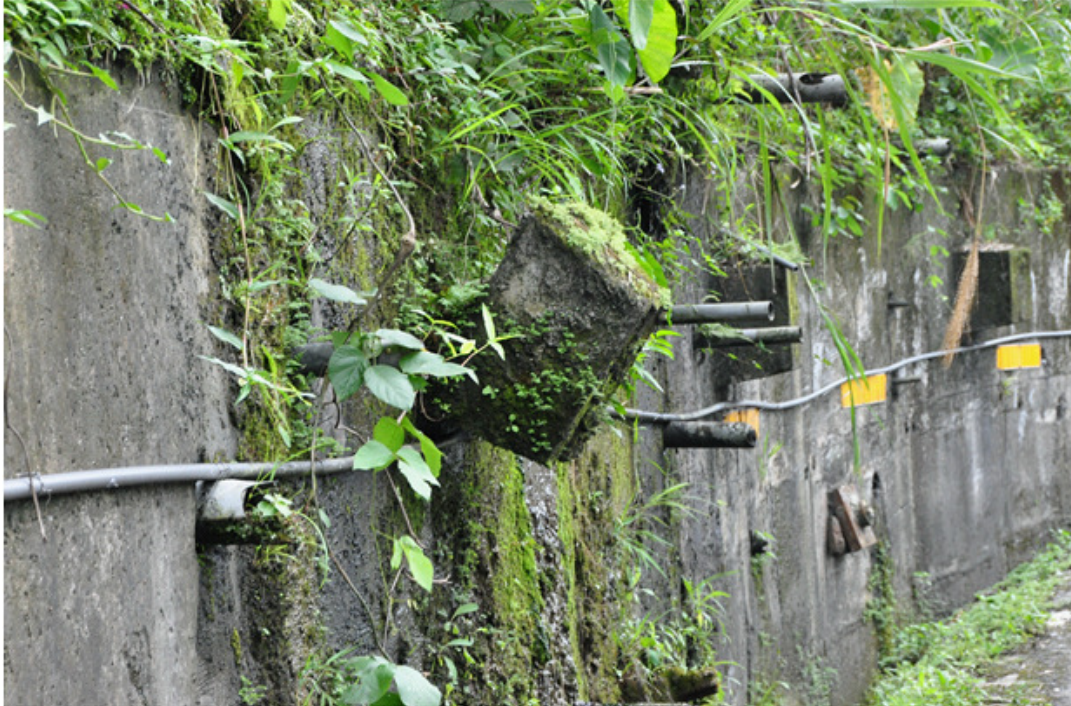
However, the actual anchor may have the fracture damage of the free length shown in Figure 15 when the amount of

shear banding is adequately large; therefore, it is impossible to maintain a very slow sliding state for 20 years.

Figure 15. Damage of the anchor head induced by the breaking of the free length
