## COMPARISON OF REPAIR METHODS FOR CRACKED EARTH DAMS BASED ON DIFFERENT TECTONIC EARTHQUAKE EFFECTS

Tse-Shan Hsu

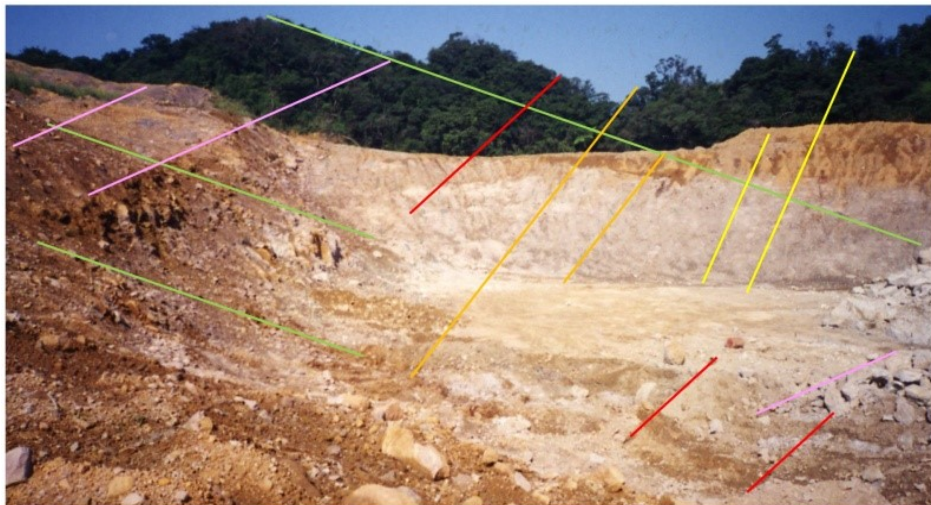
(a) After the earth dam was excavated, it was discovered that the shear bands from the valley and river bank had extended into the earth dam.

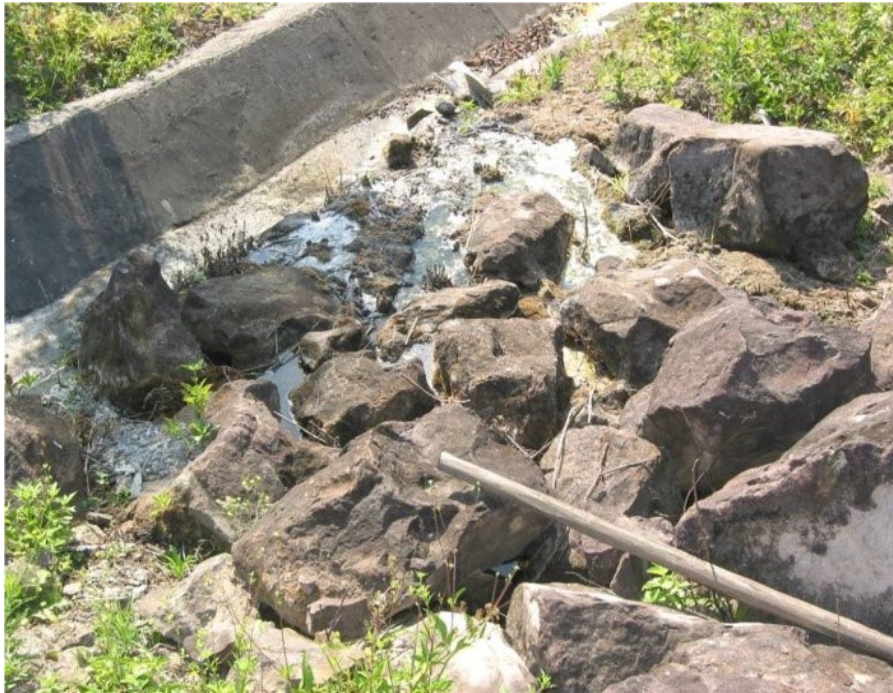
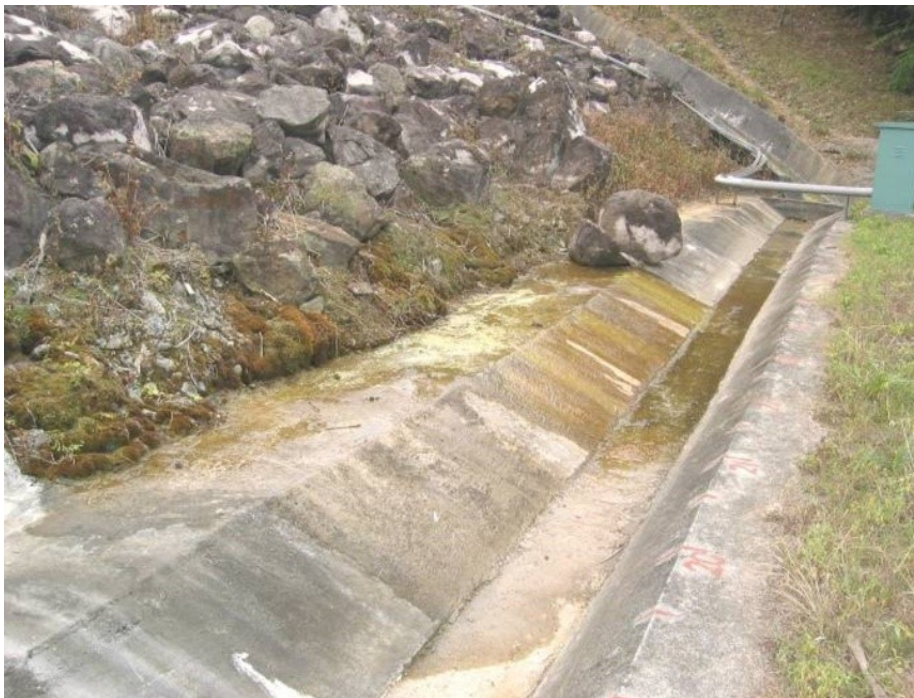
(c) On-site water leakage phenomenon 1.

(d) On-site water leakage phenomenon 2.

Figure 3. Water leakage induced by the extension of shear bands into the earth dam (Xinshan Earth Dam, Taiwan; Lin, 2009).

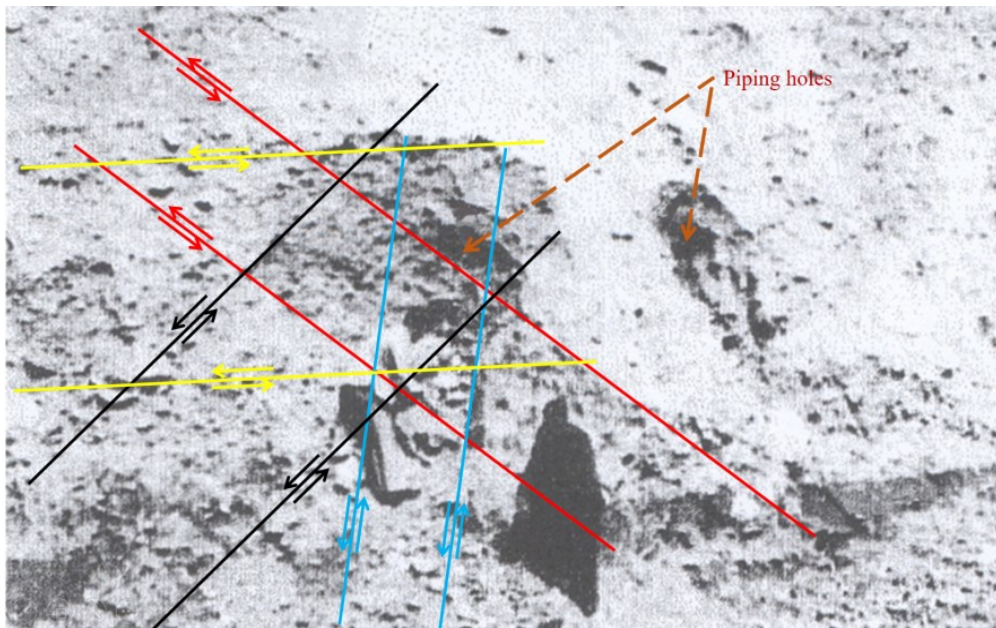
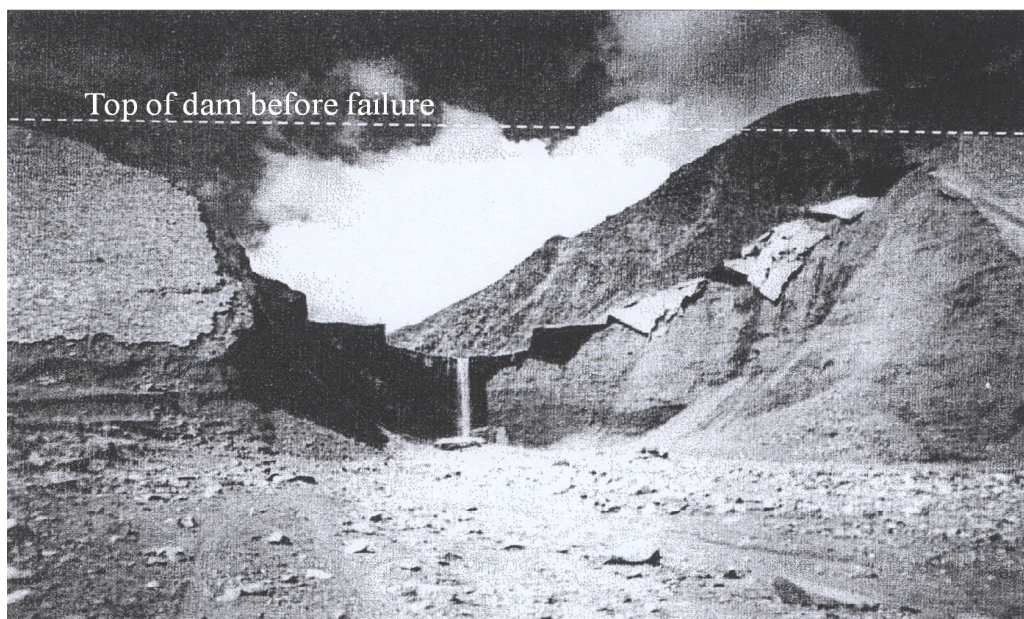
(c) The piping holes induced by the shear bands extending into the earth dam.

(d) The piping failure induced by the shear bands extending into the earth dam.

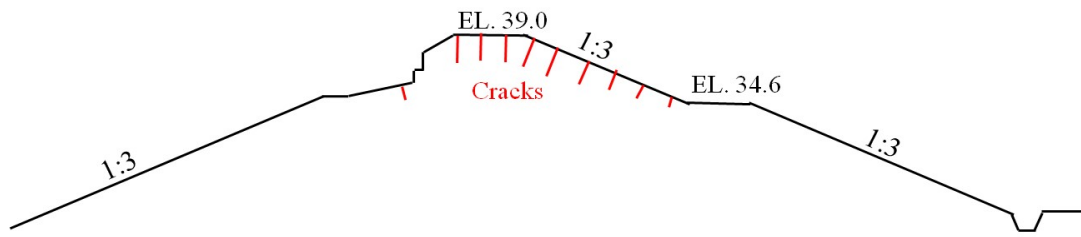
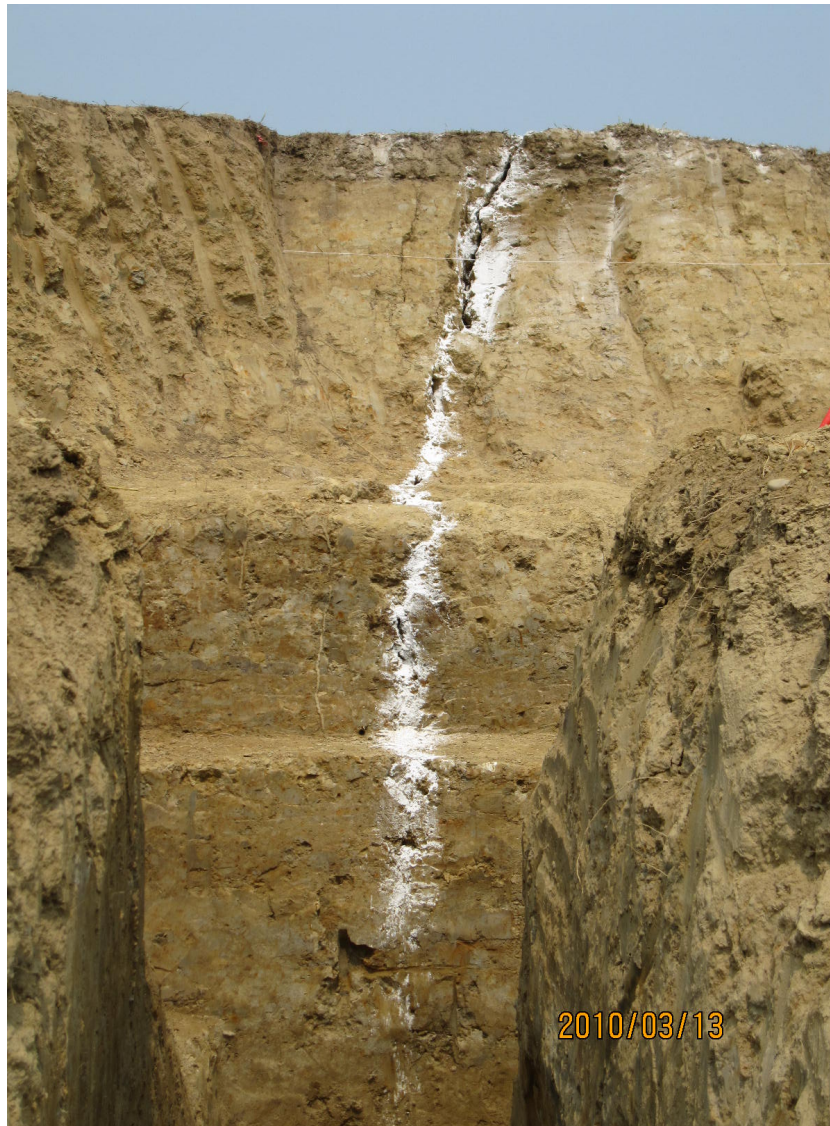
(a) The results of the survey using ground penetrating radar.

(b) The results of the investigation using in-situ excavation methods.

Figure 7. The coverage and depth of cracks as determined by conventional investigation methods (Jianan Farmland Water Conservancy Association, 2012).

Using the results of the investigation of the cracks, the engineering design for the repair was performed. Then, the site was excavated, layered with backfill, and rolled (see Figure 8). The backfill material was a mixture of the original dam body material and borrowed soil, which has properties that are nearly equal to those of the original

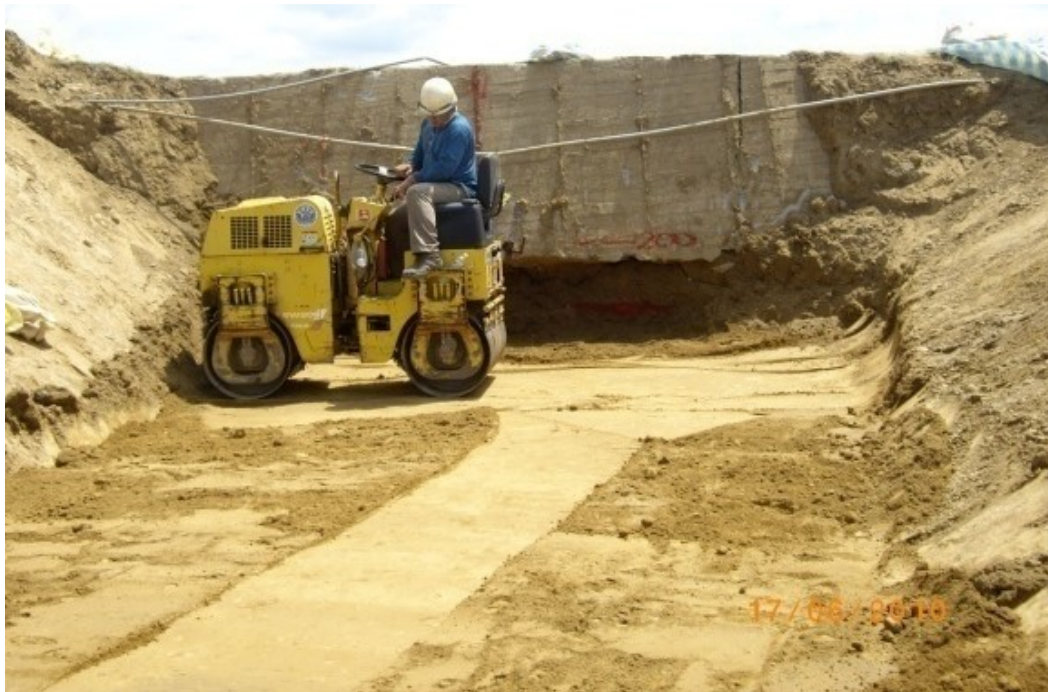
Figure 8. Layered backfilling and rolling operations for the Jiaxian Earthquake Restoration Project of the Hutoupi Earth Dam (Jianan Farmland Water Conservancy Association, 2012).

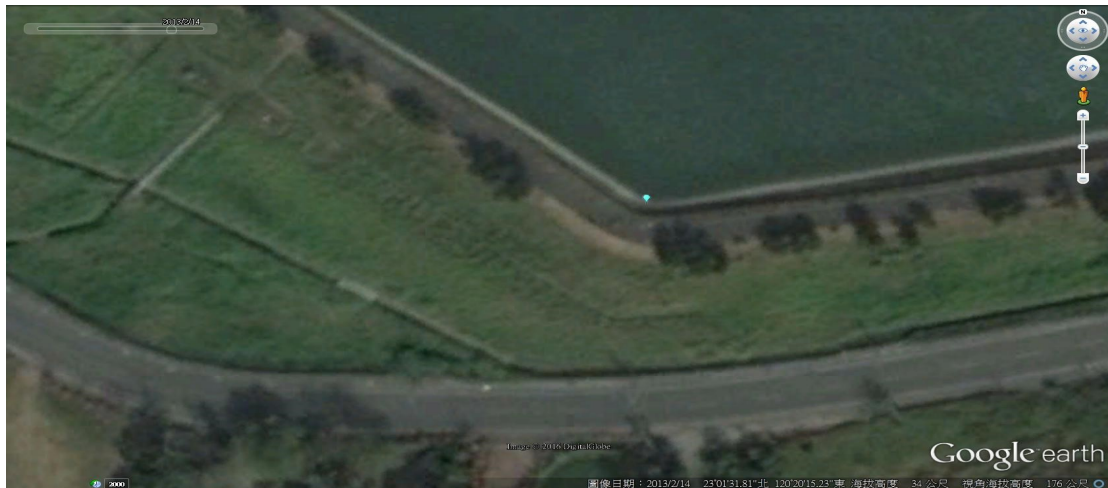
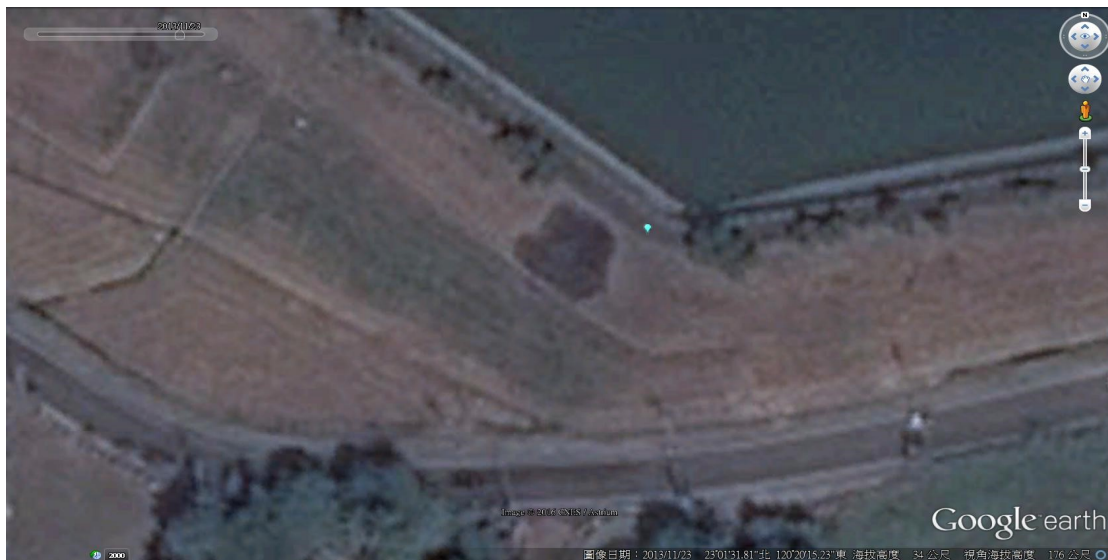
2013 (Figure 9a) was approximately the same as that of the completed project in 2010. However, a satellite image from November 23, 2013 shows that

the repaired earth dam began leaking again (see Figure 9b). Therefore, it can be concluded that the Jiaxian Earthquake Restoration Project, which was planned based on ground vibrations as

the earth dam cracking mechanism, did not meet the requirements for withstanding shear banding during tectonic earthquakes, regardless of the material, coverage, or extension depth.

Figure 9. After the Jiaxian earthquake, the Hutoupi Earth Dam restoration project was completed, and the turning point leaked again (Google Earth, 2021).

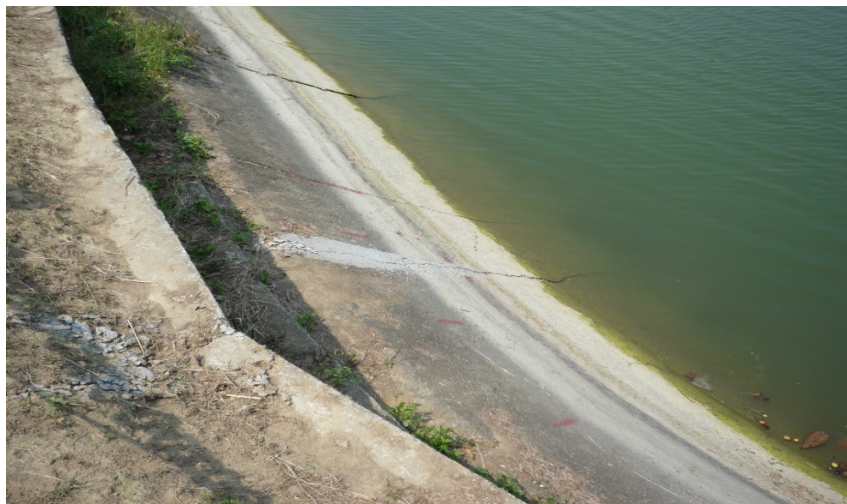
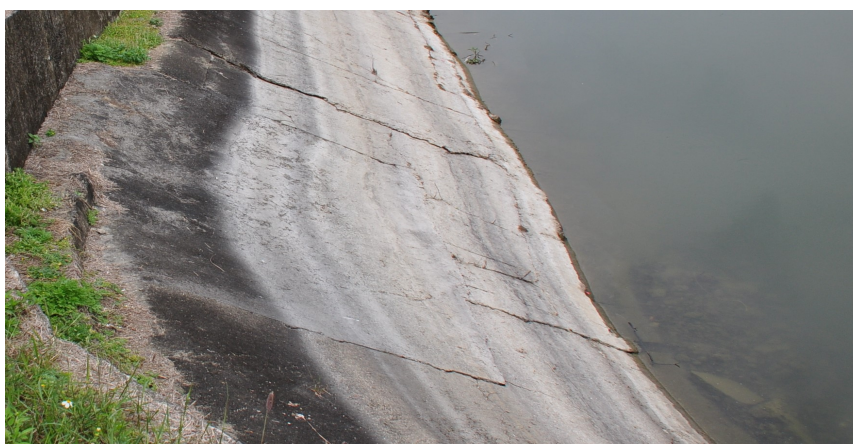
(a) 2010 Jiaxian Earthquake.

(b) 2016 Meinong earthquake.

Figure 10. Comparison of the degree of cracking in the turn of the Hutoupi Earth Dam.

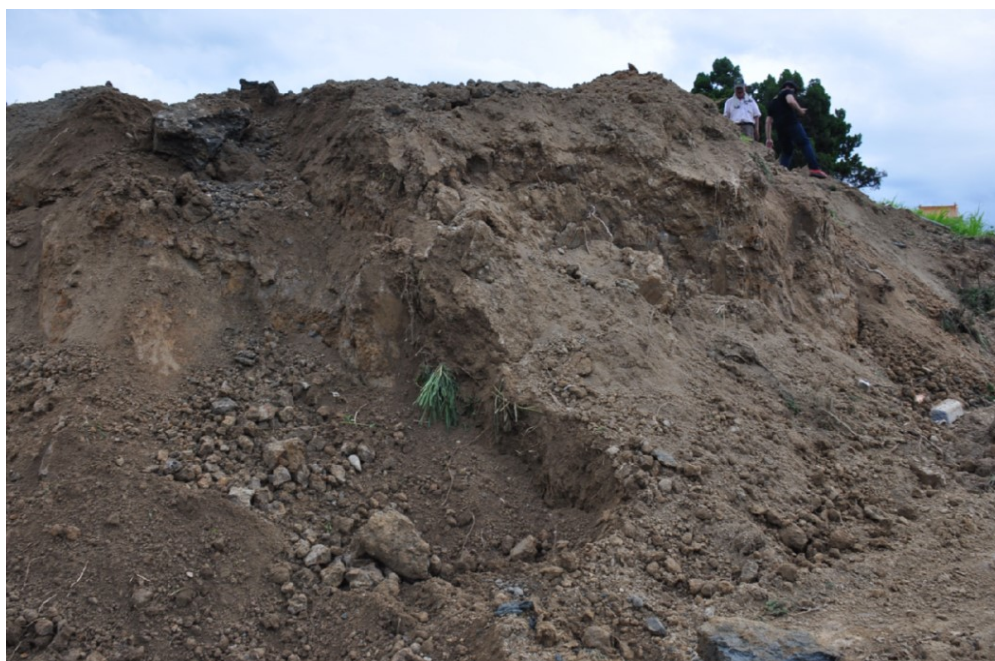
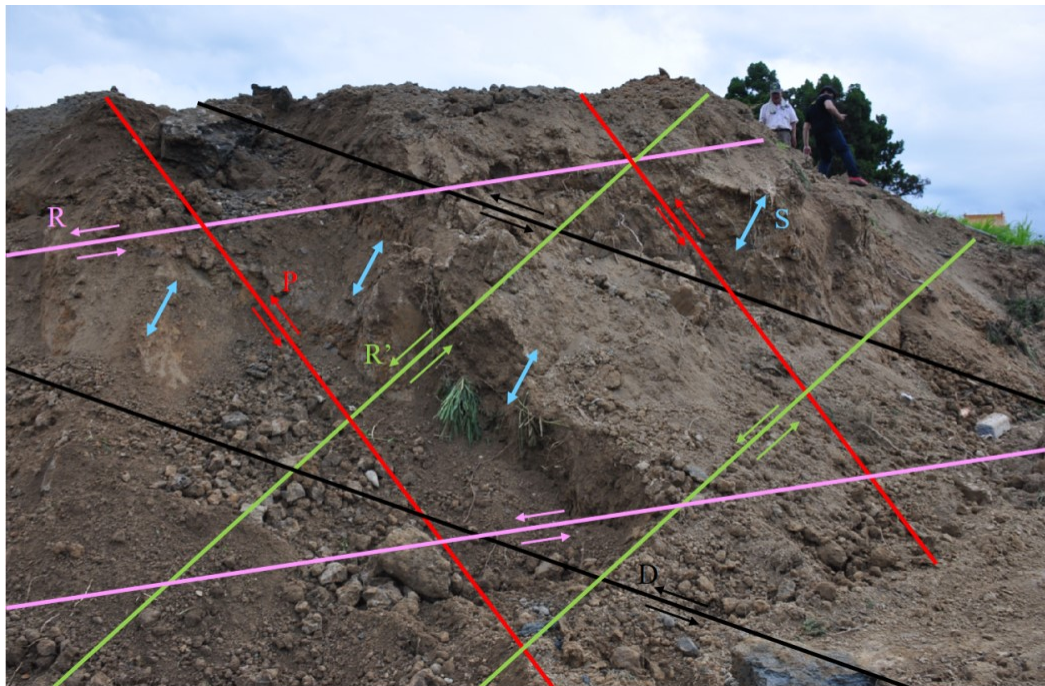
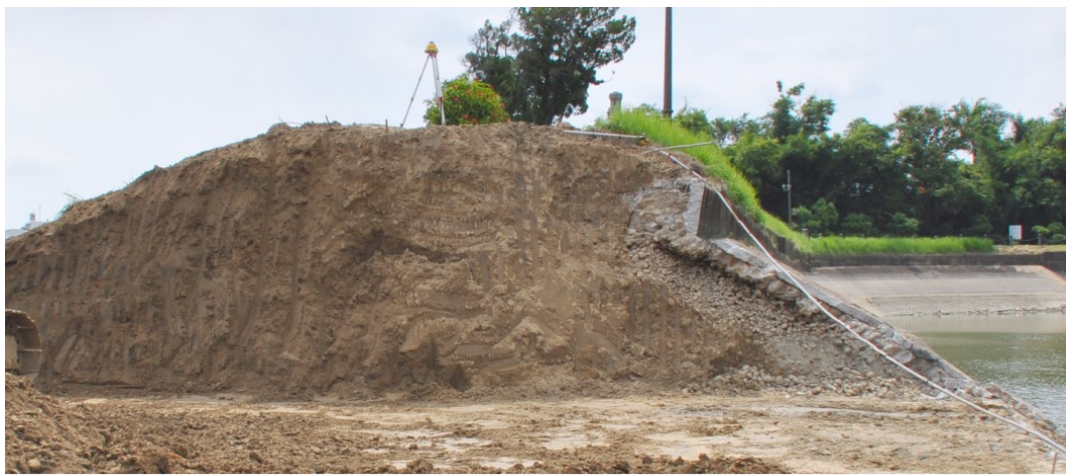
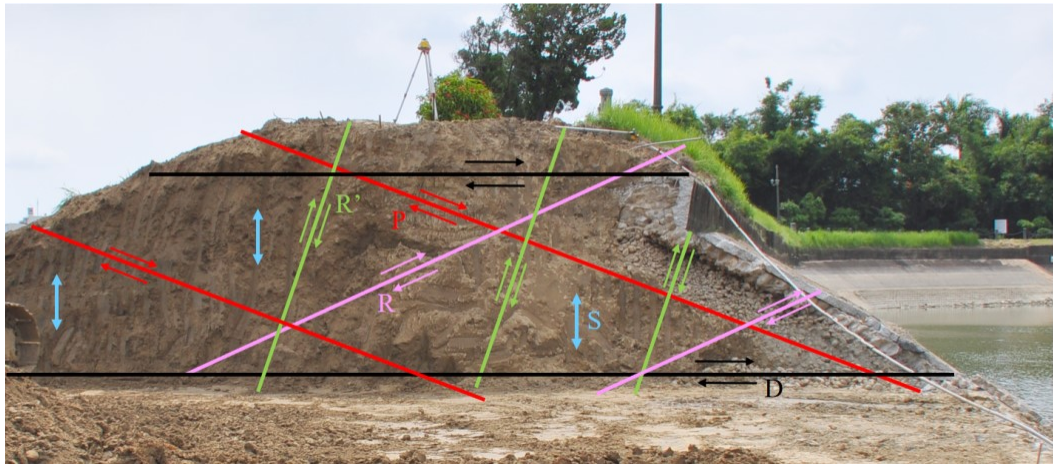
The excavated Hutoupi Earth Dam turn is shown in Figure 13a. Figure 13b shows that all five groups of shear textures, including the principal deformation shear D, thrust shear P,

Riedel shear R, conjugate Riedel shear R', and compression shear (shown in Figure 12) extended into the turn of the Hutoupi Earth Dam.

Figure 13. After the Meinong earthquake, the excavation of the Hutoupi Earth Dam revealed that the shear textures of a shear band extended into the earth dam.

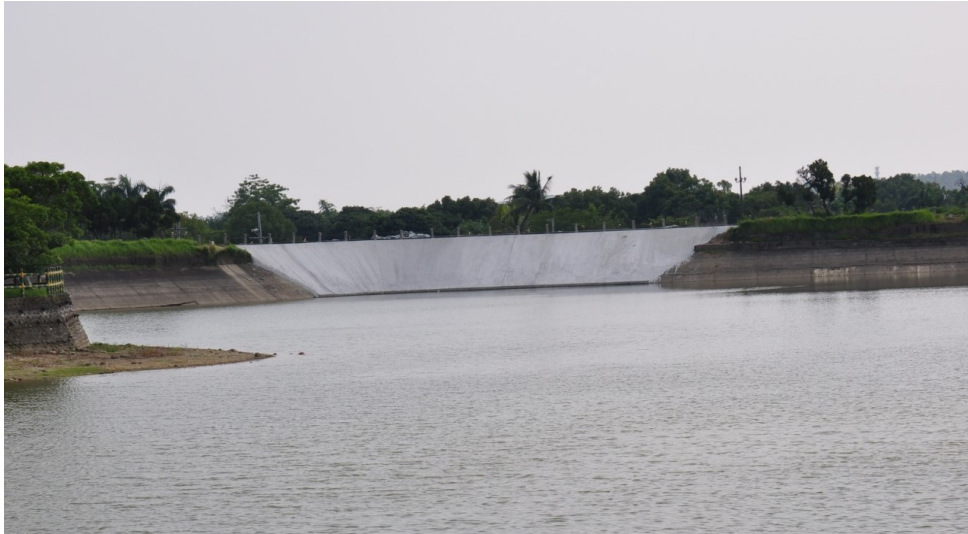
Figure 16 shows the status of the restoration work at the turn of the Hutoupi Earth Dam after its completion in August 2016.

Since the completion of the restoration project after the Meinong earthquake, seventy-one tectonic earthquakes with  $M_L = 5.0$  to 5.4, twenty-nine tectonic earthquakes with  $M_L = 5.5$  to 5.9, and twelve tectonic earthquakes with  $M_L = 6.0$  to 6.7 have occurred in Taiwan. However, the turning area of the Hutoupi Earth Dam has not experienced cracking problems during this time.
