A NEW METHOD FOR DAM FAILURE POTENTIAL
EVALUATION BASED ON SHEAR BAND
DISPLACED LANDFORM FEATURES

Keywords: tectonic earthquakes, shear banding, ground vibration, safety evaluation, failure potential evaluation.

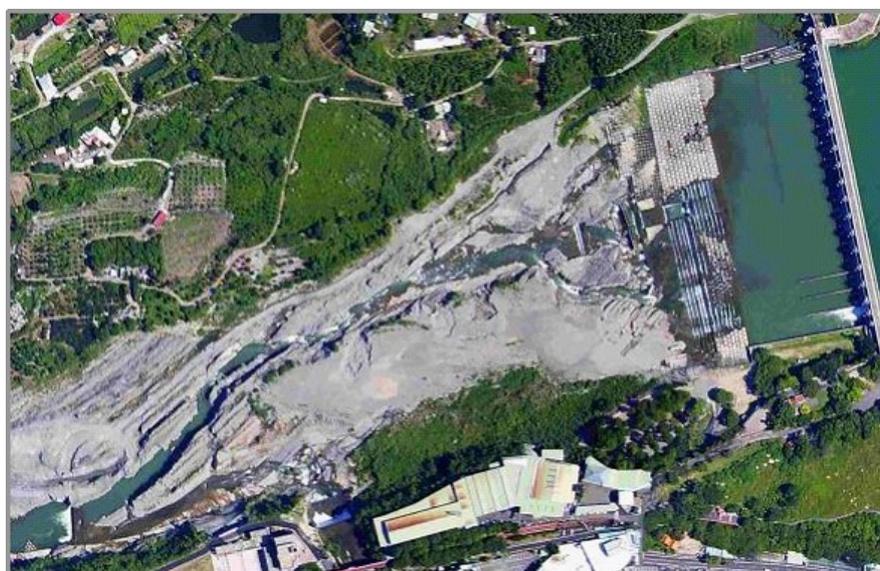
In reality, the riverbed where the dam is located has deep grooves in the shear bands with brittle fractures (Figure 4), the amount of which increases year after year. Therefore, every analysis condition used in the safety assessments of the dam body carried out cannot be the same every five years. The shear-band riverbed with discon-

Figure 4. The Shigang Dam, constructed on a riverbed with deep troughs and discontinuous, brittle, and unsteady shear bands (Google Earth, 2021).

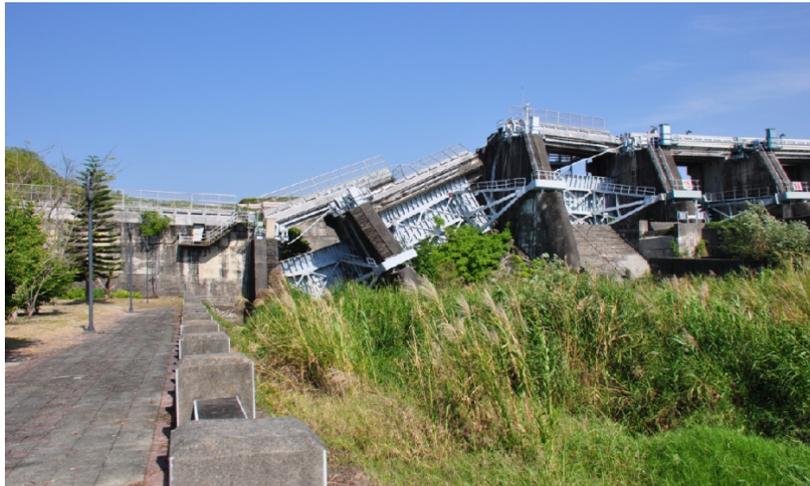
tinuous, brittle, and unsteady conditions will also extend towards the dam body, thus weakening it and inducing damage (Figure 5). The groundwater flowing through the shear-band riverbed at the bottom of the dam is actually an unsteady pipe flow, which will induce piping failure.

Figure 5. The 921 Earthquake; the shear band extending obliquely upward from the riverbed into the dam body induced the failure of the Shigang Dam.

When the upward tilted shear band (Figure 5) or the horizontal displaced shear band (Figure 6) extends into the dam body, it will undergo shear-band fracture damage. Therefore,

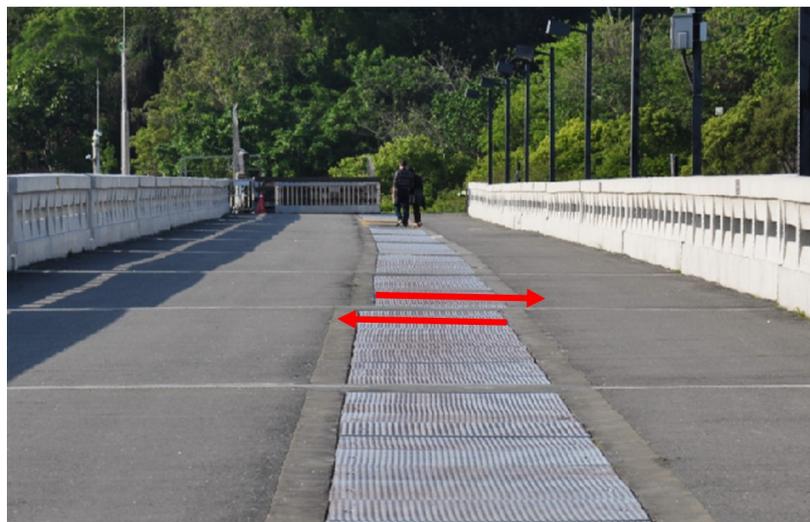
local fracture damage in the dam body is caused by shear banding derived from localizations of deformations, rather than by ground vibration.

Figure 6. The 921 Earthquake; the horizontal shear banding of the riverbed extended into the dam body and induced damage to the Shigang Dam.

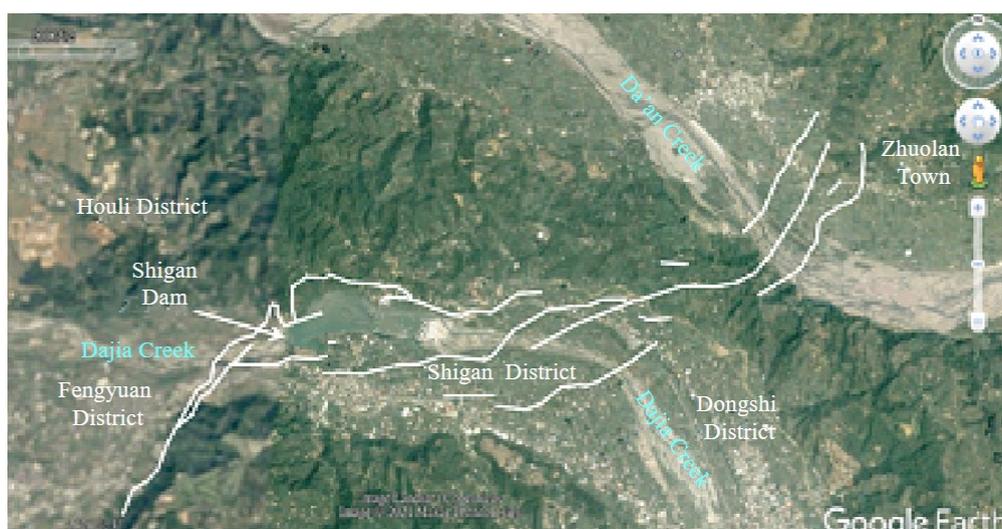
However, in the 921 Earthquake, the Chelongpu Fault passed directly through the Shigang Dam (Figure 8), and the dam body was locally fractured

and destroyed (Figures 5 and 6). This is sufficient to prove that the active fault and weak vibration areas announced by the government are inconsistent with reality, and seriously misled the design of the Shigang Dam.

Figure 8. The Chelongpu Fault, which passes directly through the Shigang Dam (background image is from Google Earth, 2021).

Because the Chelongpu Fault clearly passed through the Shigang Dam and caused the fracture damage to the dam body, the design fault changed from the Sanyi Fault to the Chelongpu Fault. The least distance between the Shigang Dam and the design fault (r_{rup}) also changed from 4.5 km to 0.0 km, and the peak ground acceleration (PGA) calculated by the attenuation formula changed from 0.5 g to infinity.

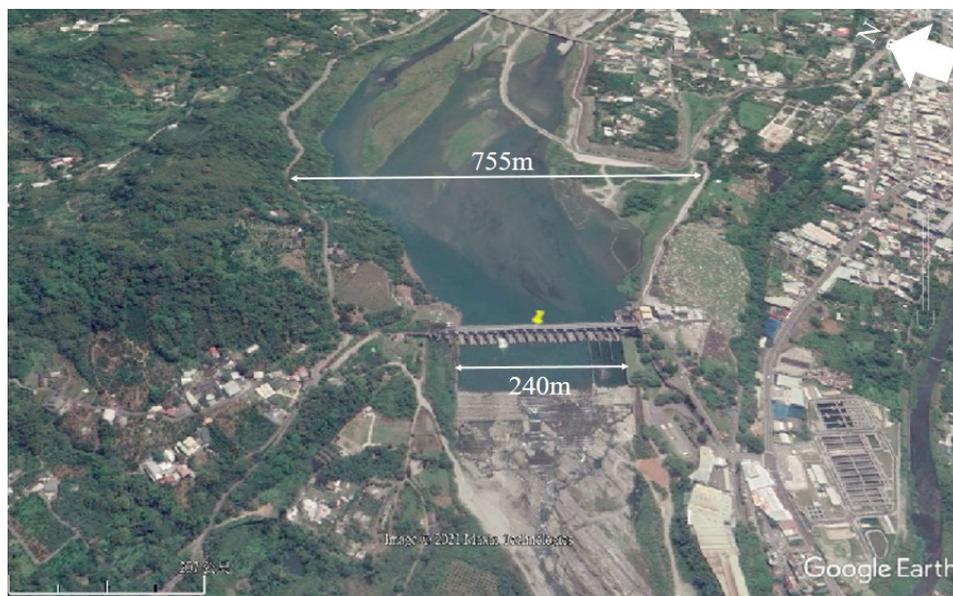
Figure 9 shows that the maximum width of the riverbed sections upstream and downstream of the Shigang Dam are 755 m and 240 m, respectively. It is clear that the width of the downstream riverbed section is necked to 32% of that of the upstream riverbed. Since the degree of necking of the riverbed section downstream of the dam is a shear-band displaced landform feature, it can be used as an index for the evaluation of the dam failure potential.

Figure 9. The Shigang Dam is located at the necking position of lateral plate compression (background image is from Google Earth, 2021).

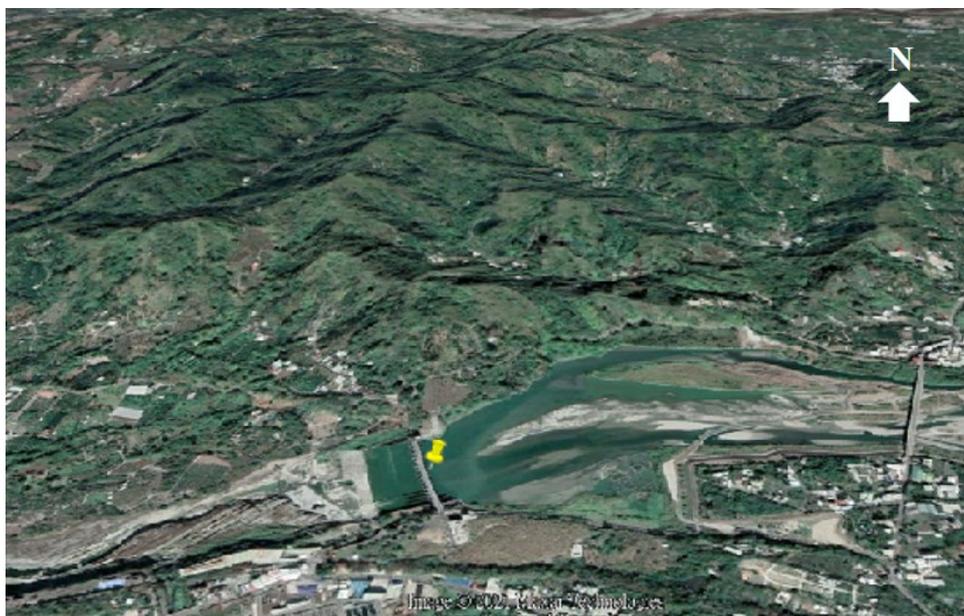
Figure 10 shows high-density triangular facets on the upper and lower slopes adjacent to the right bank of the Shigang Dam. Since triangular facets are a shear-band displaced landform feature, the density of the triangular facets on the slopes upstream of the dam can be used as an index for the evaluation of the dam failure potential.

The dam axis extension of the Shigang Dam is connected to the right bank ridge (Figure 10), where the thickness of the ridge decreases substantially. Since the change of ridge thickness is another shear-band displaced landform feature, it can also be used as an index for the evaluation of the dam failure potential.

Figure 10. High-density triangular facets on the right bank slope upstream of the Shigang Dam (Google Earth, 2021).

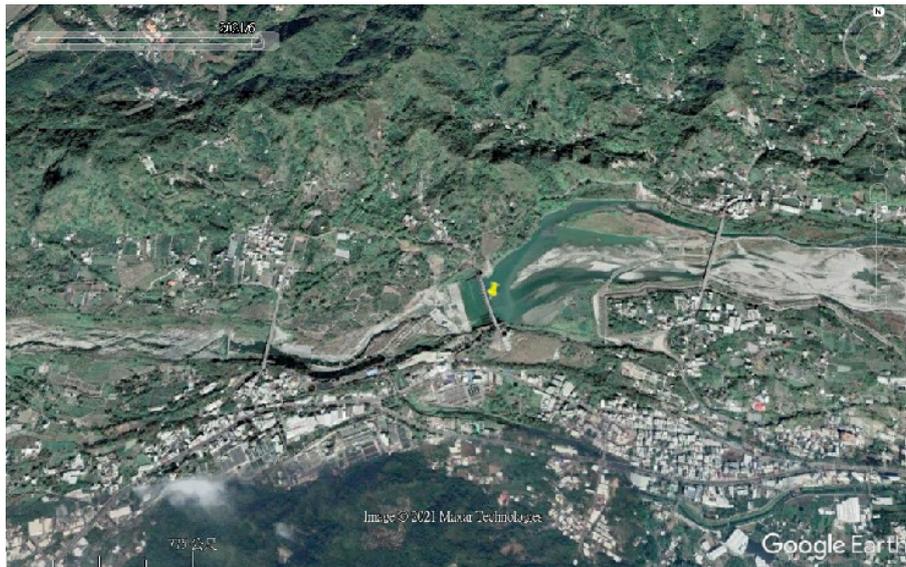
Figure 11 shows that the river upstream and downstream of the Shigang Dam has a high degree of meandering, which is also a shear-band displaced landform feature, so it can be used as an index for the evaluation of the dam failure potential.

Figure 11. The meandering appearance of the river upstream and downstream of the Shigang Dam (Google Earth, 2021).

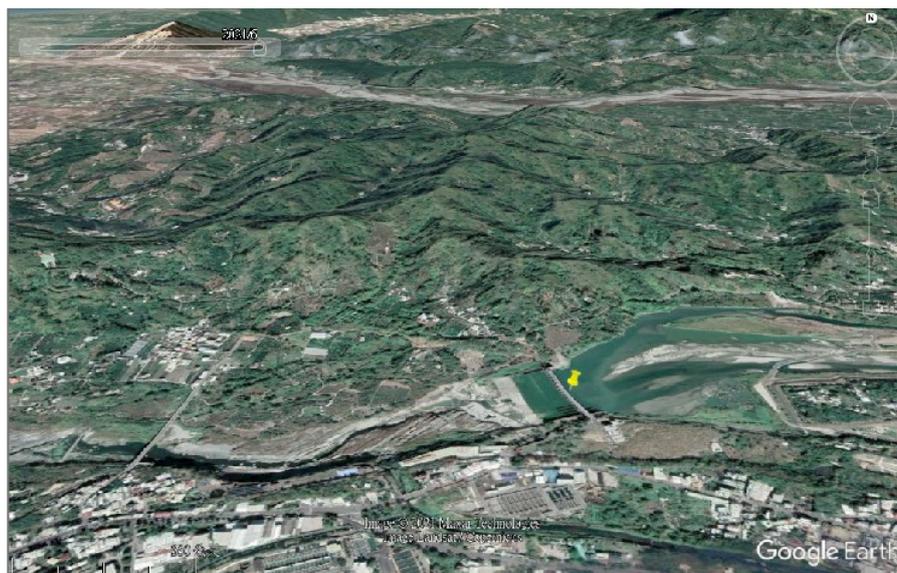
In addition, Figure 12 shows that the Shigang Dam is located in an S-shaped bend of the river, which is another shear-band displaced landform feature that can be used as an index for the evaluation of the dam failure potential.

Figure 12. The Shigang Dam is located in an S-shaped bend of the river, and the ridgeline of the adjacent mountains is undulating and winding (Google Earth, 2021).

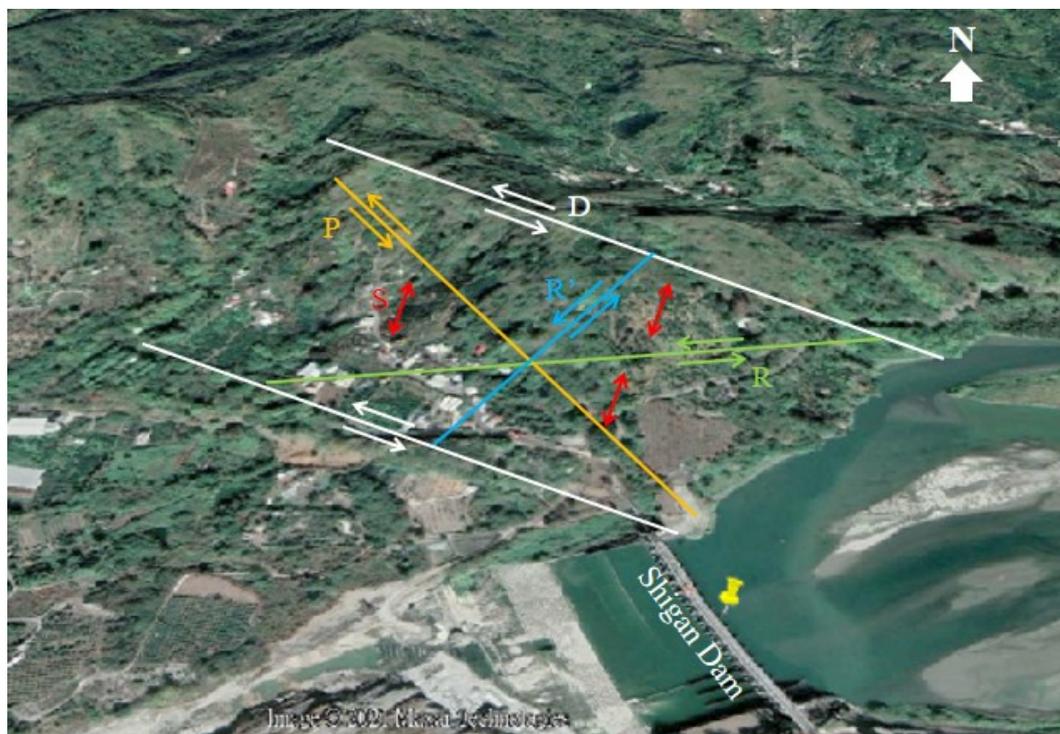
Finally, Figure 13 shows that there is a shear band on the slope next to the upper right bank of the Shigang Dam,

and there are five different strike shear textures within the total width of the shear band. Since the displacement of

the shear band and the shear texture increase the degree of brittle fracturing in the rock slope, the existence of shear

bands and shear textures can be used as an index for the evaluation of the dam failure potential.

Figure 13. Shear band and shear textures on the right bank slope upstream of the Shigang Dam (background image is from Google Earth, 2021).

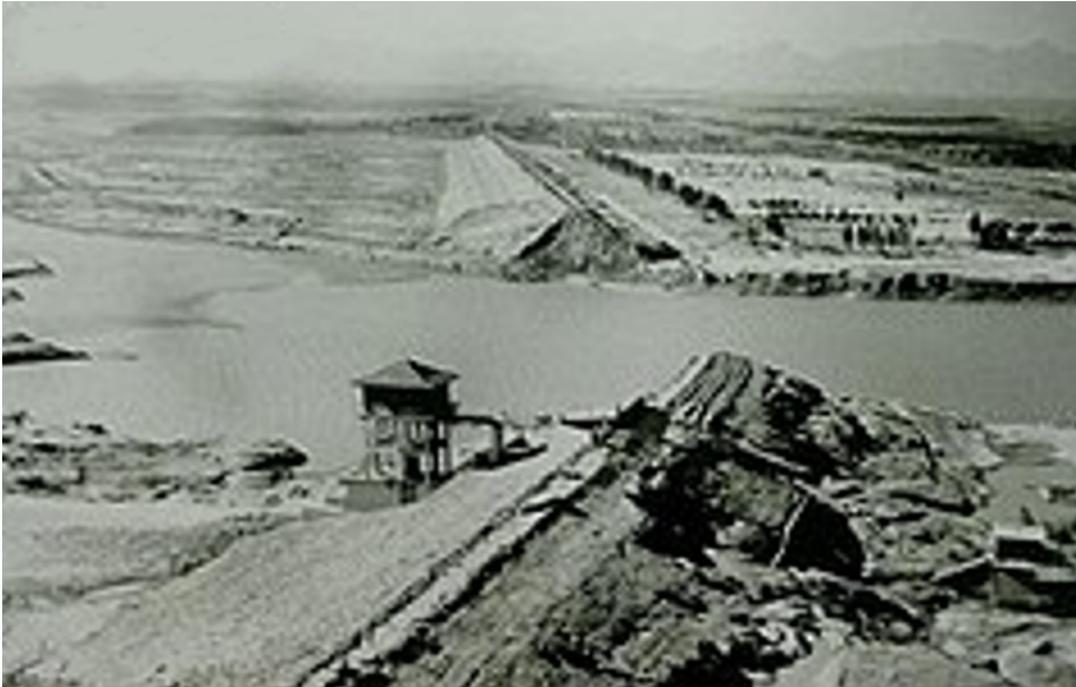
stroyed on August 8, 1975 during Typhoon Nina (Figure 14). After that, 61 dams downstream continued to fail. The flood inundated 17.8 million acres of farmland in 30 cities, resulting in the collapse of 6.8 million houses, the death of 240,000 people, and the loss of 11 million homes. This is the worst dam breach in the world.

Figure 14. Destruction of the Banqiao Dam (Wikipedia, 2021a).

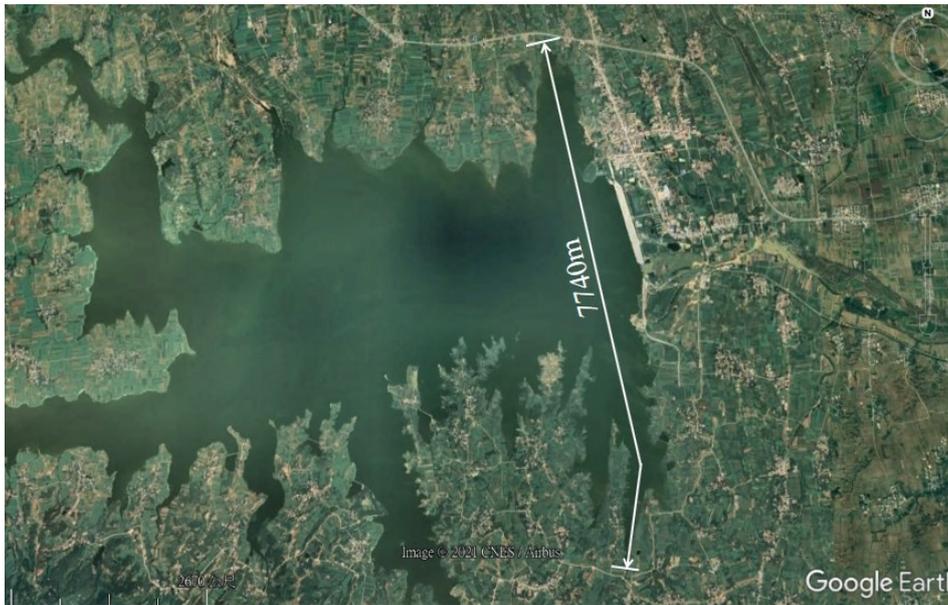
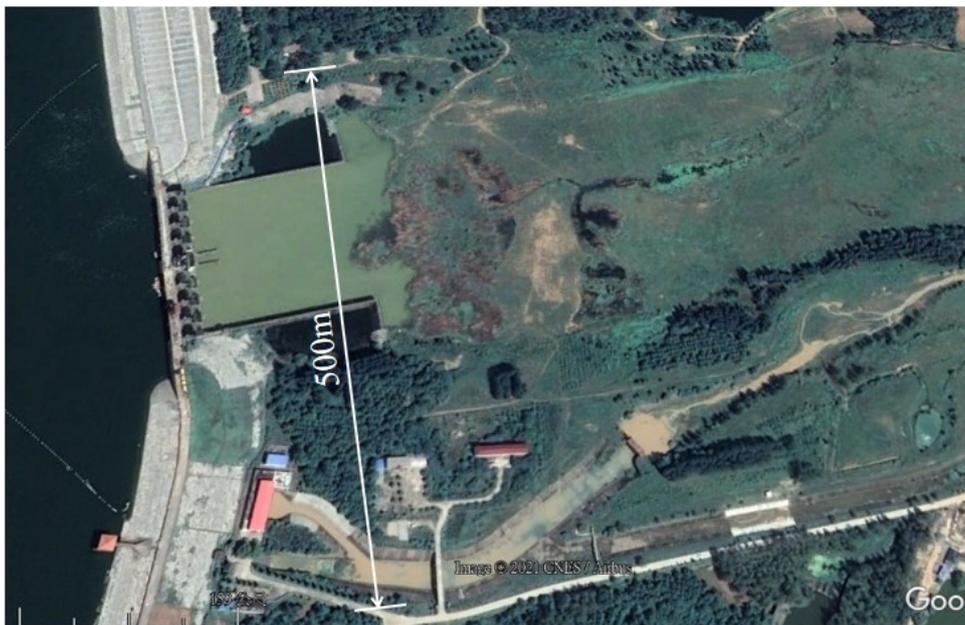
Figure 15. The Banqiao Dam, located at the necked position of lateral compression of the tectonic plate (background image is from Google Earth, 2021).

Figures 15a and 15b show that the widths of the riverbed sections of the upper and lower reaches of the Banqiao Dam are 7740 m and 500 m, respectively. The width of the downstream riverbed section thus necks down to 6.5% of the upstream riverbed section width. Since the degree of necking of the riverbed section downstream of the dam is a shear-band displaced landform feature, it can be used as an index for the evaluation of the dam failure potential.

(a) Width of the riverbed upstream of the dam.

(b) Width of the riverbed downstream of the dam.

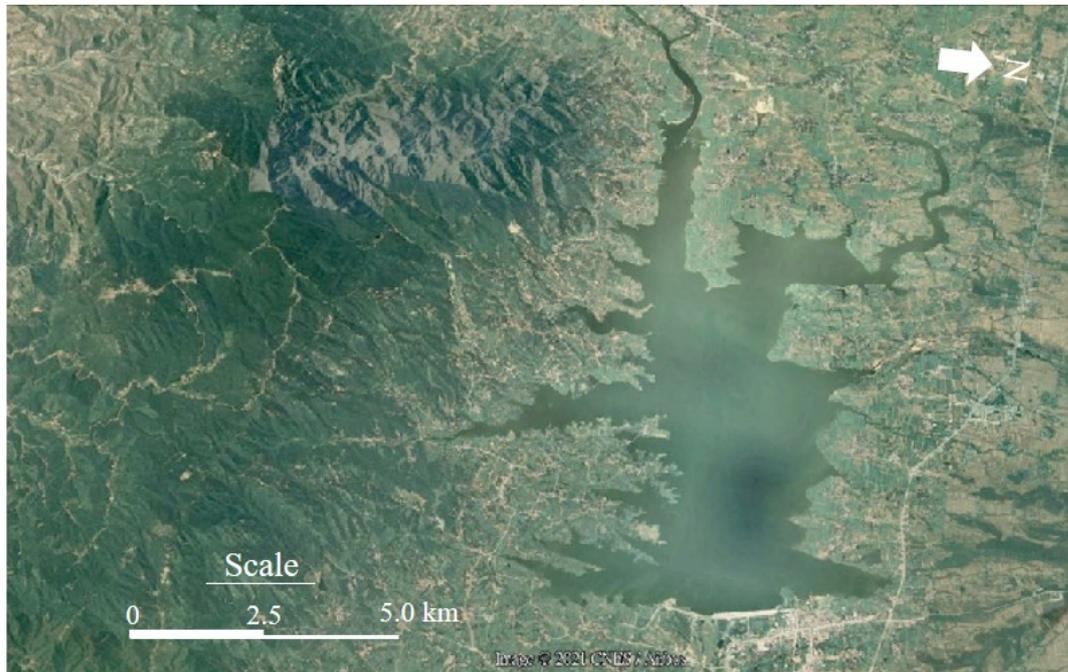
Figure 16 shows high-density triangular facets on the slopes of the right bank of the upper and lower reaches of the Banqiao Dam. Triangular facet

density is another shear-band displaced landform feature, so it can also be used as an index for the evaluation of the dam failure potential.

Figure 16. Triangular facets on the upstream and downstream slopes of the Banqiao Dam (Google Earth, 2021).

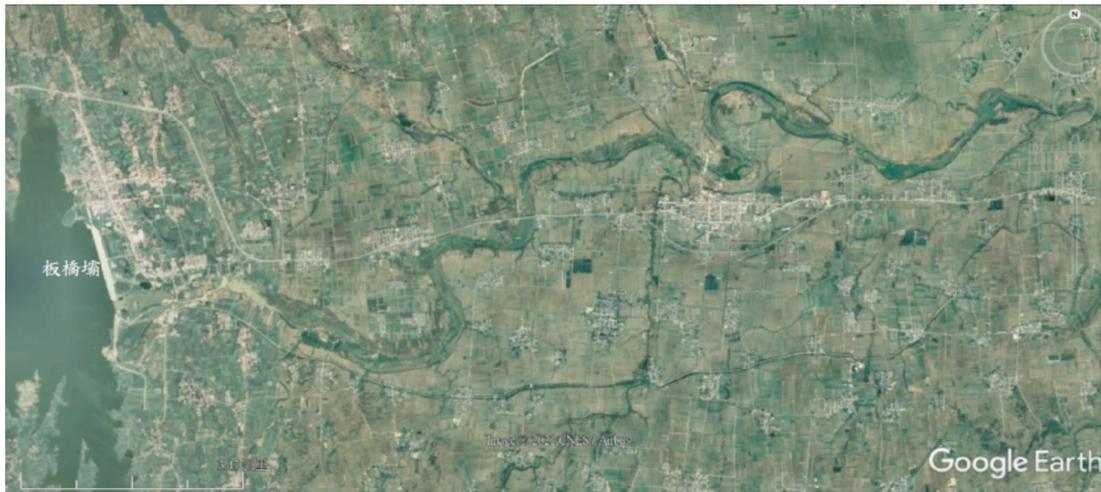
Figures 16 and 17 show that the river meanders significantly upstream and downstream of the Banqiao Dam, respectively. Since this is a shear-band displaced landform feature, it can also be used as an index for the evaluation of the dam failure potential.

Figure 17. The appearance of the river meander downstream of the Banqiao Dam (Google Earth, 2021).

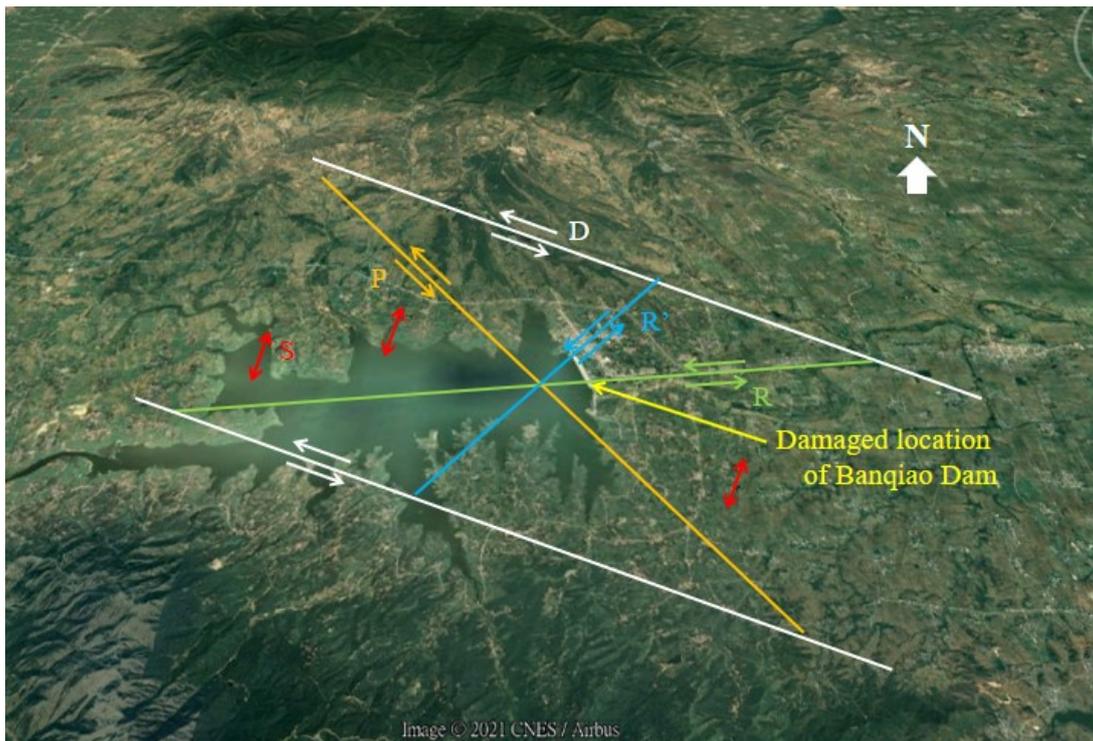
Lastly, Figure 18 shows that a shear band and five different shear tex-

tures exist in the reservoir area and on the slopes of the left and right banks of the upper and lower reaches of the Banqiao Dam. Shear bands and shear textures are shear-band displaced landform features, so they are indices for the evaluation of the dam failure potential.

Figure 18. The shear band and shear textures in the reservoir area and on the left and right banks of the upper and lower reaches of the Banqiao Dam (background image is from Google Earth, 2021).

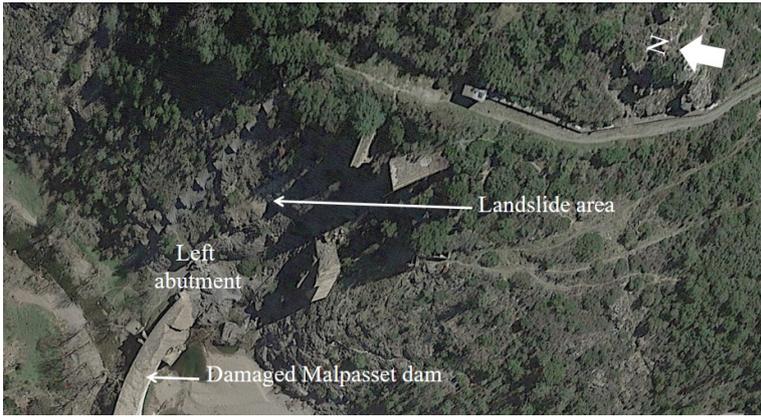
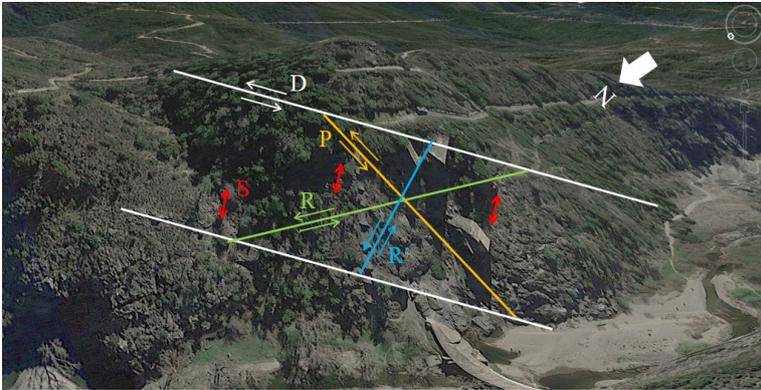
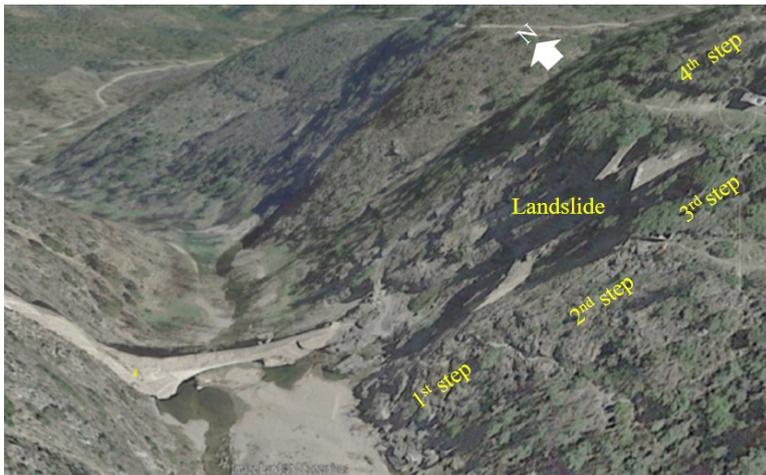
Figure 20. The left bank slope supporting the left abutment of the Malpasset Dam (background image is from Google Earth, 2021).

Since the design of a concrete arch dam uses the arch mechanism to spread the large water pressure to both banks of the valley, the conditions suitable for construction are only favorable when the rocks on both sides of the canyon are hard. Figure 20a shows that the left abutment of the Malpasset Dam is located in a geologically unstable landslide zone, and Figure 20b shows that there are shear bands and shear textures that pass through this landslide zone. Figure 20c shows a tilted four-step shear band slope on the left bank supporting the left dam abutment.

(a) Left dam abutment located in the landslide zone.

(b) Shear band and shear textures passing through the landslide zone.

(c) Tilted four-step shear band slope.

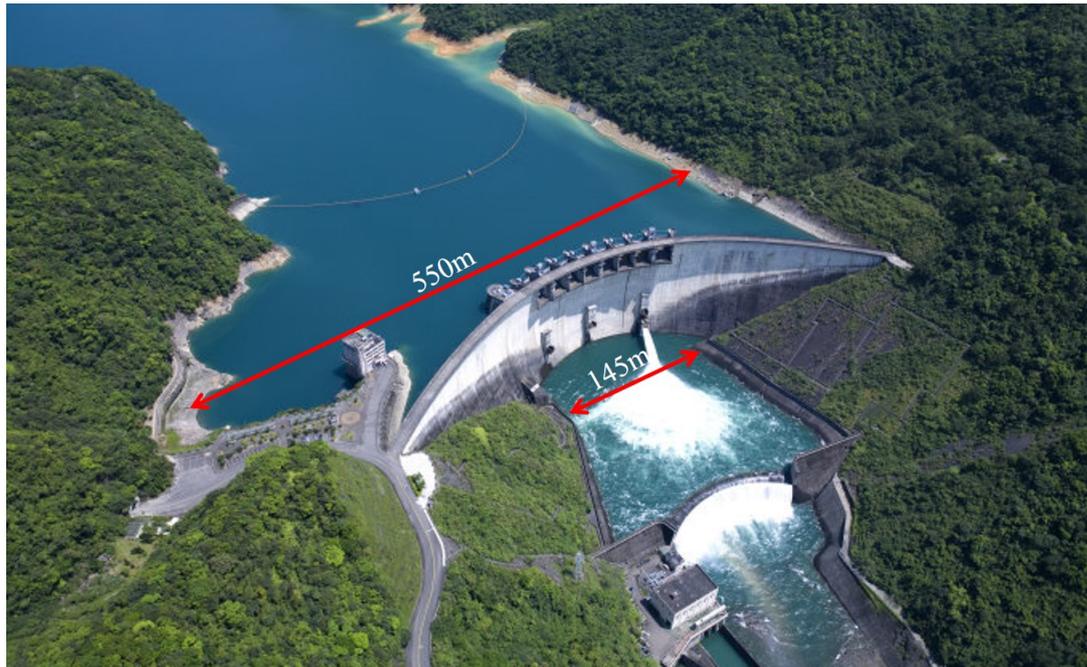
Figure 22 shows that the upstream riverbed section width of the Feitsui Dam is 550 m while the downstream riverbed section width is 145 m, which is therefore necked to 26.4% of the width of the upstream section.

Figure 22 Necking of the riverbed downstream of the Feitsui Dam (background image is from Lee, 2010).

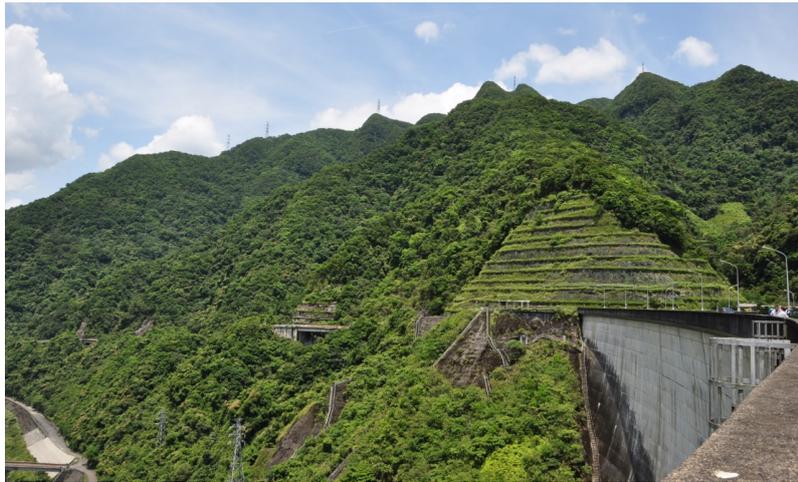
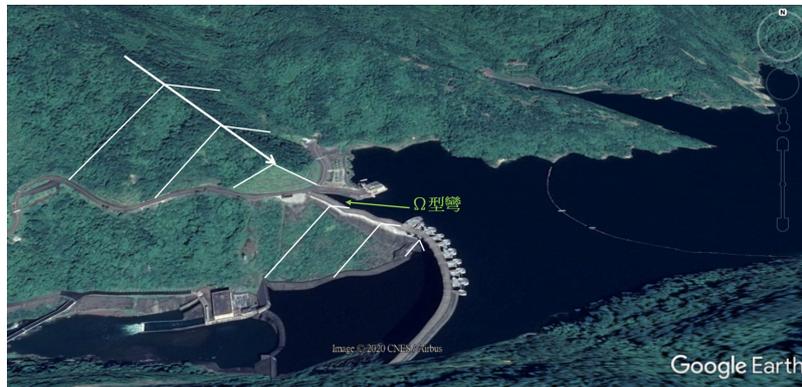
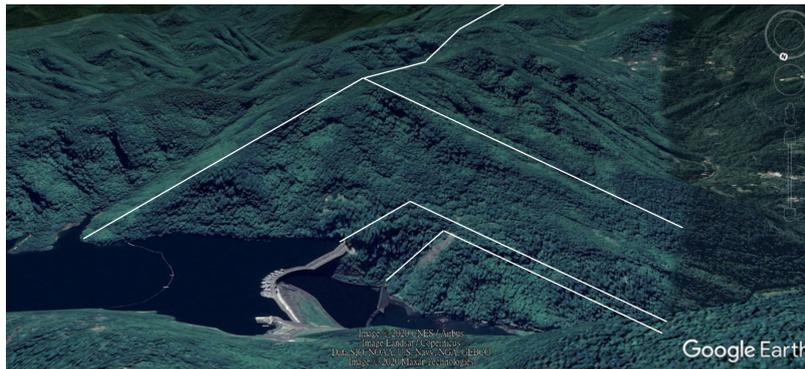
Figure 23. The Feitsui Dam and the triangular facets on the left and right banks of the dam axis extension (background images are from Google Earth, 2021).

Figure 23a shows high-density triangular facets in the mountains on the right side of the Feitsui Dam. There are also high-density triangular facets

on the right bank (Figure 23b) and the left bank (Figure 23c) of a line extended along the dam axis.

(a) Mountains to the right of the dam.

(b) Right bank of the dam axis extension.

(c) Left bank of the dam axis extension.

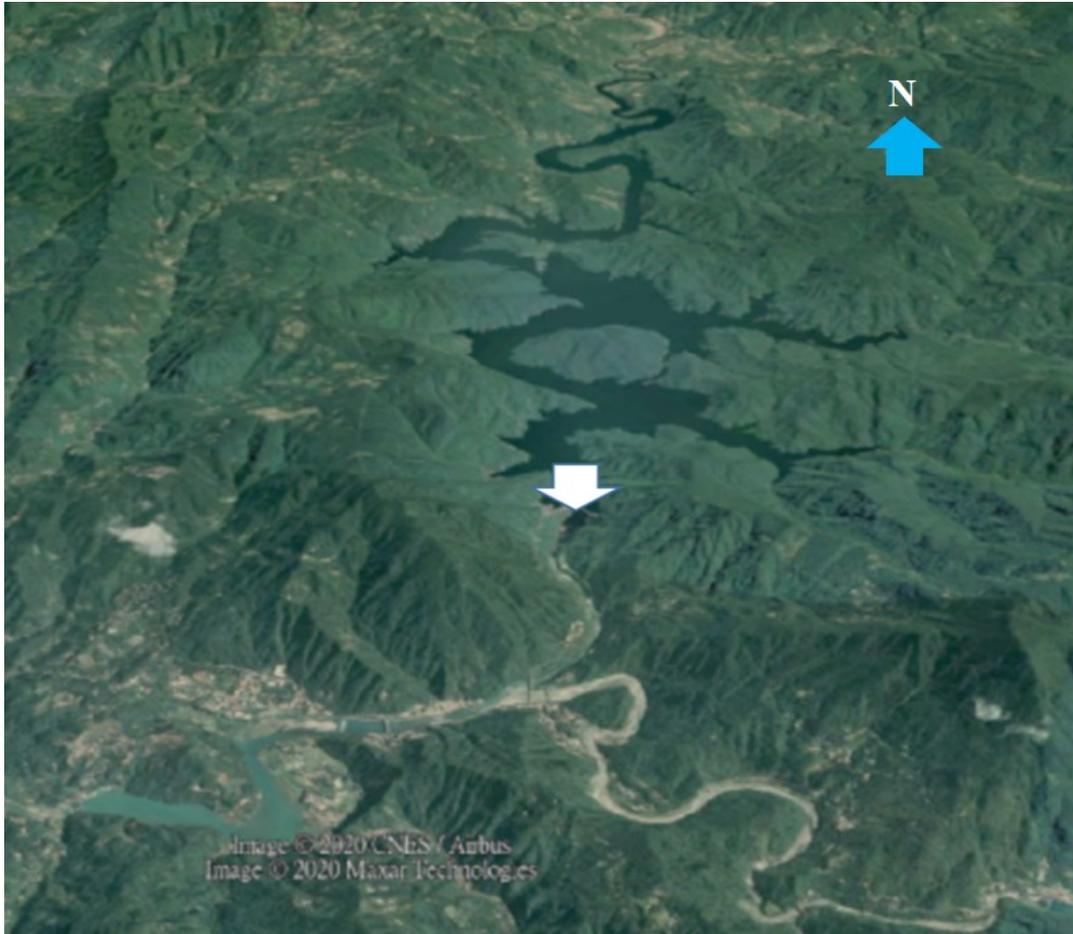
downstream has a moderate degree of meandering.

Figure 24. The meandering river system upstream and downstream of the Feitsui Dam (background image is from Google Earth, 2021).

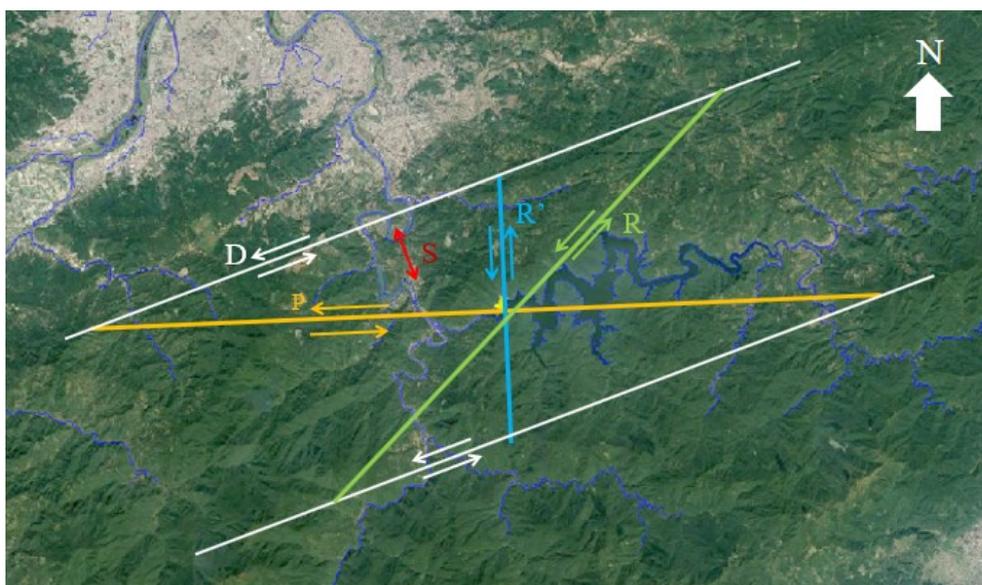
banks, and upstream and downstream of the Feitsui Dam.

Figure 25. Shear bands and shear textures in the reservoir area, on both banks, and upstream and downstream of the Feitsui Dam (background image from Google Earth, 2021).

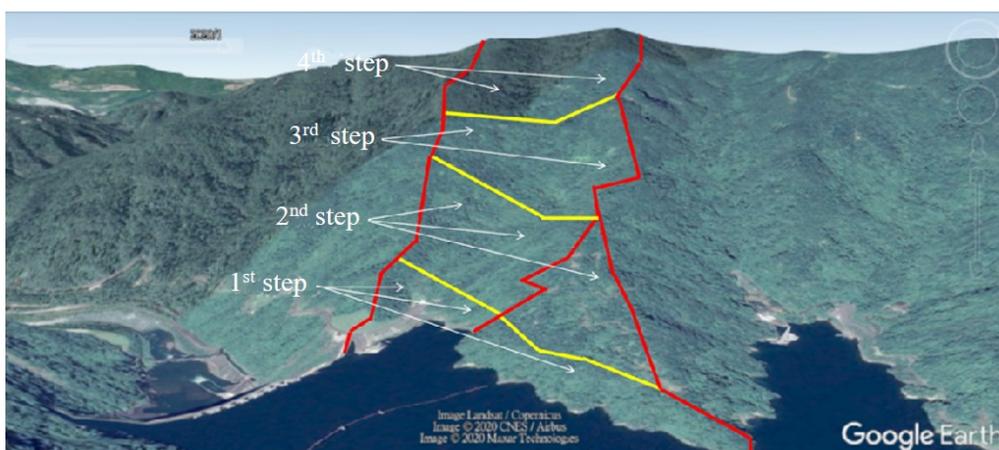
Figure 26 shows a tilted four-step shear band slope on the right bank immediately upstream of the Feitsui Dam.

Figure 26. A tilted four-step shear band slope on the right bank upstream of the Feitsui Dam (background image is from Google Earth, 2021).

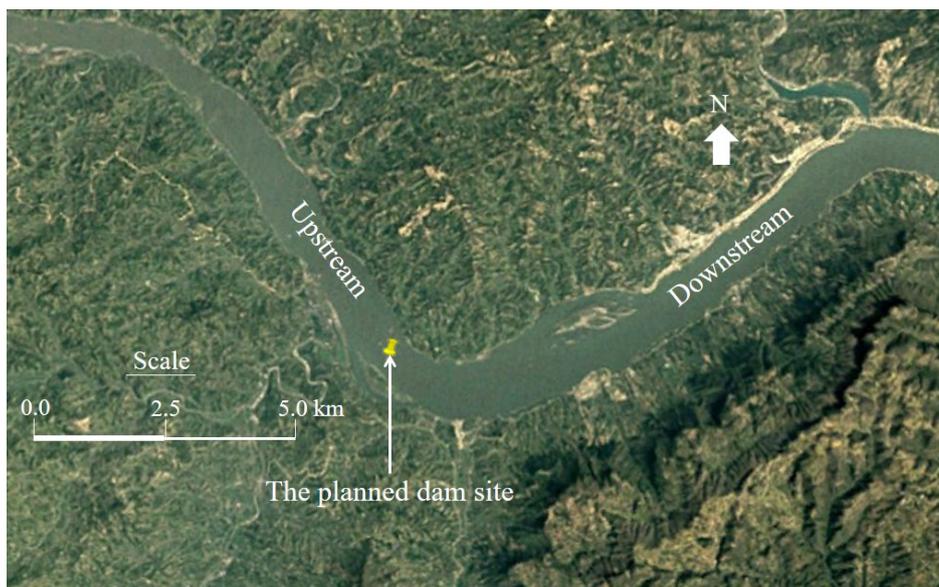
and downstream sections of the Three Gorges Dam are nearly the same, so there is no necking of the riverbed.

Figure 28. The upstream and downstream river sections of the Three Gorges Dam before its construction (Google Earth, 1986).

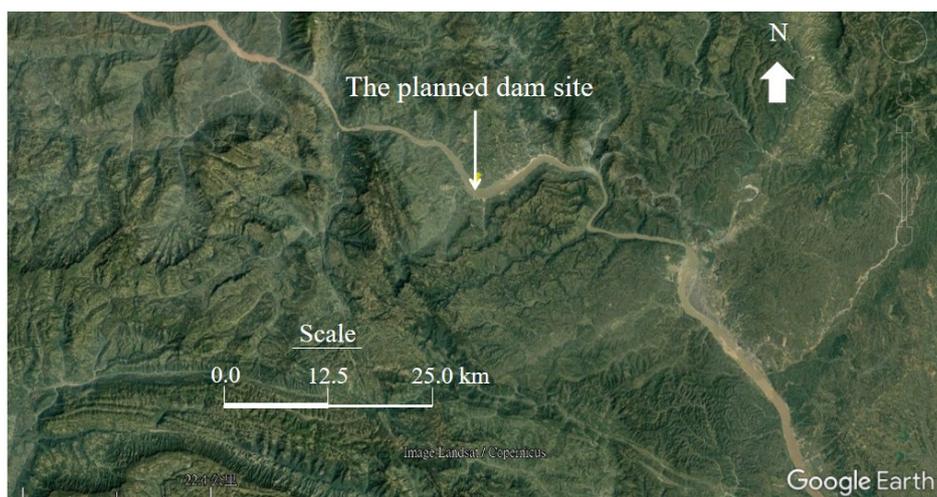
Figure 29 shows that the river upstream of the Three Gorges Dam has a low degree of meandering, and the

river downstream has a moderate degree of meandering.

Figure 29. The meandering river upstream and downstream of the Three Gorges Dam (Google Earth, 1986).

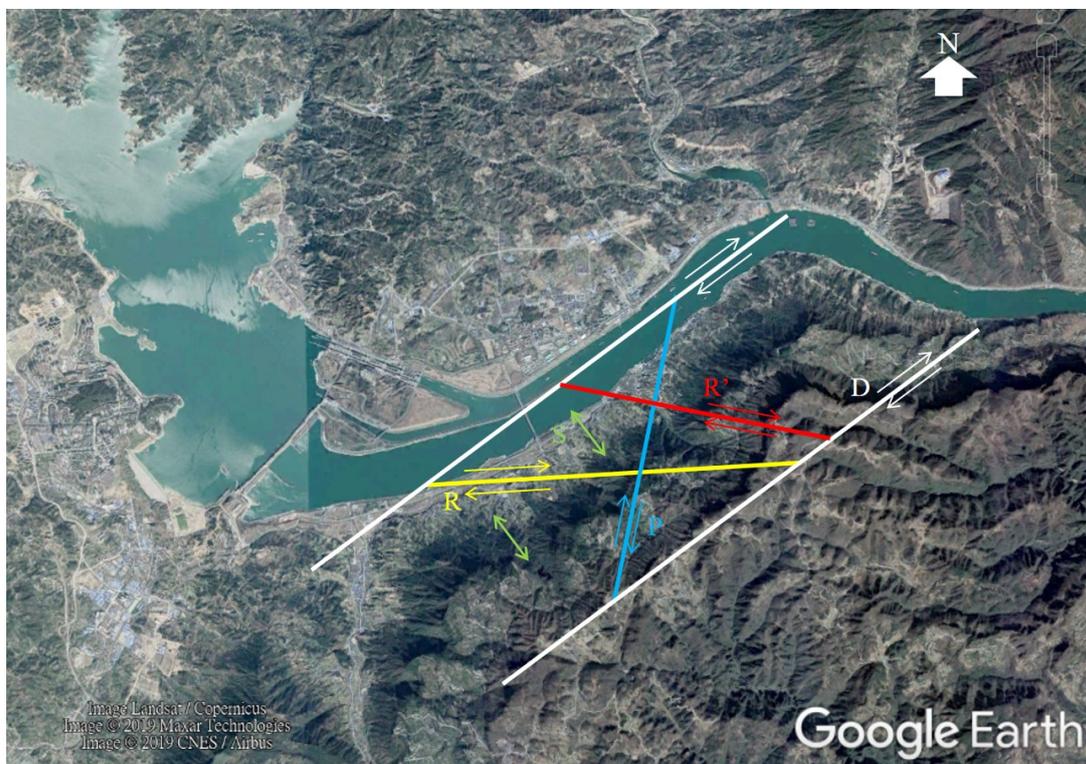
shear bands and textures are distant from the dam abutment, so they do not affect the safety of the dam.

Figure 30. Shear bands and shear textures downstream of the Three Gorges Dam (background image is from Google Earth, 2021).
