LANDSLIDE PROBLEMS CAUSED BY EXCAVATION OF SHEAR BAND TUNNELS INTO GRABENS

The Zhongliao Tunnel of Formosa Highway No. 3 was completed in 2000. The tunnel passes through shear bands, but the engineers overlooked the tilting effects of shear banding during design, resulting in ongoing uplift issues at the north portal of the tunnel. Following this, the consulting firm responsible for the tunnel design proposed mitigating the uplift by excavating the shear band section at the north portal of the tunnel into a graben. A similar section of the national highway was destroyed by a landslide induced by shear band graben slope sliding near Keelung in 2010. If the north portal of the Zhongliao Tunnel is excavated into a shear band graben, it is likely to replicate this landslide disaster, which shocked the international community. For this reason, the authors of this paper

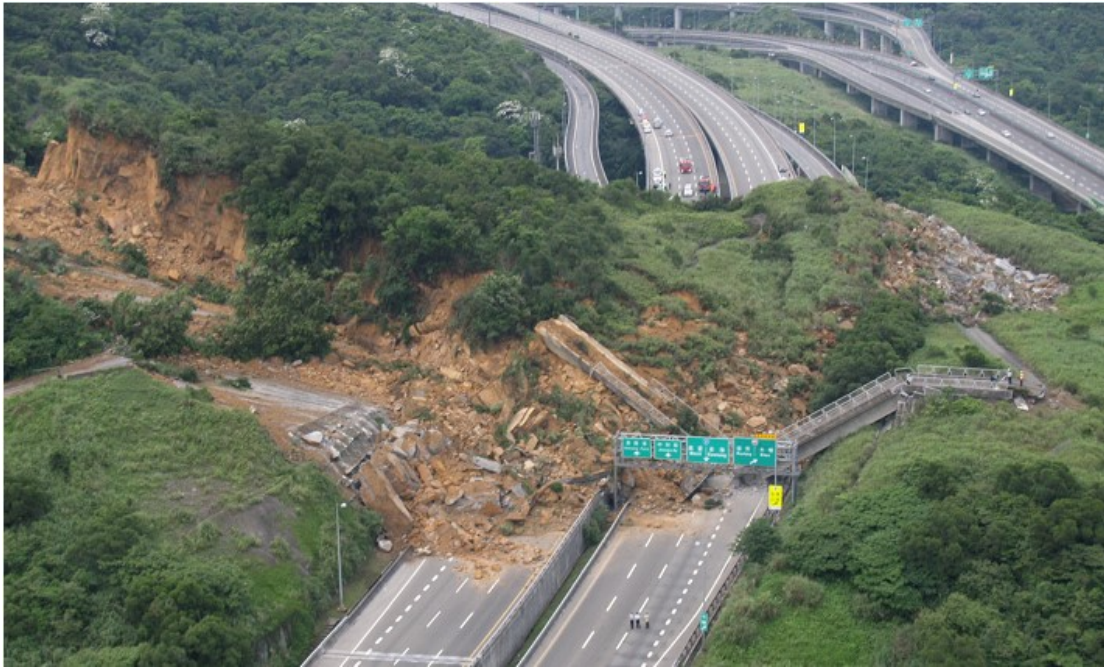
In the past, seismic design specifications for various structures only focused on fortifying against ground vibration, completely overlooking the influence of shear banding. As a result, the 3.1K ground anchor retaining wall slope on Formosa Highway No. 3 (Hsu et al., 2018)), designed with a lifespan exceeding 50 years, was damaged by sliding only 6 years after completion because of excessive accumulation of shear banding (see Figure 1).

Figure 1. Sliding failure of the anchor retaining wall slope on Formosa Highway No. 3 at 3.1K (Taiwan Geotechnical Society, 2011).

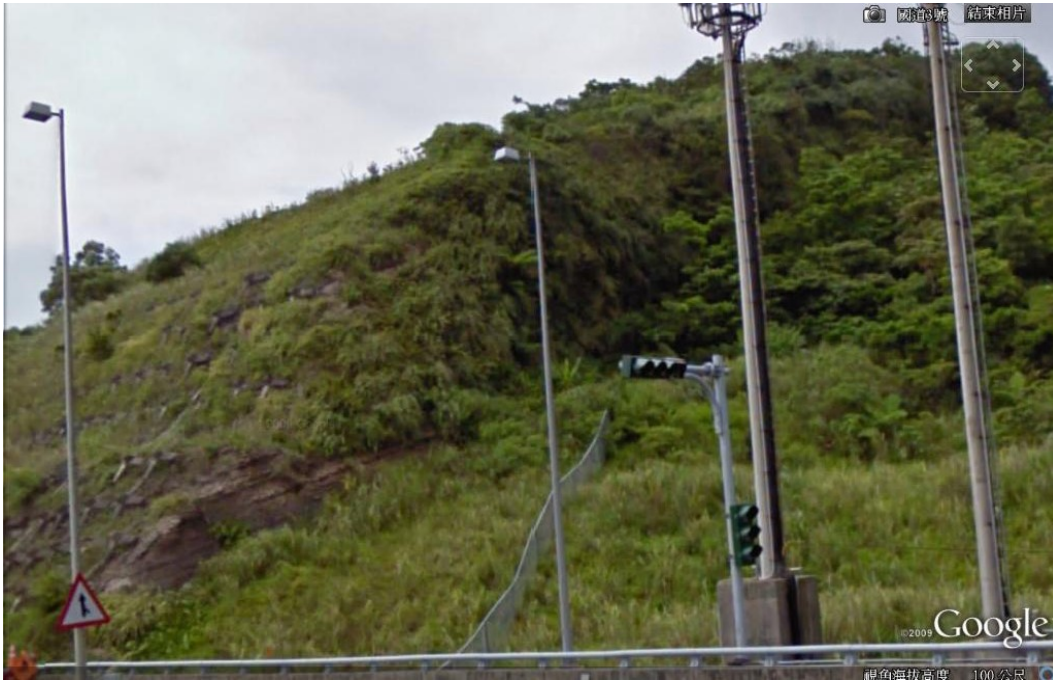
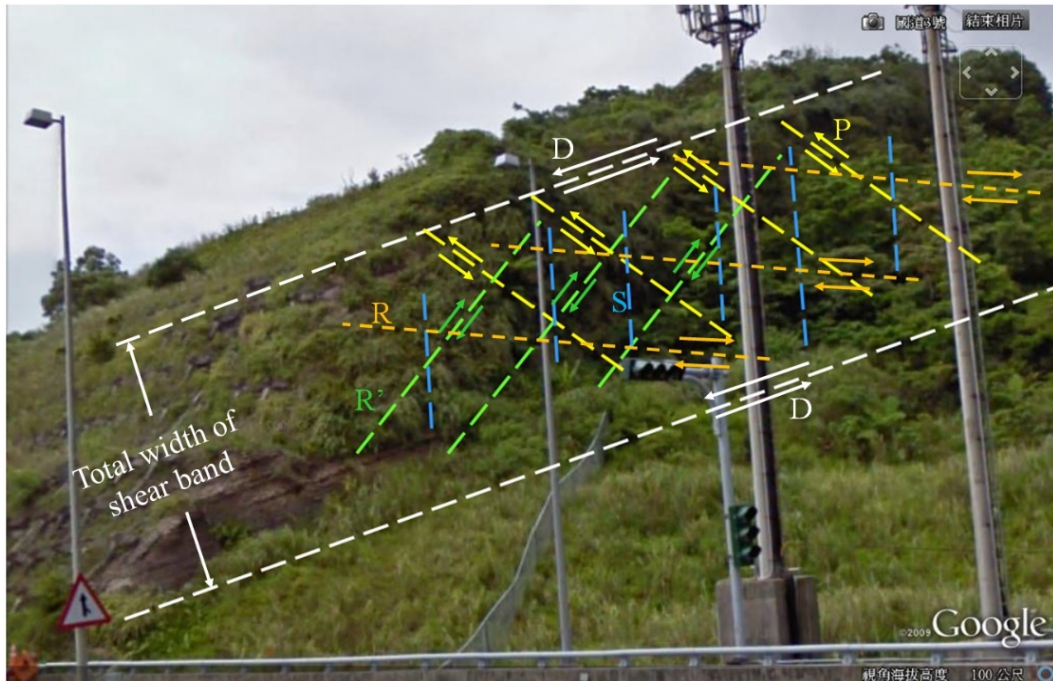
Figure 2. Shear textures at the 3.1K slope of Formosa Highway No. 3.

Figure 2 shows the cliffs at 3.1K on Formosa Highway No. 3, which are displaced landforms resulting from shear banding. It is evident that the shear band slope of Formosa Highway No. 3 shown in Figure 1 was excavated

into a graben, and one side of the graben's shear band slope began to slide downwards after completion, leading to a major landslide disaster 6 years later.

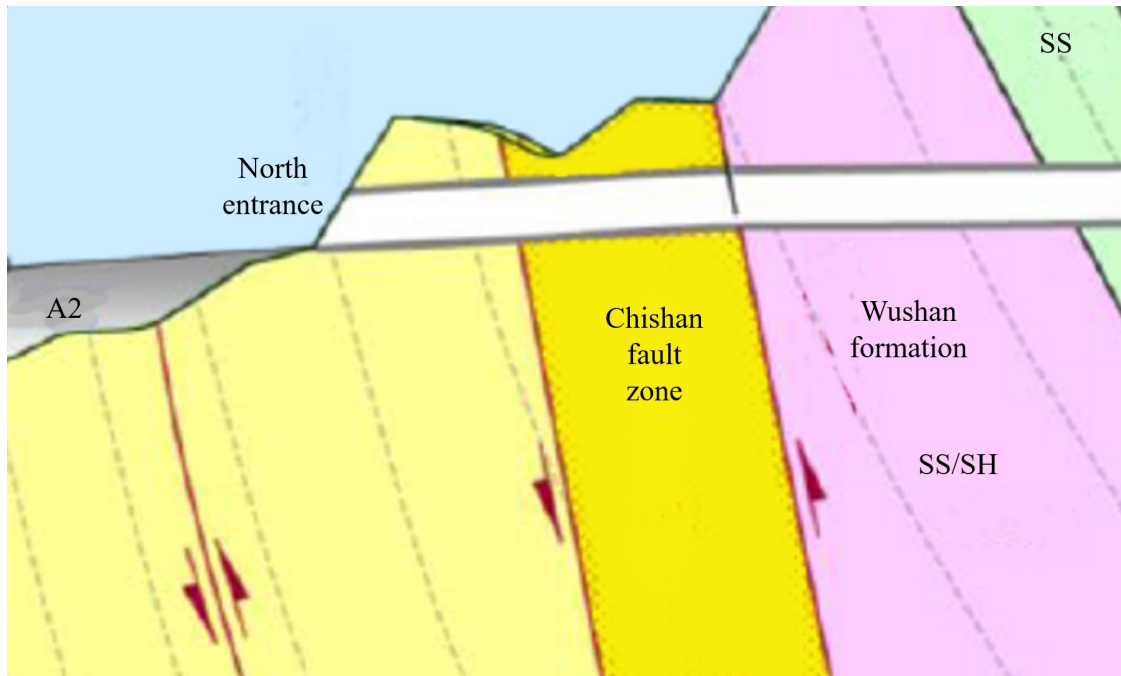
Figure 3 shows the north tunnel entrance of the Zhongliao Tunnel on a different section of Formosa Highway No. 3. According to on-site surveys, the Qishan Fault is encountered approximately 50 m after entering the north tunnel entrance, so that the tunnel

is affected by Qishan faulting. Since completion of the tunnel and opening it to traffic in February 2000, the north side of the Qishan Fault has risen by 115 cm. The government therefore aims to address this problem by implementing the project.

Figure 3. North entrance of Zhongliao Tunnel at Formosa No. 3 Highway 378K is excavated into a shear zone graben (Taiwan Highway Bureau, Ministry of Transportation and Communications, 2016).

However, the improvement project proposed by the government involves excavating the north entrance of the Zhongliao Tunnel into a shear band graben. Therefore, the potential sliding failure mechanism of the graben slope is the same as the sliding failure mechanism of the 3.1K graben slope of Formosa Highway No. 3.

Because the engineering consulting company commissioned by the Highway Bureau of the Ministry of Transportation did not consider the concept of shear banding, the influence of shear banding was not included in the design; therefore, because the north portal of Zhongliao Tunnel was excavated into the graben, sliding failure of the shear band slope cannot be avoided.

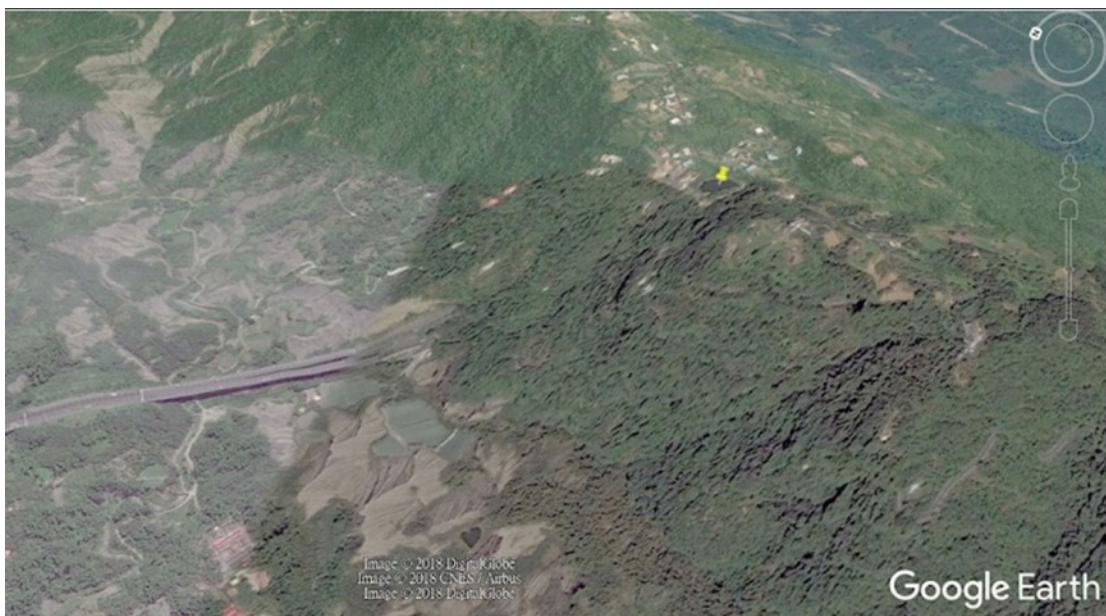
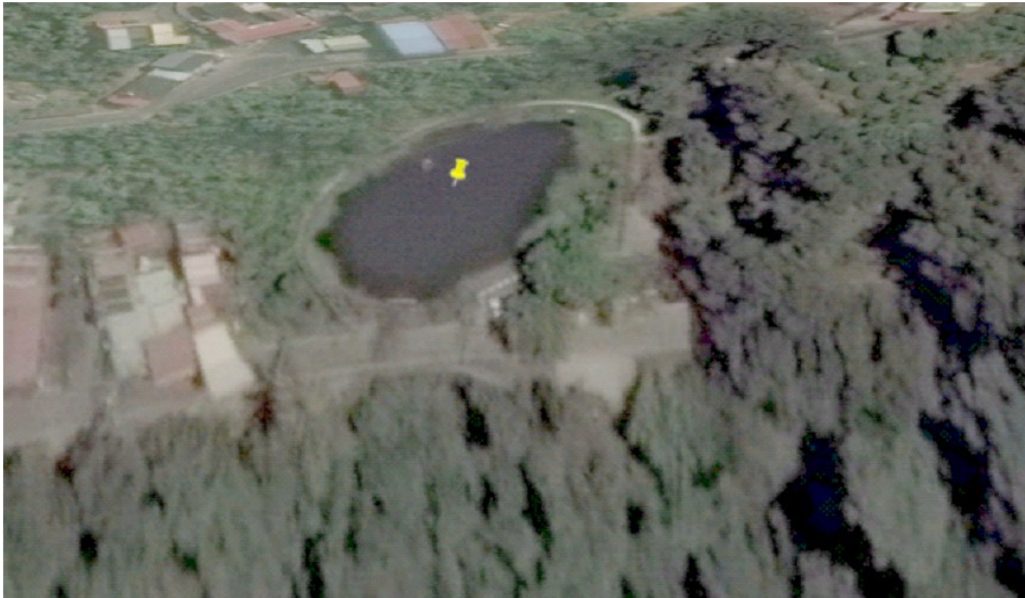
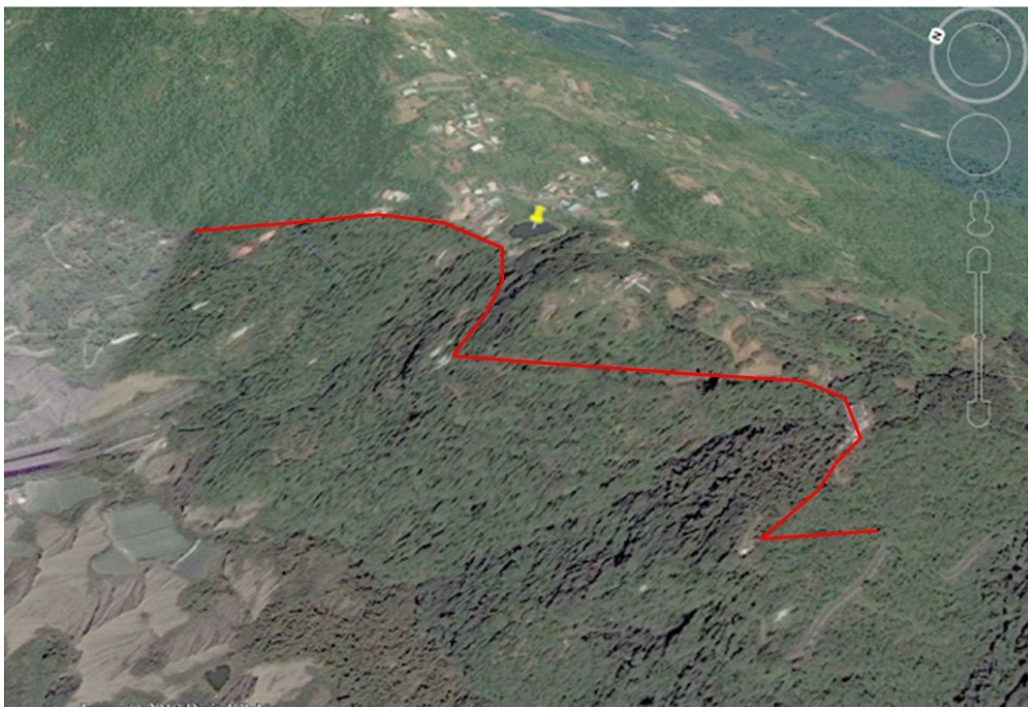
Figure 4. Shear band displaced landform features near the Zhongliao Tunnel.

Figure 4 shows the mountain traversed by the Zhongliao Tunnel. Shear band displaced landform features include winding and undulating ridge lines, exposed shear banded rocks, dense omega-shaped bends, and a mountain lake on the top of the mountain.

Note: The yellow needle points to the mountain lake.

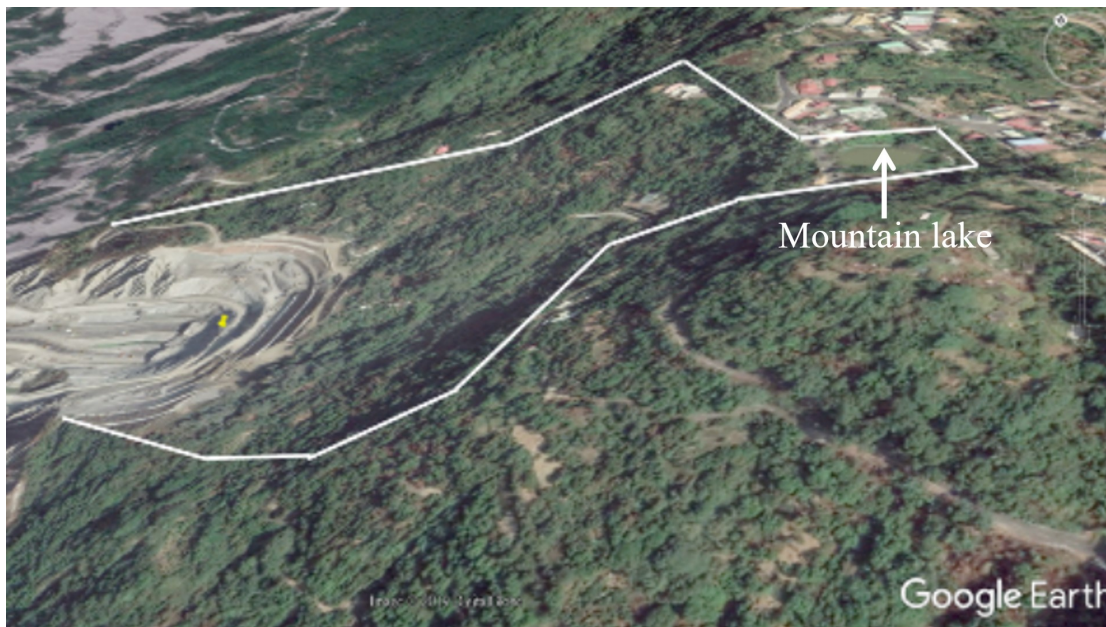
In the presence of a mountain lake, produced by the tilting effect of the shear zone as shown in Figure 4, lake water fills the pore spaces of brittle fractured shear bands with the result that landslides on the shear band slope below the lake are more likely to occur. Before excavation into the graben at the north entrance of the Zhongliao Tunnel, the intact tunnel structure restrained faulting, causing only localized fractures from the Qishan Fault

without inducing large-scale collapse damage to the tunnel. However, when the north entrance of the tunnel is excavated into a graben, the Qishan Fault is exposed on both sides of the graben slopes. Therefore, the dislocation of the fault and the water derived from the mountain lake are detrimental to the stability of the graben slope. For the Zhongliao Tunnel, the possible range of influence of the mountain lake water when the north entrance tunnel is excavated into the graben is shown in Figure 5.

Figure 5. The area of influence of water from the mountain lake above the Zhongliao Tunnel (Background image from Google Earth, 2019).

- 1) Although current slope stability regulations do not explicitly stipulate that tunnels must not be excavated into shear bands in grabens, it is recommended that such excavations are not conducted because shear band graben slopes are prone to sliding damage.
- 2) Given that water sources above tunnels readily infiltrate shear bands and seriously endanger the stability of the shear graben slope, water sources such as mountain lakes above the shear band graben must be removed to reduce the impact of groundwater on slope stability.

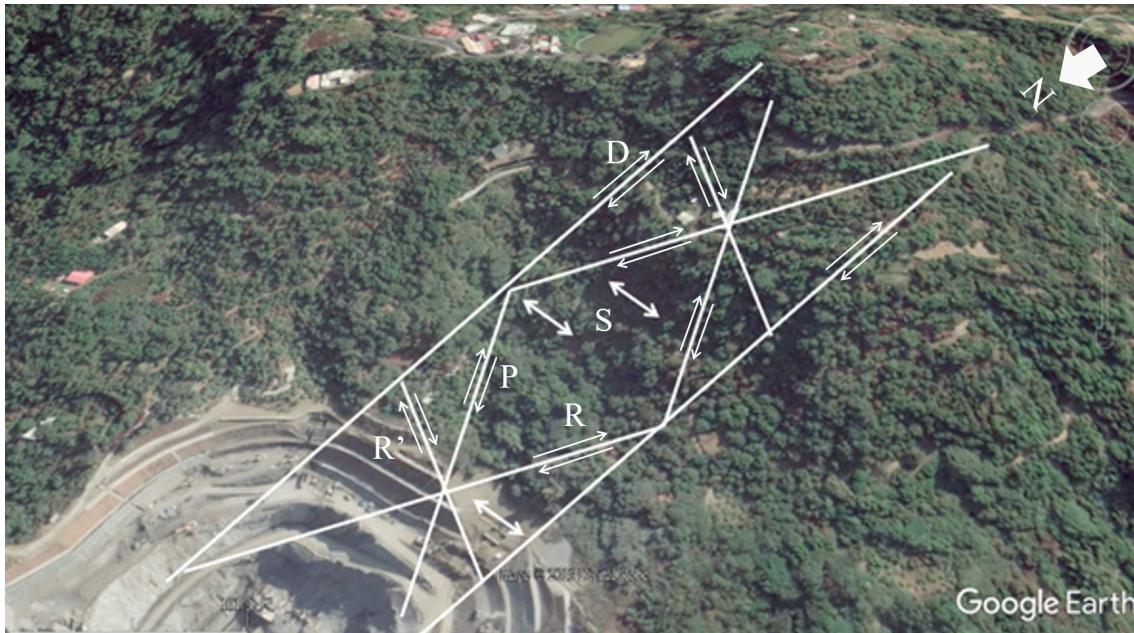
When the north entrance of the Zhongliao Tunnel was excavated into the graben, as shown in Figure 6, the

principal displacement shear D, thrust shear P, Riedel shear R, conjugate Riedel shear R', and compression textures S contained within the total width of the shear band developed, and these affect the stability of the graben slope.

Figure 6. Shear band and shear textures observed after the graben was excavated at the north entrance of the tunnel (Background image from Google Earth, 2019).

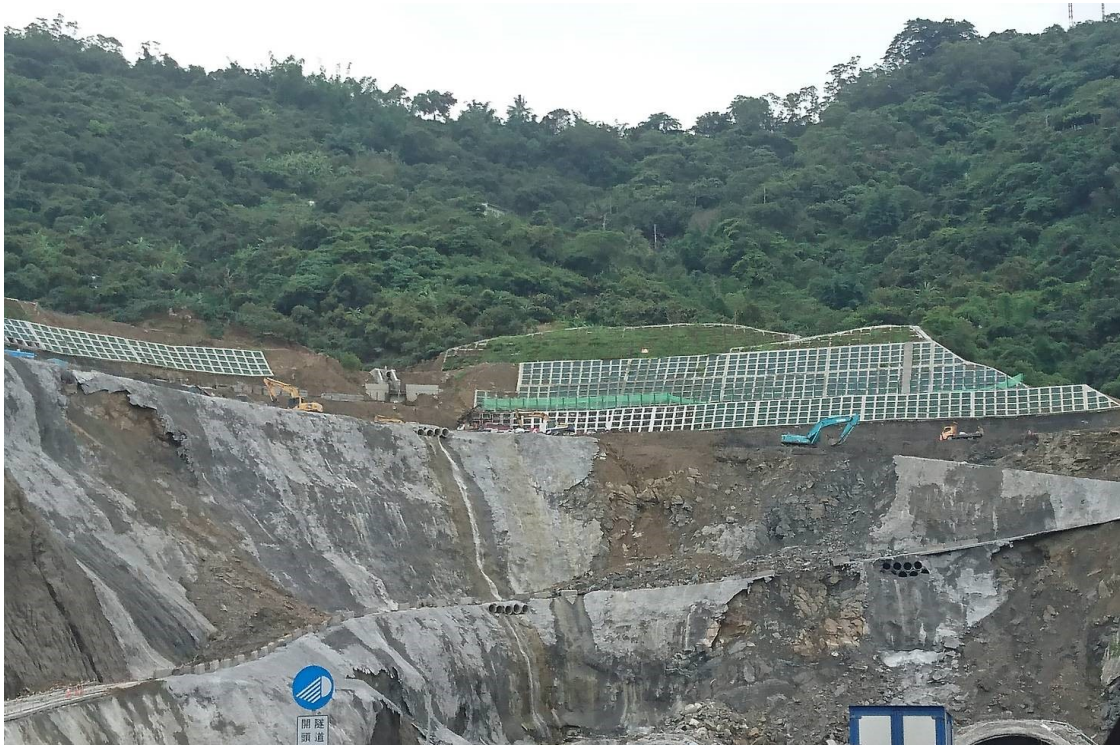
Under the influence of shear banding and shear texturing, as shown in Figure 7, the slope above the tunnel

remained unstable during the excavation of the north entrance of the Zhongliao Tunnel into the graben.

Figure 7. Instability of the slope during the excavation process of the north entrance of the Zhongliao Tunnel into the graben.

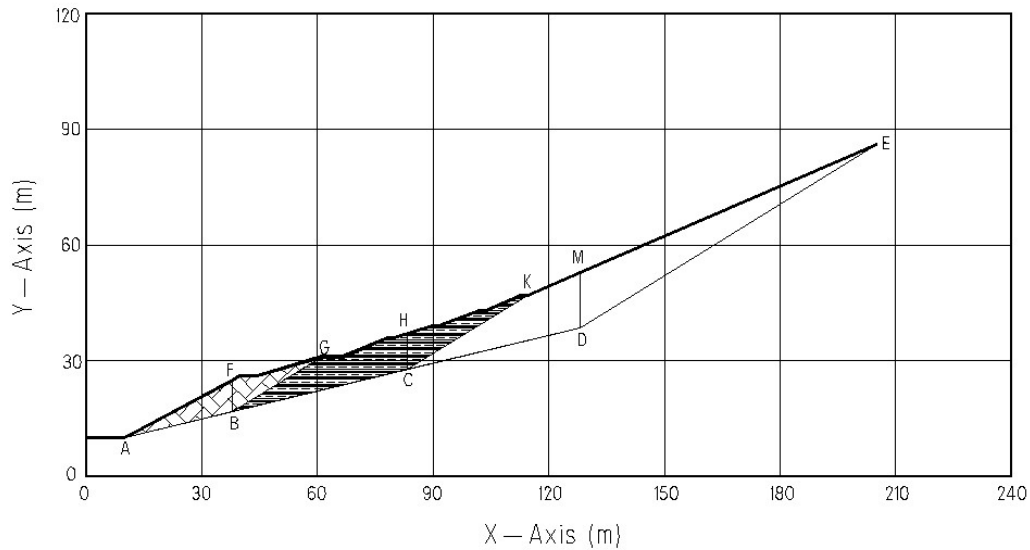
Figure 10. Profile of the shear banding tilting slope after graben excavation at the north entrance of the Zhongliao Tunnel.

Figure 10 shows the shear banding tilting slope after graben excavation at the north entrance of Zhongliao Tunnel. During the slope stability analysis process, the slope stability of block ABGF sliding along the potential sliding surfaces AB and BG was first analyzed. Second, the slope stability analysis of block BCKHG sliding along the potential sliding planes BC and CK was performed. Finally, the slope stability analysis of block CDENK sliding along the potential sliding surfaces CD and DE was carried out.

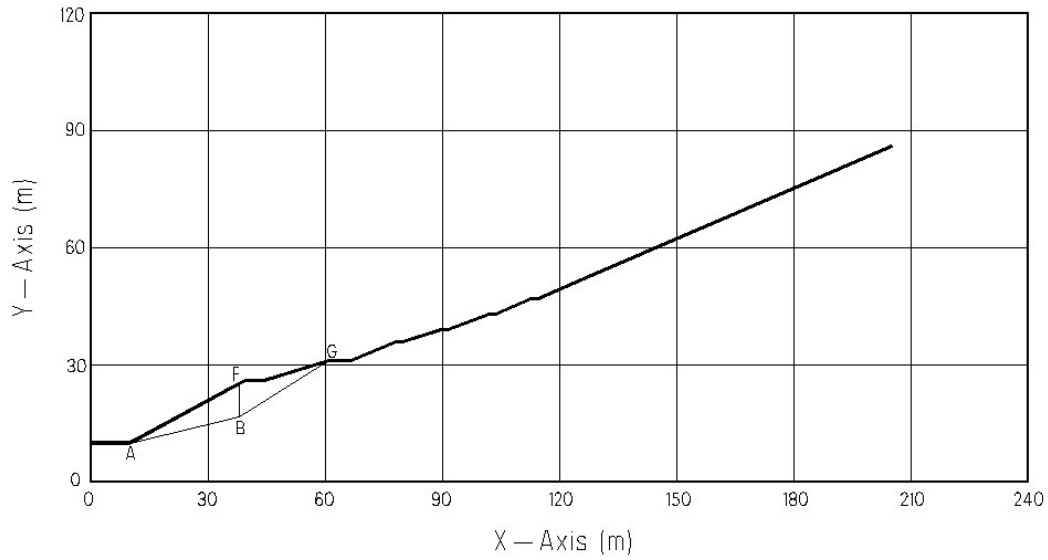
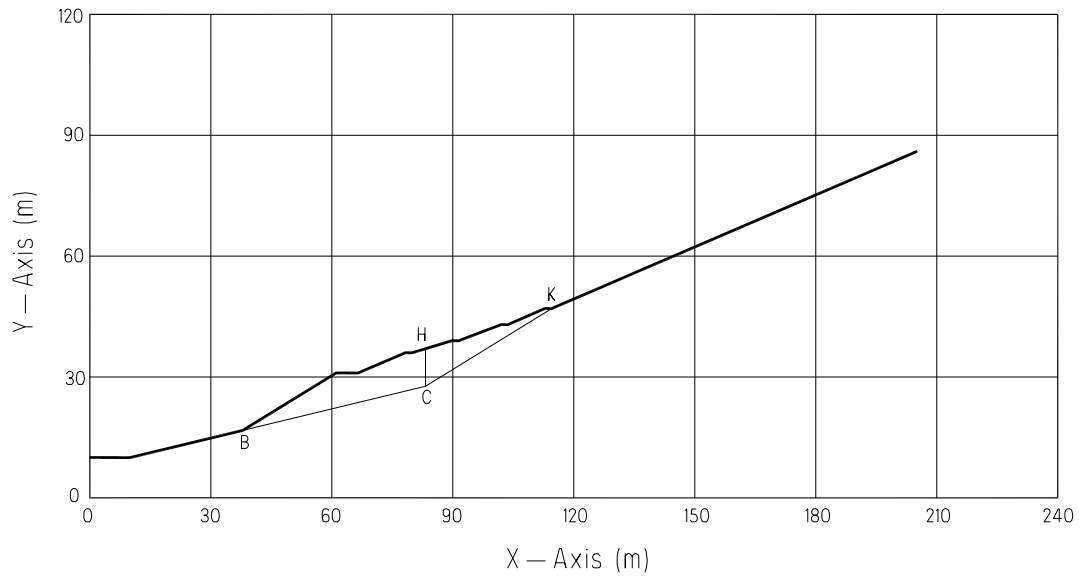
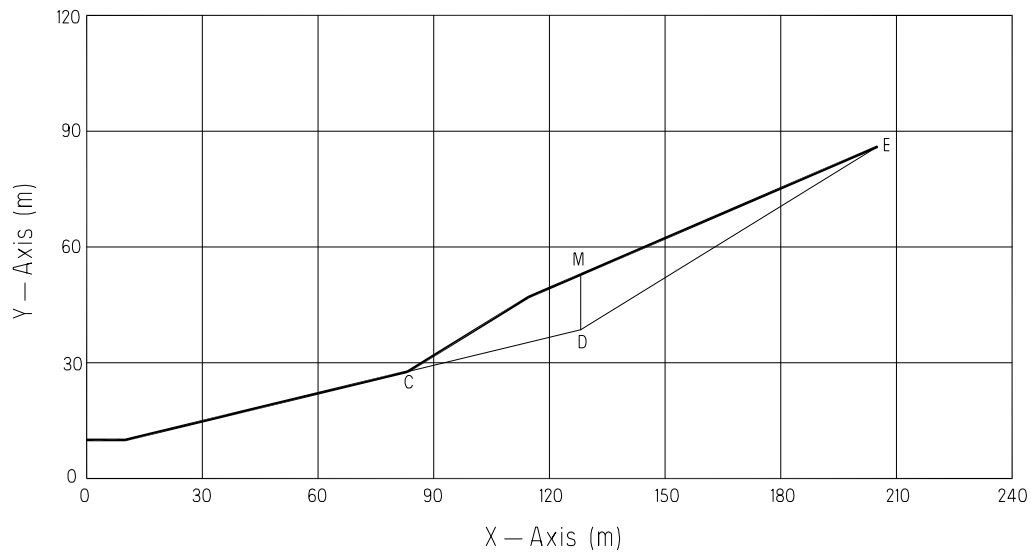
Figure 11. Profiles of three double sliding surfaces after excavation of the graben at the north entrance of Zhongliao Tunnel.

Figures 11(a) to 11(c) show cross-sections of the three double sliding blocks ABGF, BCKHG, and CDEMK after graben excavation at the north entrance of Zhongliao Tunnel. Given

that the sliding surface is caused by groups of interlaced shear bands and shear textures, the angles between the upper sliding surface and the horizontal plane of the three selected sliding blocks are all 31.65° , and the angle between the lower sliding surface and the horizontal plane is 13.59° ; the internal friction angle of the vertical interface selected to distinguish the upper sliding block and the lower sliding block is 30° , and the adhesion force of the upper sliding surface and the lower sliding surface is 3 kN/m^2 ; the friction angles of the upper sliding surface and the lower sliding surface are both 30° , and the unit weight of the water is 9.807 kN/m^3 .

For the graben slope adjacent to the north entrance of the Zhongliao Tunnel, the data in Table 1 indicate that when the potential sliding block is

ABGF, this block has the potential for sliding failure only when the analysis considers the influence of groundwater or shear zone dislocation, i.e., when the safety factor against slope sliding failure FS is less than 1.0.

For the same graben slope, Table 1 indicates that when block ABGF slides and fails, and the potential sliding block is BCKHG, *FS* obtained through the slope stability analysis is less than 1.0 under the influence of groundwater, indicating that block BCKHG has the potential for sliding failure. Under the influence of shear

banding, *FS* is slightly greater than 1.0, indicating that block BCKHG is approaching sliding failure.

When both blocks ABGF and BCKHG slide and fail, and the potential sliding block is CDEMK, *FS* obtained from the slope stability analysis is less than 1.0 under the influence of

groundwater or shear banding, indicating that block CDEMK, and thus all blocks, may experience sliding failure. For this case (lower third of Table 1), FS is considerably less than 1.0, indicating that the CDEMK block has a very high sliding failure potential.

When the planned excavation at the north entrance of Zhongliao Tunnel into the graben commences, the sliding blocks will have a high potential for failure. The reason for this is that the shear band has a high permeability coefficient and water from the mountain lake is likely to infiltrate and fill the void space in the shear zone, thus reducing FS obtained from the slope stability analysis to values far less than 1.0.

For the north entrance of Zhongliao Tunnel on Formosa No. 3 Highway, when the graben slope block ABGF adjacent to the north entrance slides and fails, block BCKHG above it is also at risk of sliding and failing; failure of both blocks ABGF and BCKHG increases the risk of sliding and failing for block CDEMK above them.
