FORMATION MECHANISMS FOR VARIOUS FAILURE IN THE REAR-LINE REGION OF THE TAICHUNG PORT DOCK CAISSON

Tse-Shan Hsu

Hung-Chia Chang

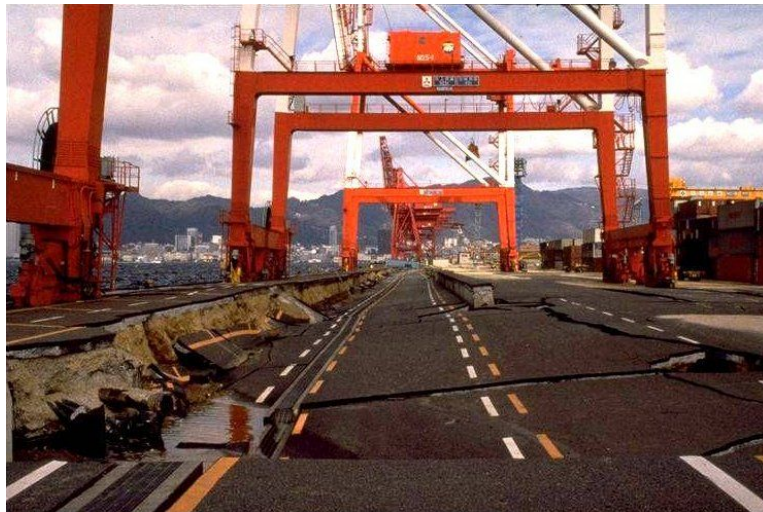
Figure 1. Damage to the rear-line region of the dock caisson induced by the 1995 Great Hanshin-Awaji Earthquake, Kobe Port (Kobe Geotechnical Collection, 2019).

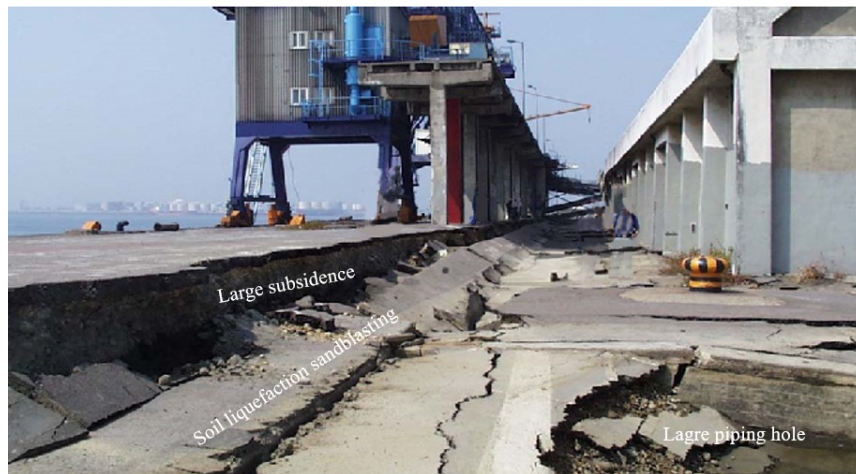
Figure 2. Damage to the rear-line region of the dock caisson induced by the 1999 Jiji earthquake, Taichung Port (Lai et al., 2007).

continues, with progressively larger particles being transported, leading to the gradual loss of the backfill in the rear-line region. Ultimately, this continuous loss of material results in the formation of a large piping cavity, as shown in Figure 2.

2. The traditional design of the caisson dock at Taichung Port involves placing the caissons directly on the seabed. Under this design, the rear-line region of the caisson dock experienced significant damage during the 1999 Jiji earthquake, including large-scale settlement, formation of large piping cavities, and sand boil-type soil liquefaction.

4. Based on the need for earthquake disaster mitigation at Taichung Port's caisson dock rear-line region, future designs should incorporate a minimum embedment depth of 1 meter for the caisson. Only by doing

so will the hydraulic gradient at the exit point E, as shown in Figure 10, remain below the critical hydraulic gradient, thereby preventing the occurrence of piping failure.

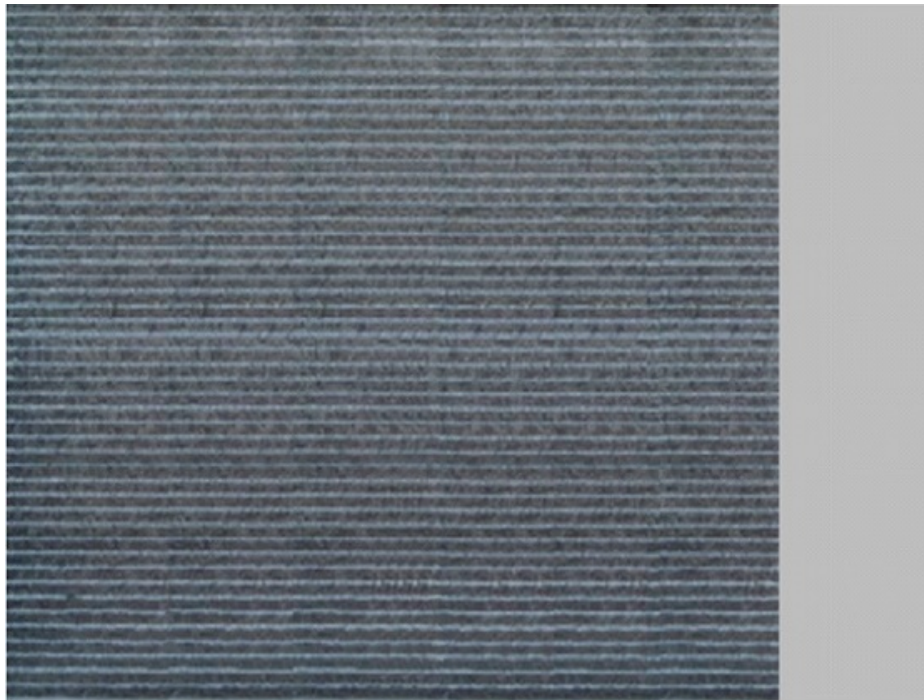
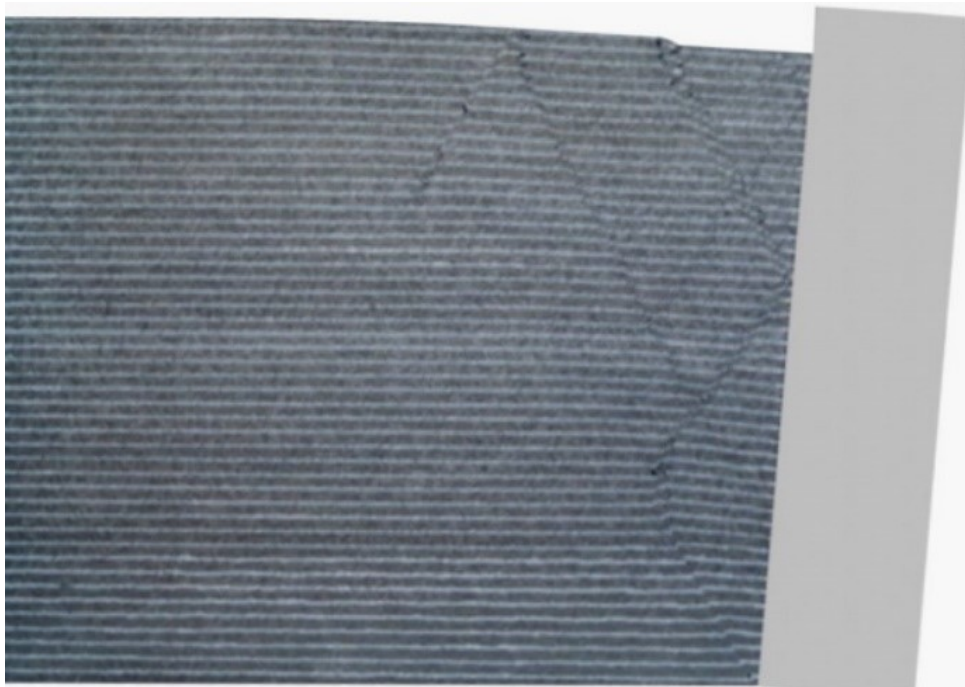
Figure 3. Simulation of shear bands induced by the caisson and backfill model in the rear-line region.

Figure 3(a) presents a model of a dock caisson and a very densely packed sand backfill model in the rear-line region. As shown in Figure 3(b), when the dock caisson model undergoes a rotation of approximately 3 to 5 degrees about its bottom right edge, shear bands with different strikes are induced in the backfill model.

(a) Before the caisson rotation.

(b) After the caisson rotation.

1. The caisson rotates around its seaward bottom edge, resulting in horizontal displacements that increase proportionally with height above the caisson base.
2. When the caisson rotation reaches approximately 3 to 5 degrees, the densely packed sand layer in the rear-line region undergoes plastic strain softening, leading to a loss of

3. The localizations of deformations in the rear-line region produces shear bands with different strikes.

1. The rotation or movement of the dock caisson toward the sea side induces plastic strain softening in the densely compacted backfill within the rear-line region.
2. Highly concentrated excess pore water pressure locally occurs in the shear band groundwater.
3. The earth pressure and water pressure acting on the caisson increase significantly.
4. Significant rotation or movement of the dock caisson induces substantial settlement in the rear-line region.

1. After the caisson rotates or moves seaward, it induces shear bands, as shown in Figure 3.
2. Highly concentrated excess pore water pressure appears locally in the groundwater within the shear bands, as illustrated in Figure 6.
3. The soils within the shear bands undergo brittle fracture. After the soil particles, ranging from fine to coarse, float in the groundwater, the

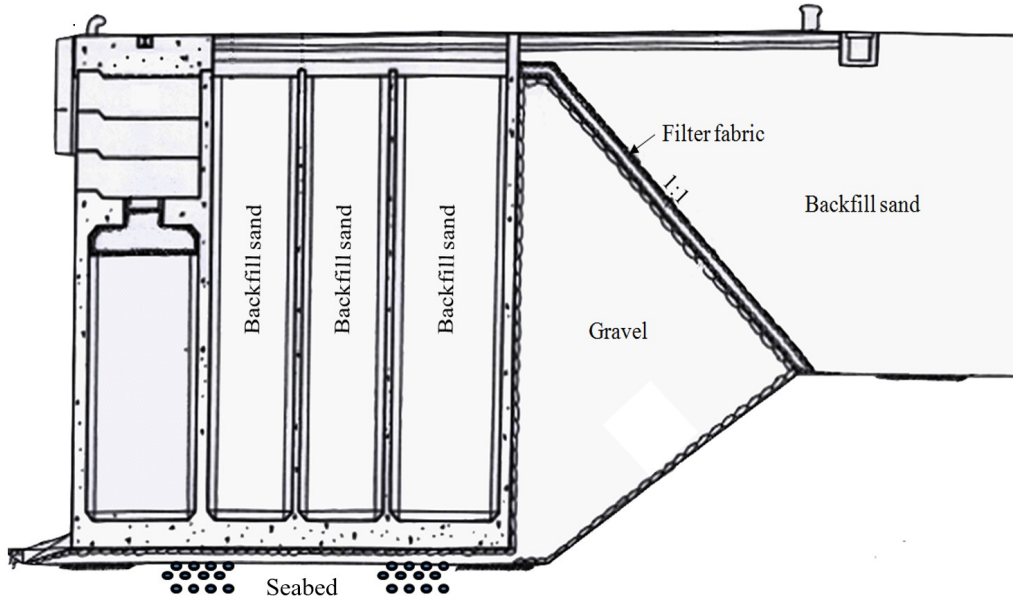
Generally, dock caissons are directly placed on the seabed (as shown in Figure 7). Since the embedded depth $D=0$, and if the groundwater level in the rear-line region of the caisson is higher than the seawater level, piping failure occurs when the hydraulic gradient i at the water exit point E of the caisson (as shown in Figure 8) exceeds the critical hydraulic gradient i_c . Once piping failure occurs, large cavities, as illustrated in Figure 3, will appear in the rear-line region.

Figure 7. Schematic diagram of a dock caisson directly placed on the seabed without any embedded depth (Chang, 2019).

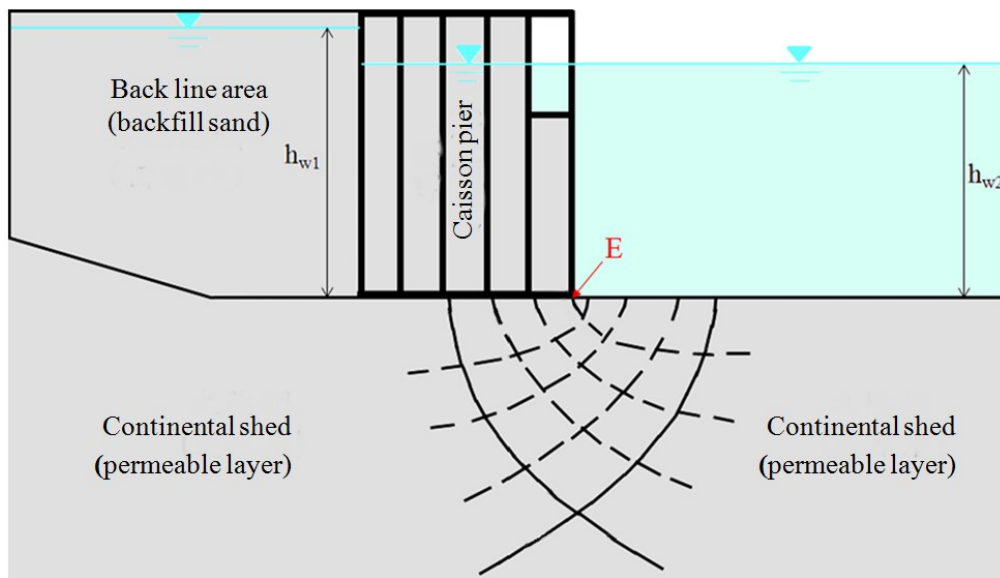
Figure 8. Dock caisson with an embedded depth of $D = 0$ (Chang, 2019).

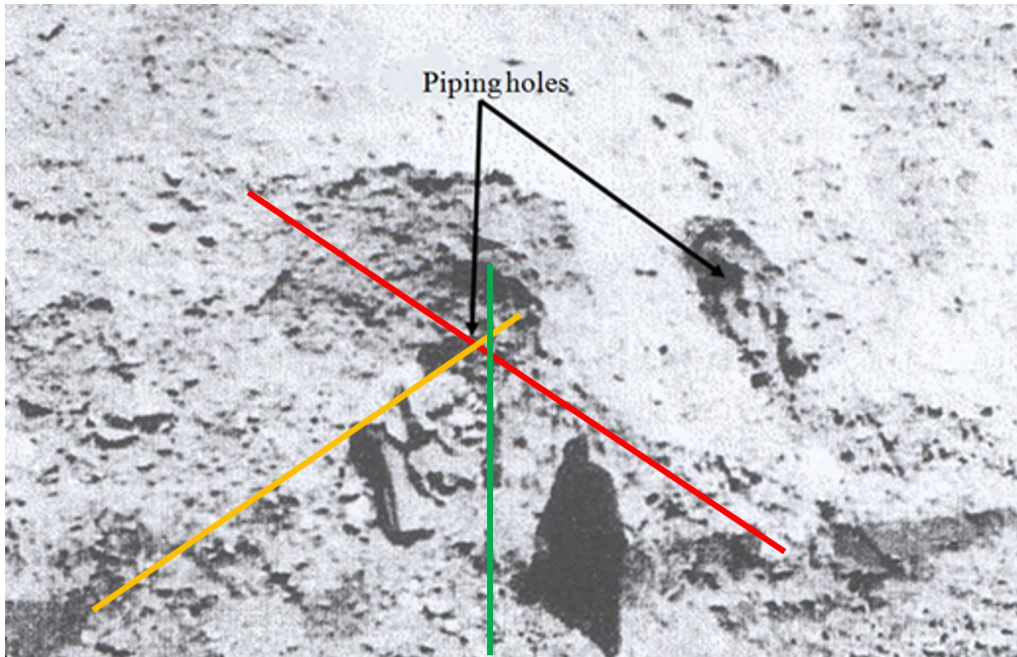
Moreover, the formation mechanism of the piping failure in the rear-line region of the dock caisson is similar to that of piping failure in dams, where it follows the axis of intersection of shear bands with different strikes

Figure 9. Piping tunnels induced at the intersection of shear bands with different strikes in a dam structure (Sinotech Foundation for Research and Development of Engineering Sciences and Technologies, 2008).

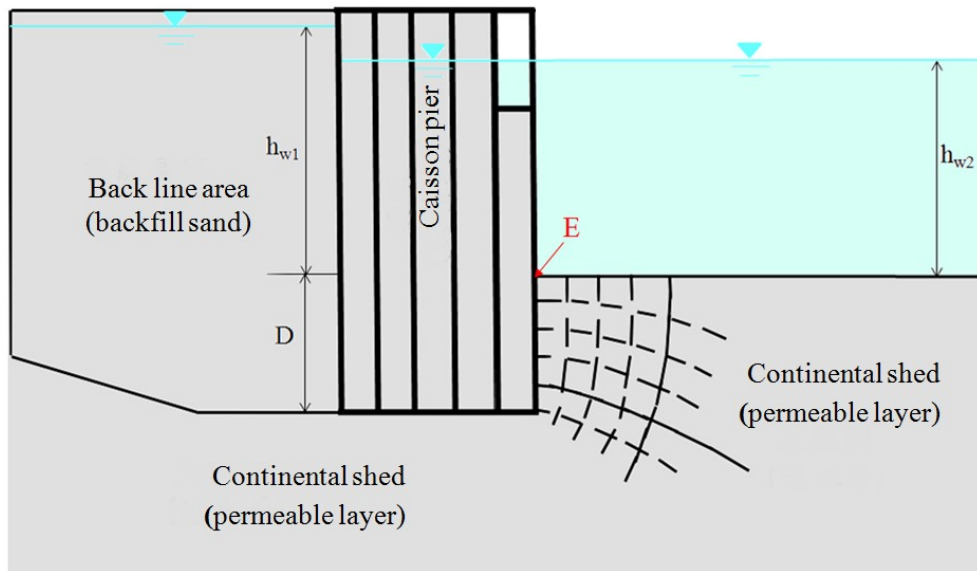
Figure 10. Caisson Dock with Embedment Depth D (Chang, 2019).

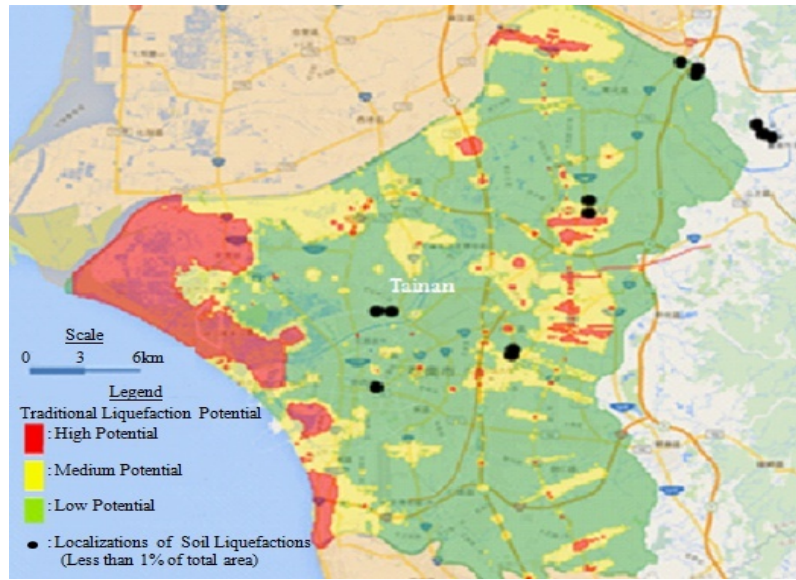
7. Figure 12 shows the soil liquefaction potential distribution map for Tainan City, Taiwan, while Figure 13 shows the same for Alameda, California, USA. Both Figure 12 and Figure 13 indicate that nearly the entire areas of Tainan City and Alameda, California, USA, possess soil liquefaction potential. However, Figure 12 also reveals that during the 2016 Meinong earthquake in Tainan, Taiwan, soil liquefaction only occurred

locally at the positions marked by the black dots in the figure. Since the actual area of soil liquefaction accounted for less than 3% of the total area, this demonstrates that the soil liquefaction potential distribution maps in Figure 12 and Figure 13, which suggest nearly complete liquefaction potential throughout these regions, do not align with the observed facts.

Figure 12. Distribution map of soil liquefaction potential of Tainan, Taiwan (Hsu et al., 2017; Central Geological Survey, MOEA, 2016).

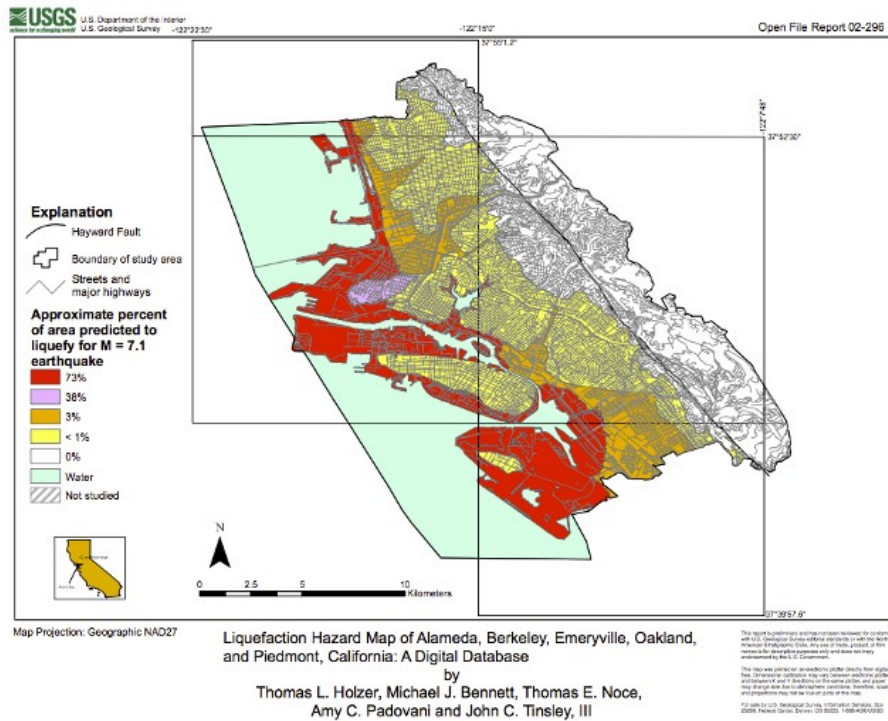
Figure 13. Distribution map of soil liquefaction potential of Alameda, California, USA (Holzer et al., 2019).
