THE MAJOR CAUSE OF HIGH-RISE BUILDING FAILURE DURING THE 921 JJI EARTHQUAKE

Tse-Shan Hsu

Abstract

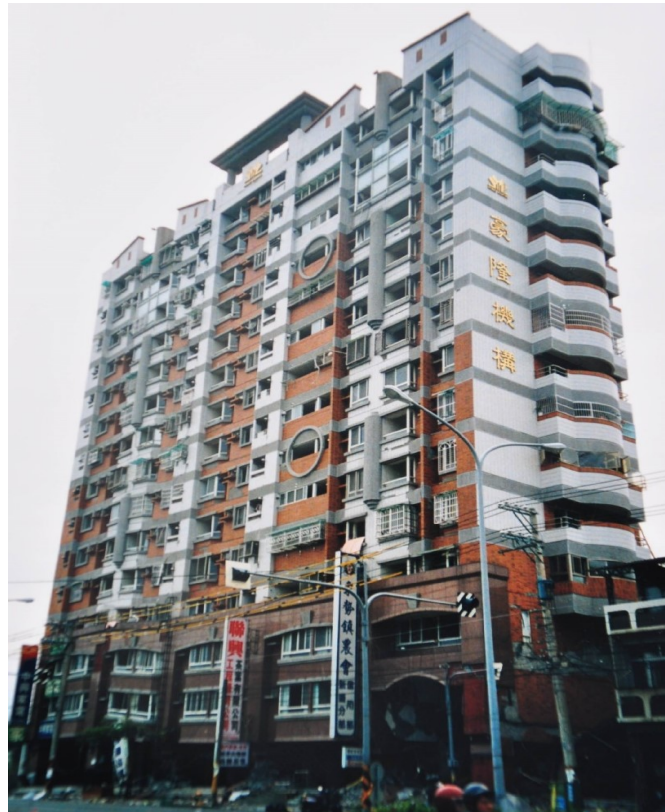
Haolong Building in Dongshi, Taichung, Taiwan, significantly subsided during the 921 Jiji earthquake, exhibiting localized damage to its first-floor columns (see Figure 1(a)), while overall tilting was observed from the first to the third floors (see Figure 1(b)). Typically, scholars and engineers assess such failures through on-site inspections, often attributing them to design flaws and poor construction practices.

(a) Panoramic view.

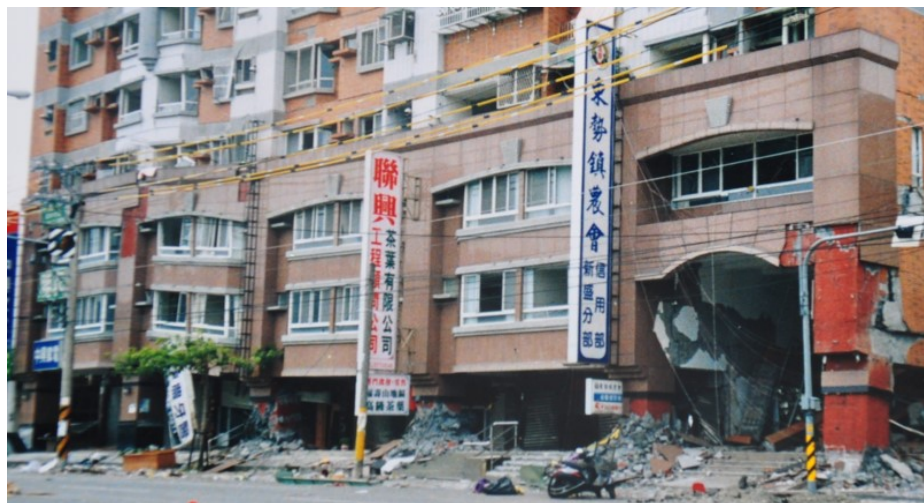
Even experienced professionals may find it challenging to determine the primary cause of a collapse through visual inspections alone. As shown in Figure 2, only one basement column of the Haolong Building experienced significant subsidence during the earthquake, primarily due to a loss of load-bearing capacity in the mat foundation. This subsidence led to fracture failures in three adjacent ground-floor columns at their bases due to arching effects (see Figure 1(b)).

(b) Close-up view.

Figure 1. Subsidence failure of the Haolong Building during the 921 Jiji earthquake (Dongshi, Taichung, Taiwan).

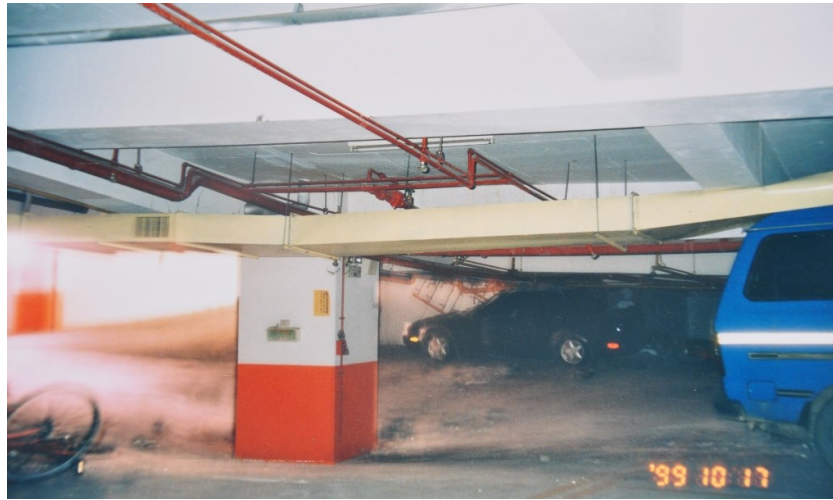
Figure 2. Significant subsidence of the mat foundation of the Haolong Building during the Jiji earthquake (Dongshi, Taichung, Taiwan).

Importantly, the failure of the mat foundation, as illustrated in Figure 2, did not occur under normal conditions or during heavy rainfall, indicating that its load-bearing capacity remained intact during these scenarios. However, the foundation failed during the 921 Jiji earthquake, suggesting a temporary reduction in its load-bearing capacity under severe seismic conditions. Generally, the primary reason for localized loss of load-bearing capacity in mat foundations during earthquakes is their positioning atop shear banding zones. Therefore, identifying the shear bands and shear textures surrounding the Haolong Building is crucial for substantiating that the significant subsidence was primarily caused by the

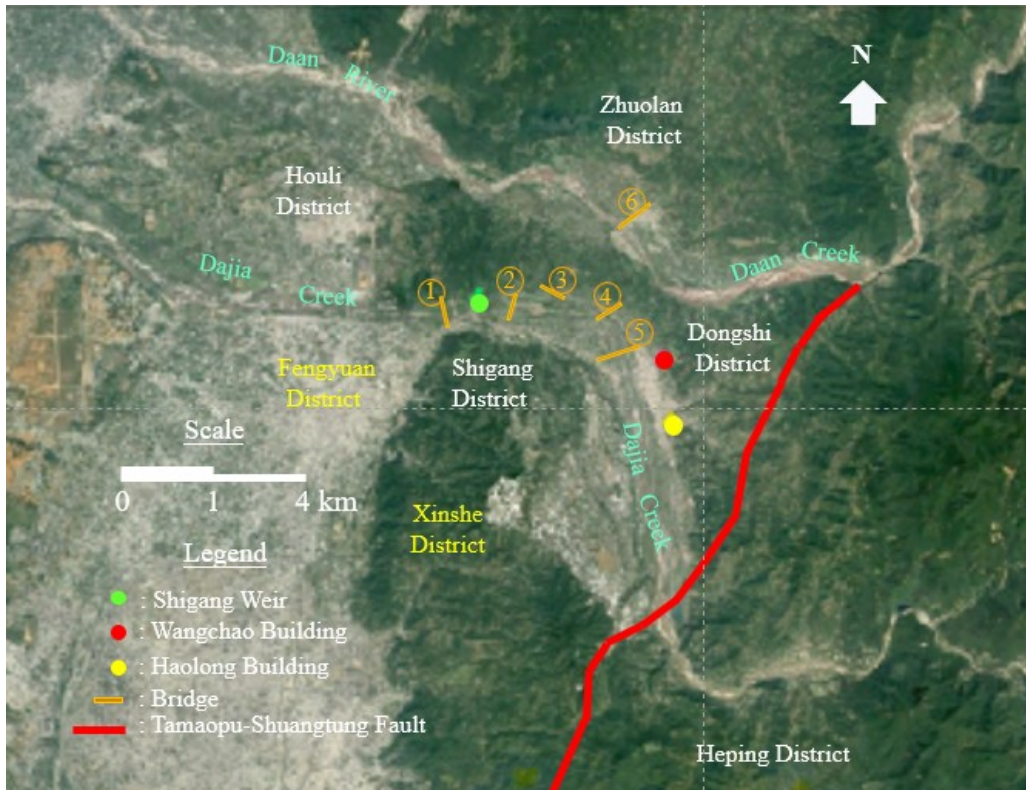
Figure 6 illustrates the necking phenomenon in the tectonic plate at the intersection of the Dongshi and Shigang districts, as well as Zhuolan town in Taichung, Taiwan. In this region, several structures, including the Shigang Weir, six bridges, the Wangchao Building, and the Haolun Building, sustained damage during the 921 Jiji earthquake. The affected bridges include the Pifeng, Chang Gung, Dongshi, Shihwei, Fengshi, and Zhuolan bridges.

Figure 6. Damage to dams, bridges, and buildings in the vicinity of Dongshi during the 921 Jiji earthquake (Background image is taken from Google Earth, 2024).

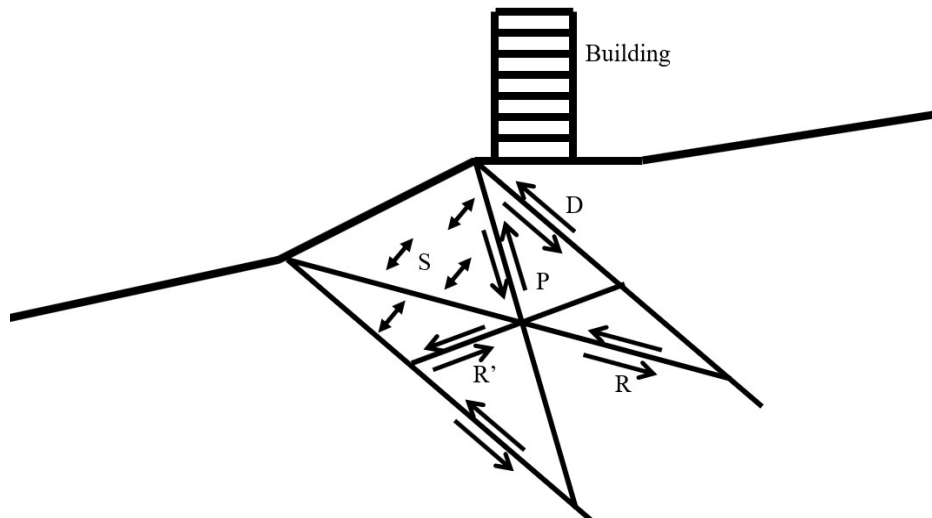
Thus, during the Jiji earthquake, the eastern ground of both the Haolong and Wangchao Buildings exhibited an uplift relative to the western ground, with a maximum uplift of 0.44 meters at the Haolong Building and 0.66 meters at the Wangchao Building. This uplift phenomenon resulted in the development of shear bands and shear textures, as depicted in Figure 10.

Figure 10. The sites of the Wangchao Building and the Haolong Building are located within shear banding zones.

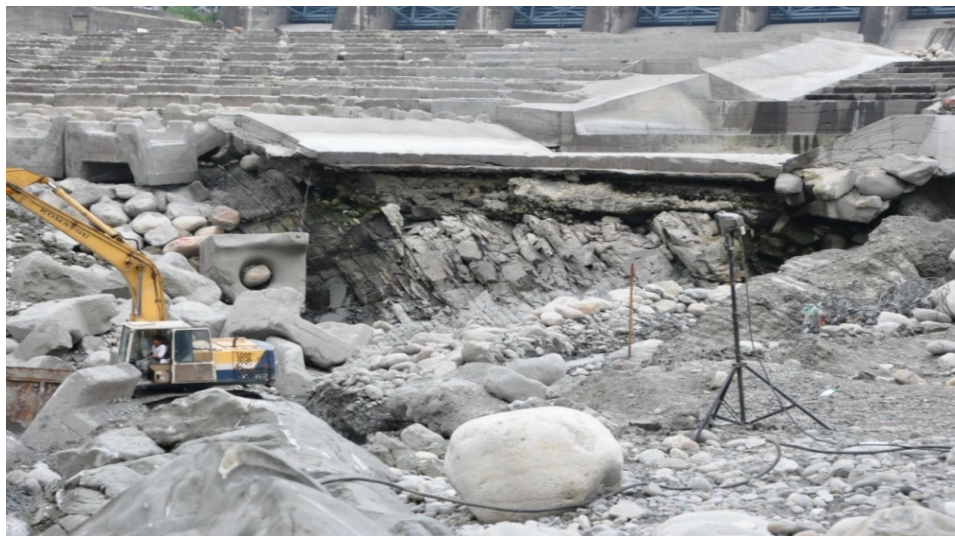
Figure 14. Outcrops of brittle fractures in the zones of shear banding and shear texturing in the riverbed downstream of the Shigang Weir.

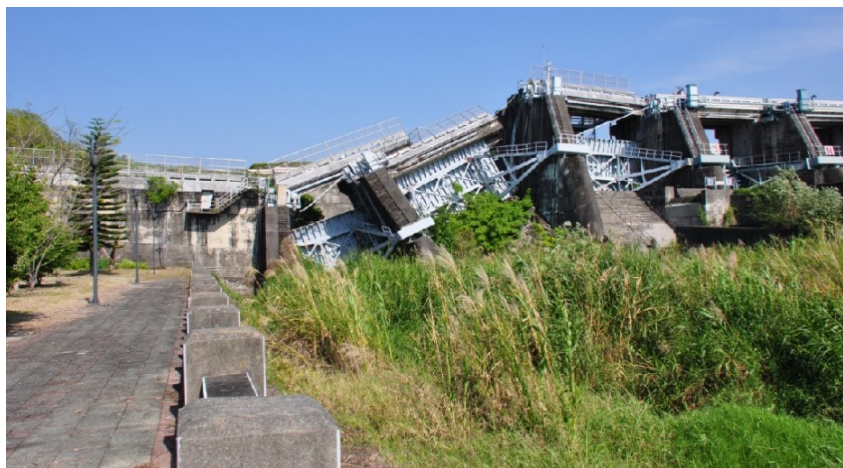
- 4) The shear banding zone extends toward the Shigang Weir, where uplift and tilting effects have caused significant damage to the structure (see Figure 15).

Figure 15. Severe damage to the Shigang Weir resulted from the uplift and tilting effect associated with shear banding.

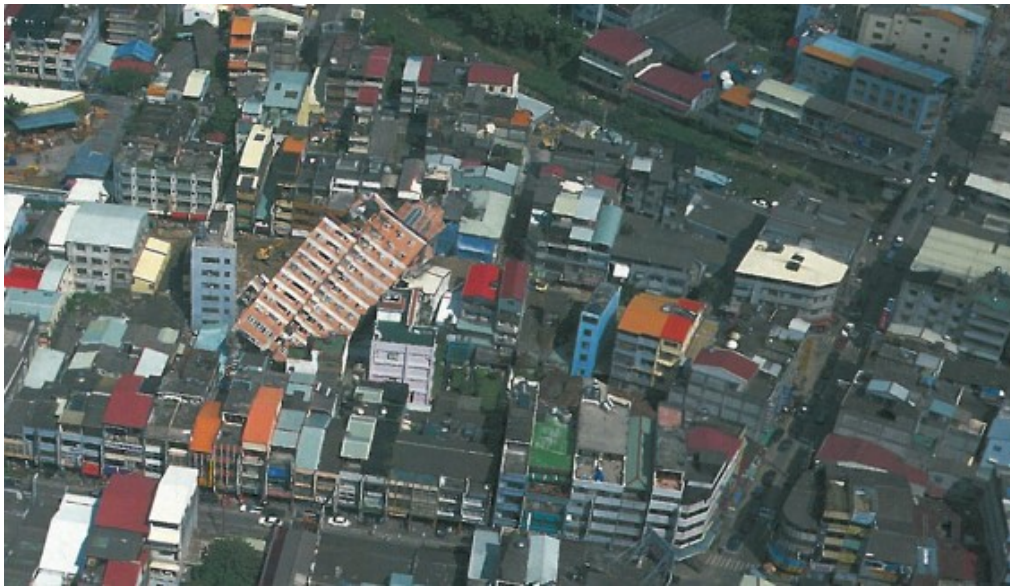
Figure 16. Tilting failure of the Wangchao Building during the 921 earthquake (Lian, 1999).

- 7) The uplift and tilting effects of shear bands and shear textures often trigger soil liquefaction (Hsu et al., 2017). The tilting failure of the Wangchao Building and the subsidence failure of the Haolong Building during the 921 Jiji earthquake were primarily caused by the loss of load-bearing capacity in their mat foundations due to soil liquefaction. The main contributor to soil liquefaction is the strain-softening of the soil within the shear bands beneath the mat foundations, combined with highly concentrated excess pore water pressure in localized areas of groundwater within shear bands or shear textures. Consequently, soil
