A STUDY ON THE CAUSES OF HIGH-RISE BUILDING FAILURE

Dr. Tse-Shan Hsu

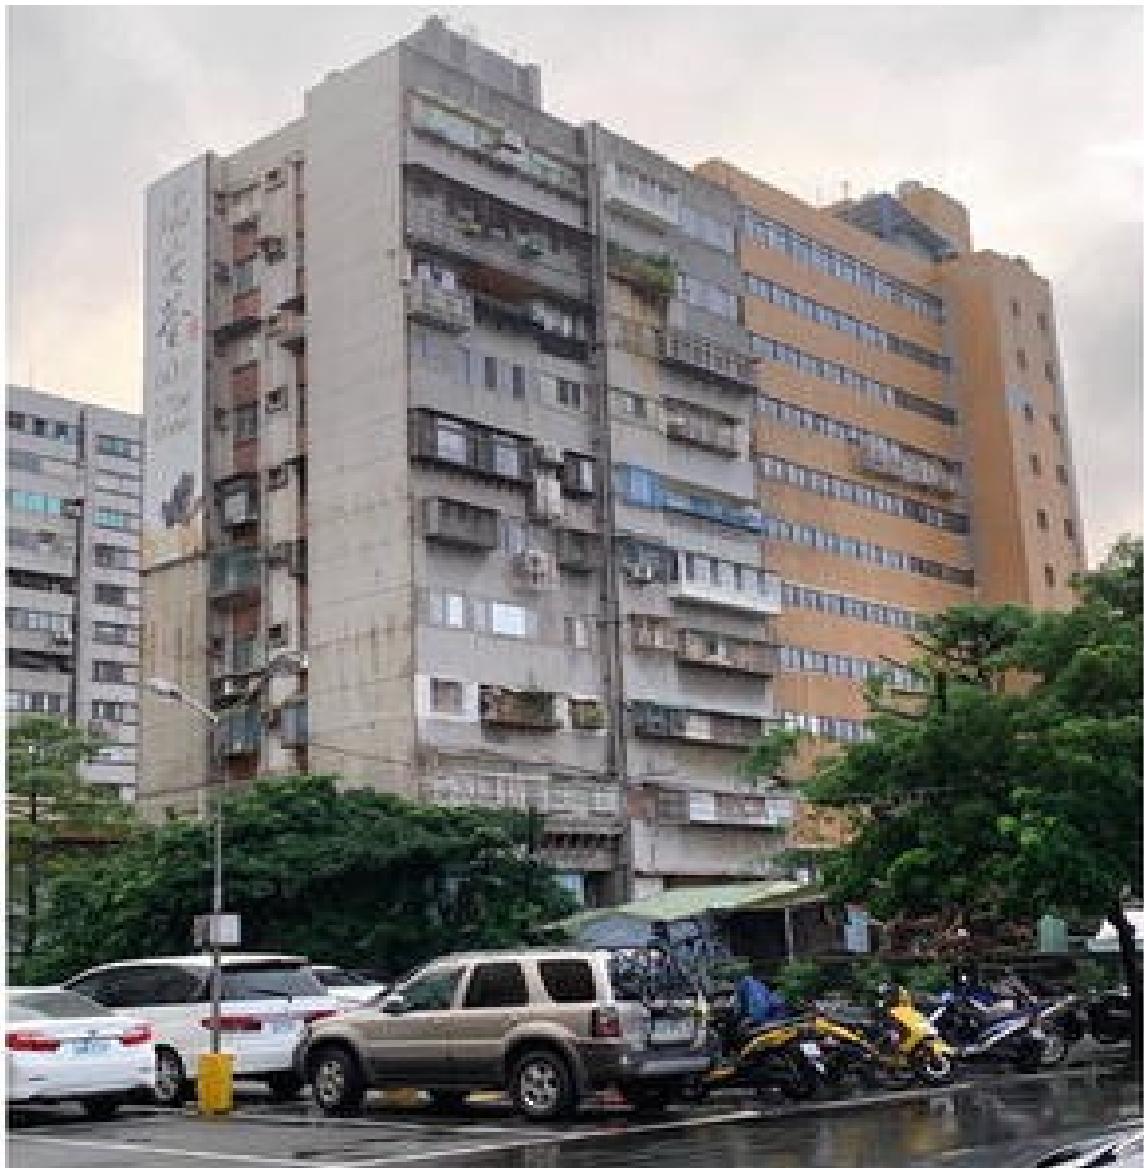
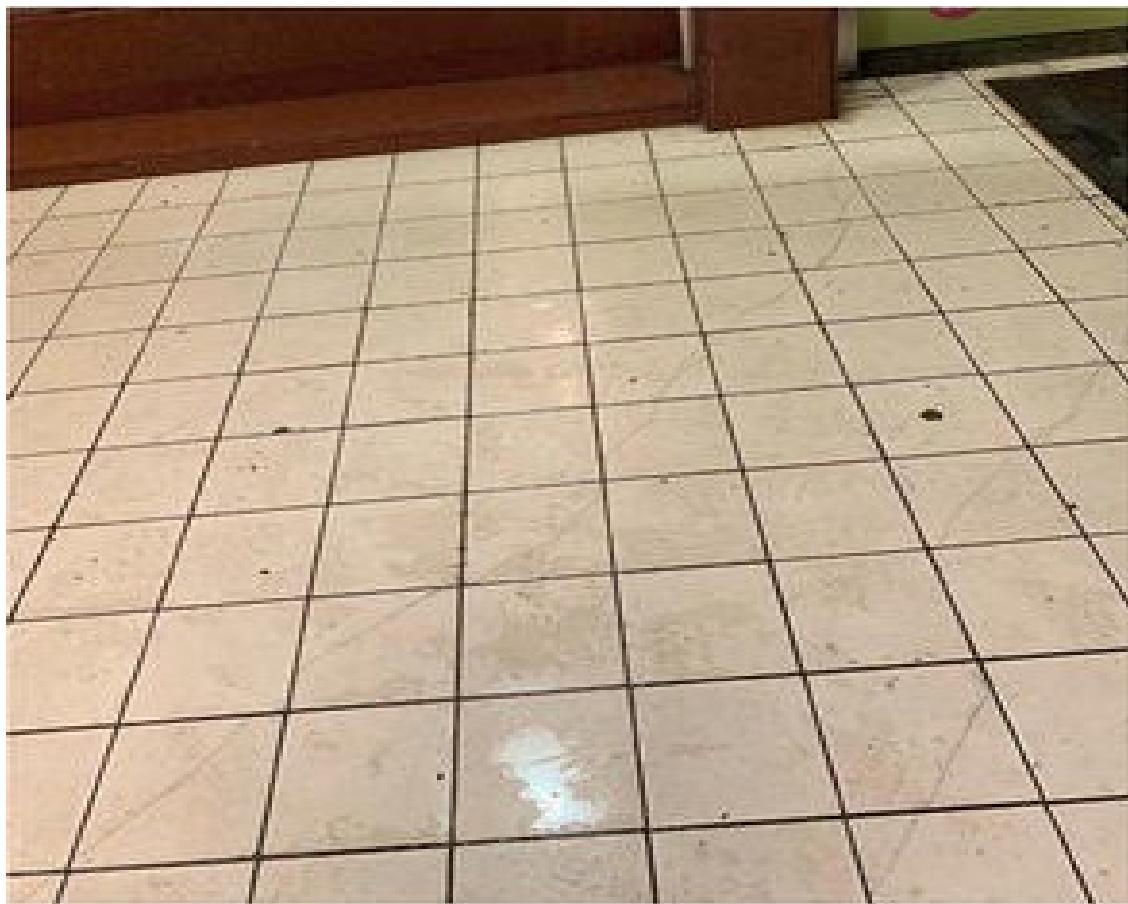
Figure 4. The Zhenong building damaged in the April 18, 2019 Hualien earthquake (Hsu, 2022).

exhibited floor cracking (Figure 4); (b) the Yutai Building, which experienced tilting and subsidence (Figure 5); and (c) the Dongshing Building, which collapsed (Figure 6) (Hsu, 2022).

(a) Failure of tilting and subsidence.

(b) A close-up view of the damage resulting from tilting and ground subsidence.

Because the Zhenong Building is located in Soft Region 1—an area affected solely by compression—its floor cracking suggests that the structure was in a lightly non-earthquake-resistant state. For the Yutai Building, also within Soft Region 1, the observed tilting and subsidence indicate a moderately non-earthquake-resistant state. In contrast, the collapse of the Dongsing Building, located in Soft Region 2, reflects a highly non-earthquake-resistant state.

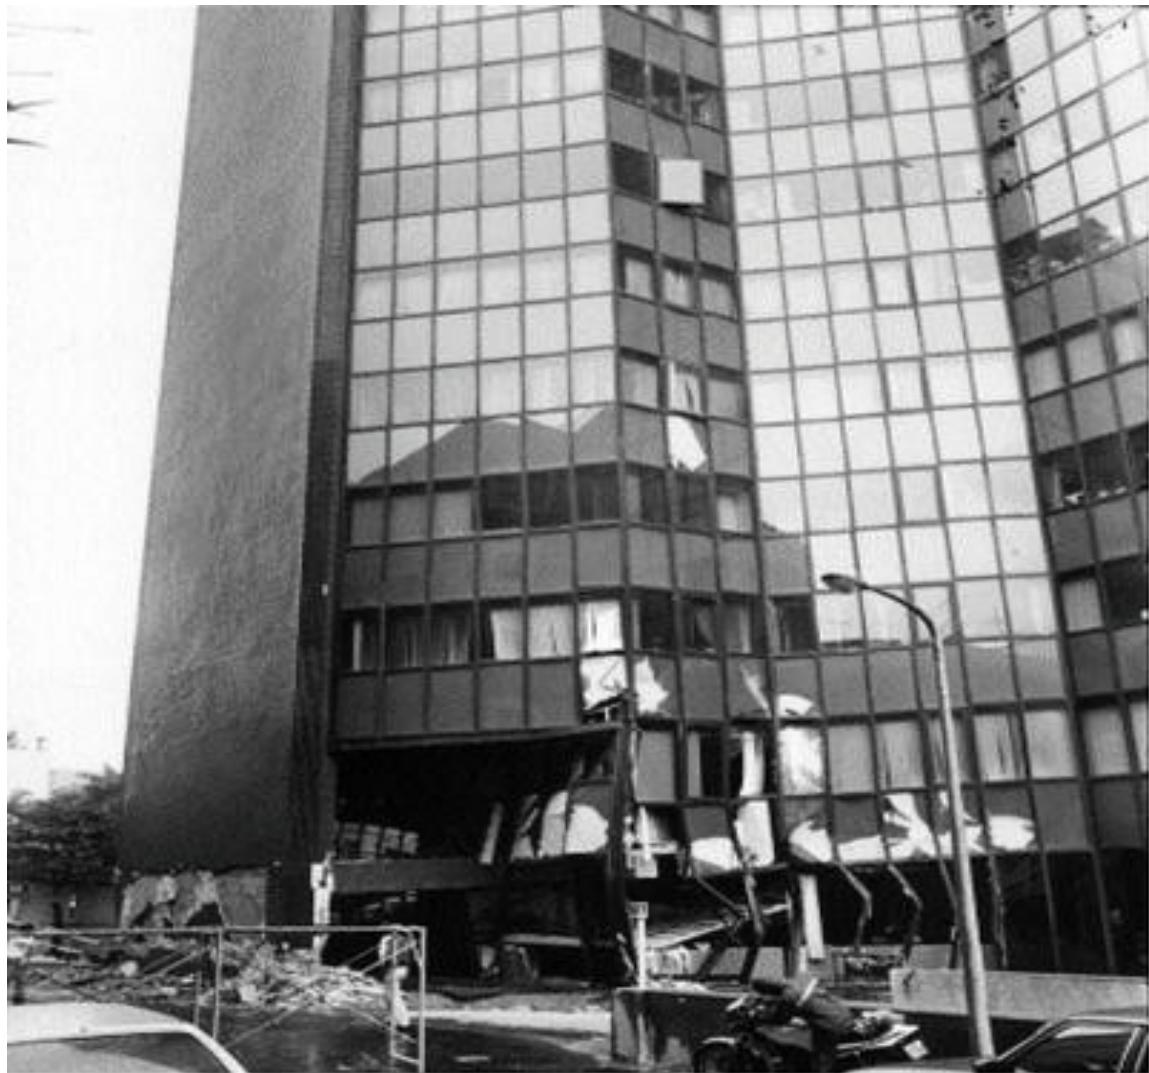
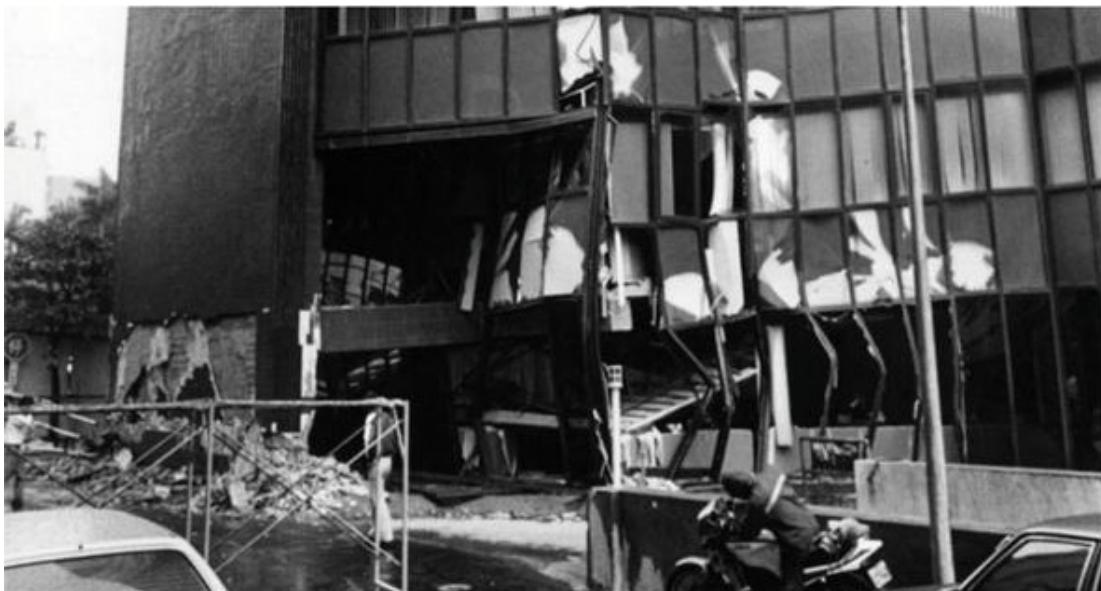
Figure 5. The Yutai building damaged during the April 18, 2019 Hualien earthquake (Hsu, 2022).

(a) Failure of tilting and subsidence.

(b) A close-up showing damage caused by tilting and subsidence.

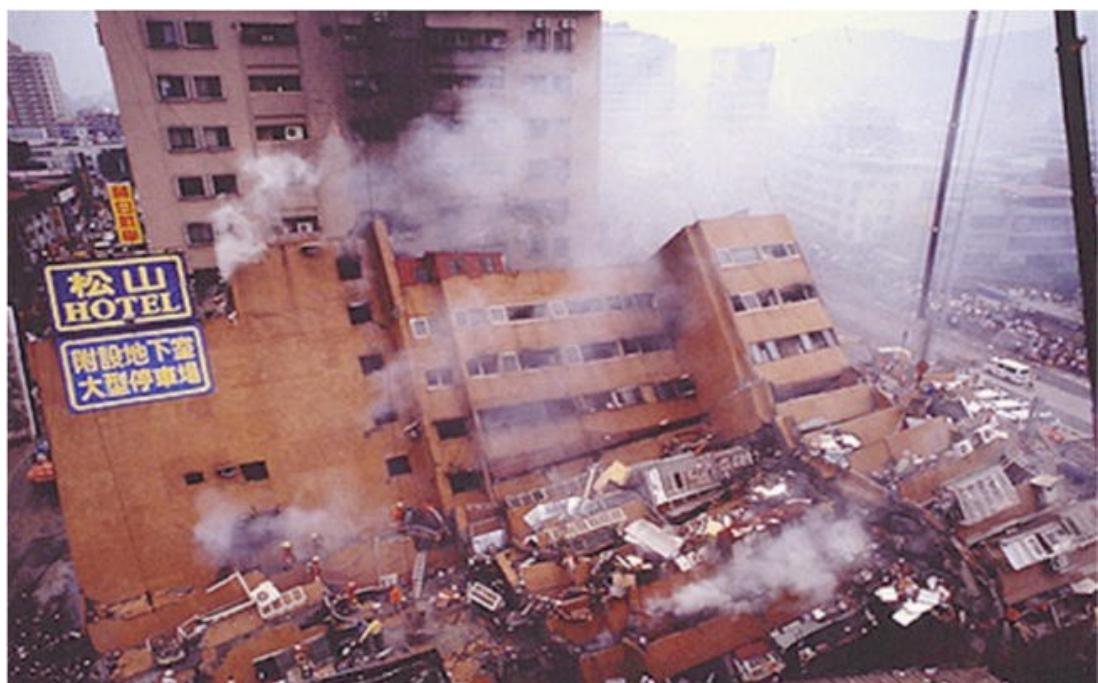
Figure 6. The Dongshing Building collapsed during the 1999 Jiji (921) earthquake (Hsu, 2022).

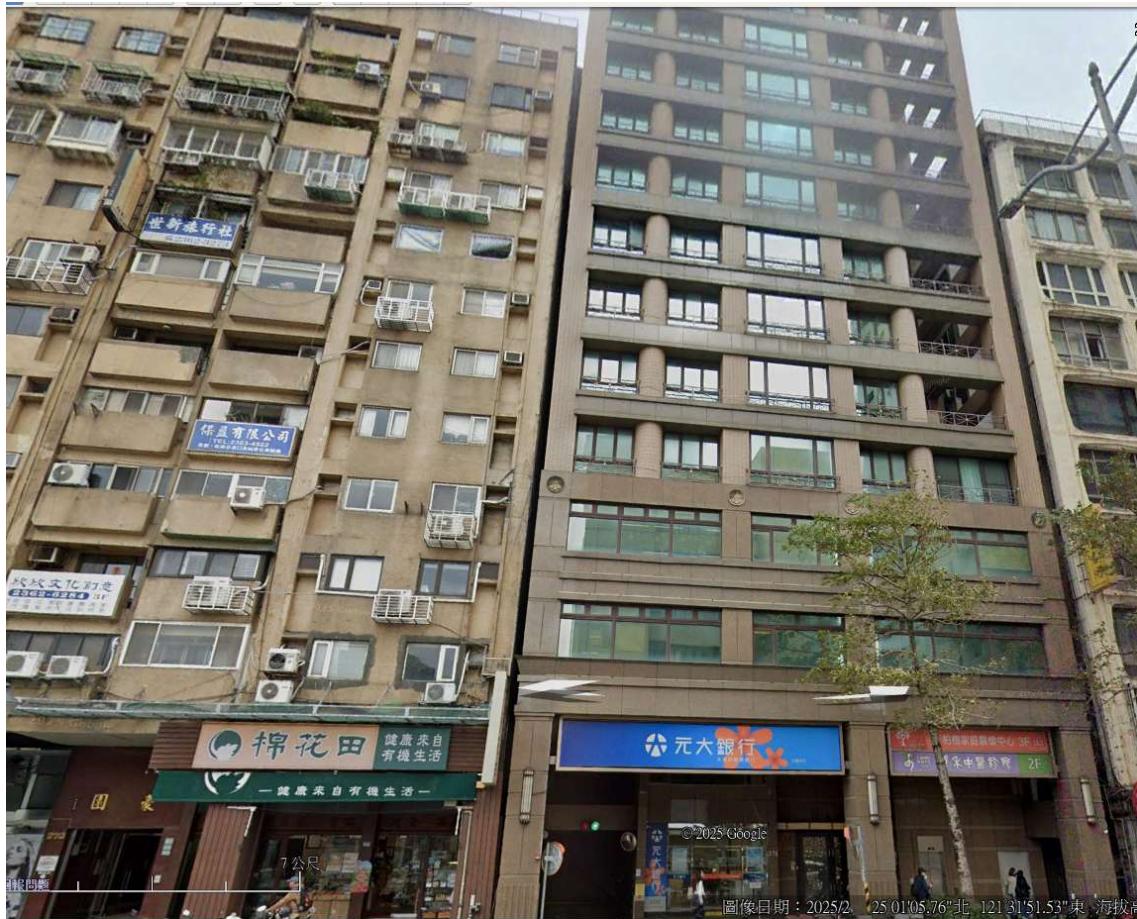
Figure 14. Building D (Google Earth (2022)).

Figure 14 shows that the first floor of the building on the left is nearly in contact with the first floor of the building on the right. However, gaps appear between the upper floors of the two

buildings, and these gaps increase progressively with height. As a result, at the top floors, the gap between the left and right buildings widens to more than 10 centimeters. This phenomenon clearly indicates that the building on the left has tilted and subsided relative to the one on the right. If the building on the right meets seismic-resistance requirements, then the building on the left can be classified as a moderately non-seismic-resistant structure.

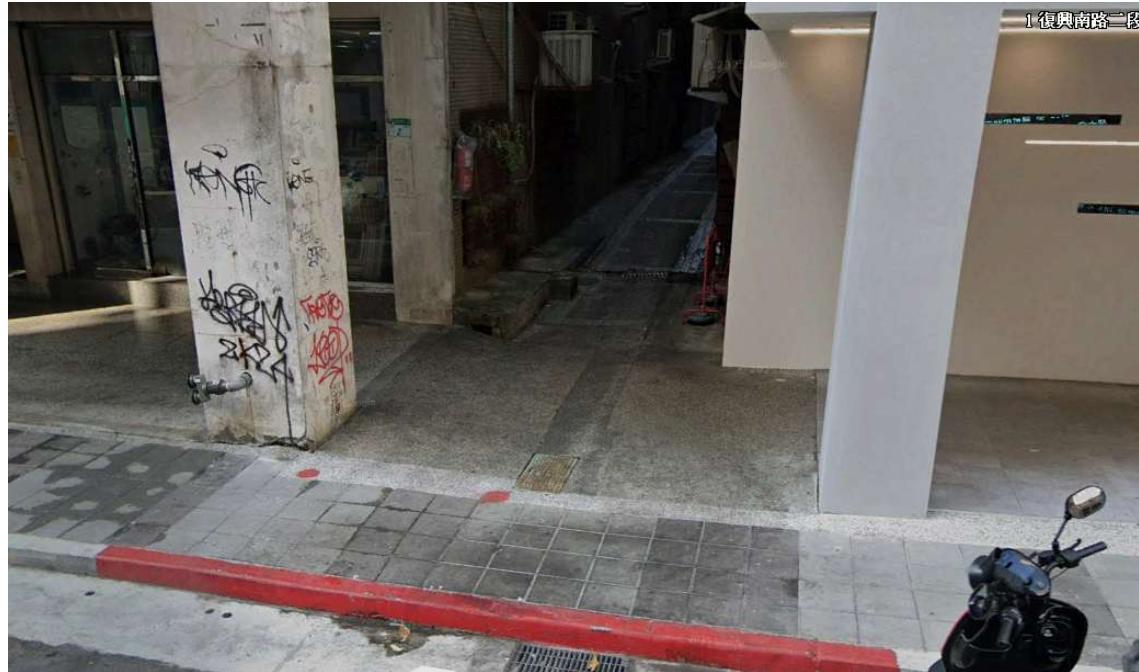
Figure 15 shows floor cracking in Building A, indicating that it is in a slightly non-earthquake-resistant state. Figure 16 shows damage to the exterior wall tiles of Building B—including cracking, spalling, and uneven coloration—suggesting that Building B is also slightly non-earthquake-resistant. Figure 17 presents cracking of the walls and floors in Building C, likewise indicating a slightly non-earthquake-resistant condition. Figure 18 shows uneven settlement of the road adjacent to Building D and cracking of

Figure 15. Floor cracking between Building A and the adjacent building (Google Earth, 2022).

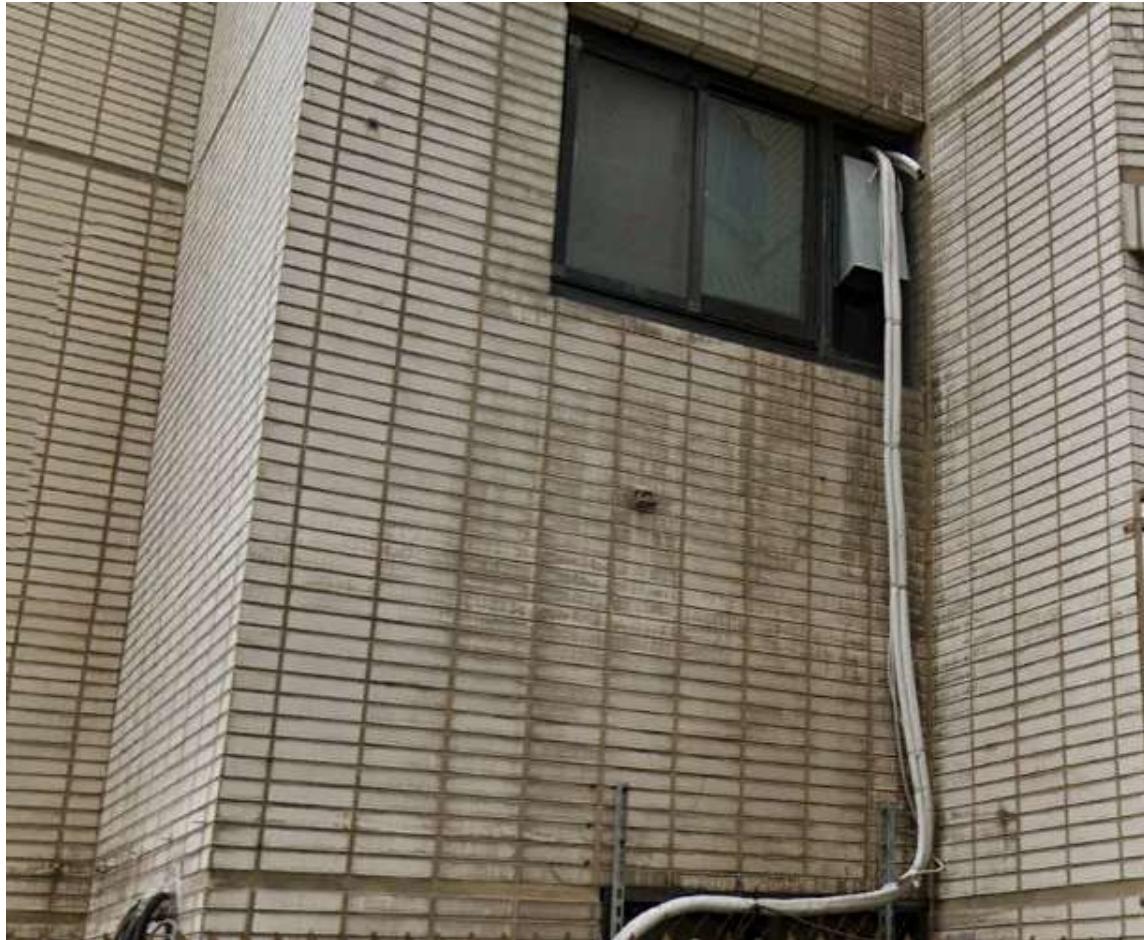
Figure 16. Cracking, spalling, and uneven coloration of Building B's exterior wall tiles (Google Earth, 2022).

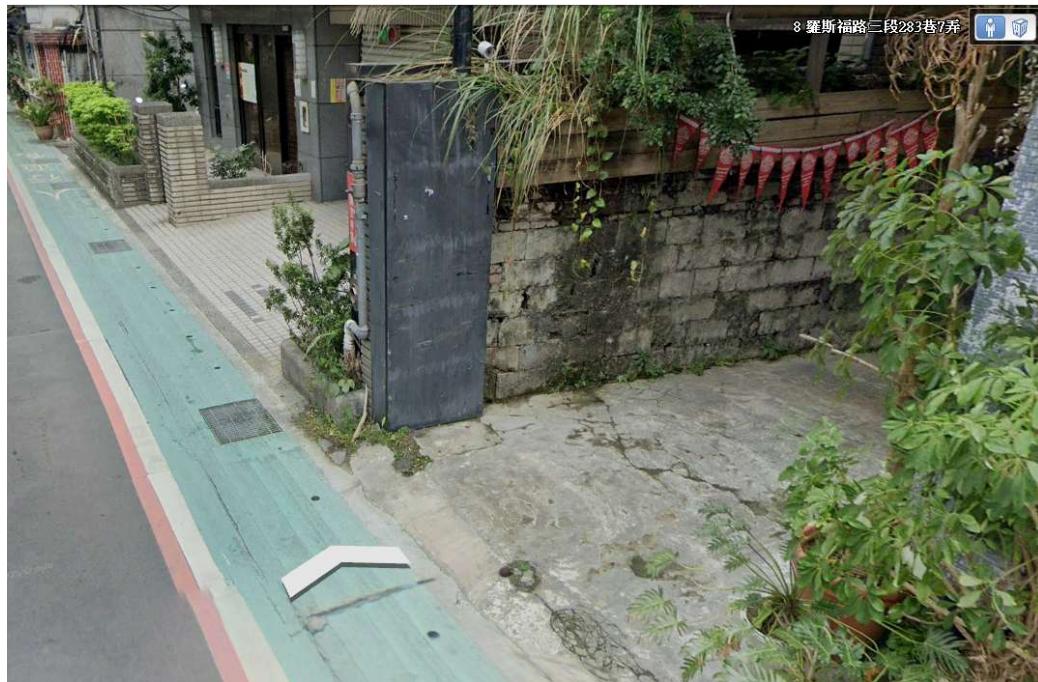
Figure 17. Cracking observed in the walls and floors of Building C (Google Earth, 2022).

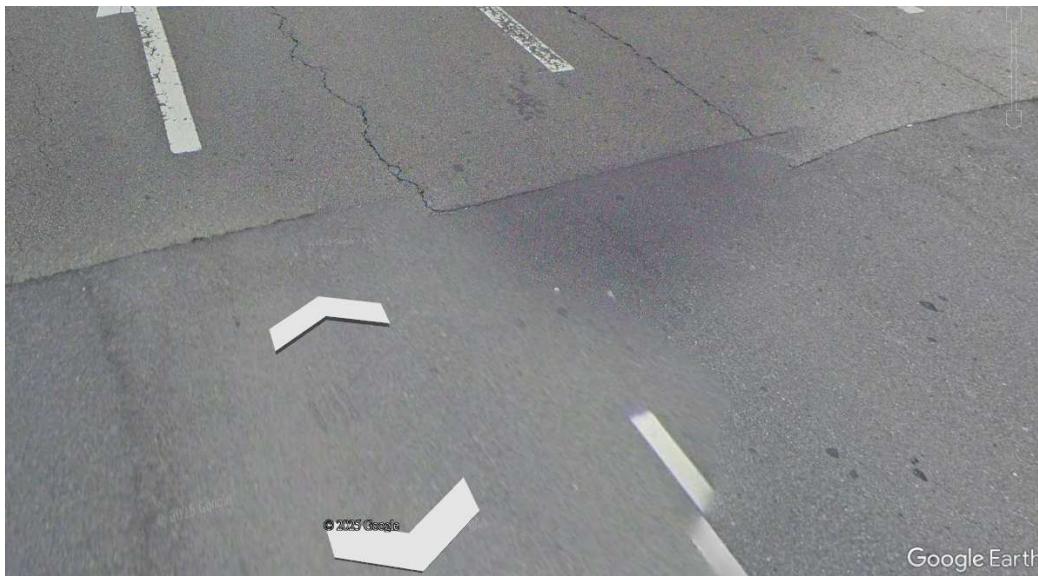
the asphalt concrete (AC) surface layer, indicating that Building D is in a mod-

erately non-earthquake-resistant state.

Figure 18. Uneven settlement of the road adjacent to Building D and cracking of the AC pavement (Google Earth, 2022).
