## THE MAJOR CAUSE FOR THE DESTRUCTION OF THE GANGWEIGOU CREEK FLOODWAY

Tse-Shan Hsu

President, Institute of Mitigation for Earthquake Shear Banding Disasters  
Professor, Department of Civil Engineering, Feng-Chia University  
Taiwan, R.O.C.  
tshsu@fcu.edu.tw

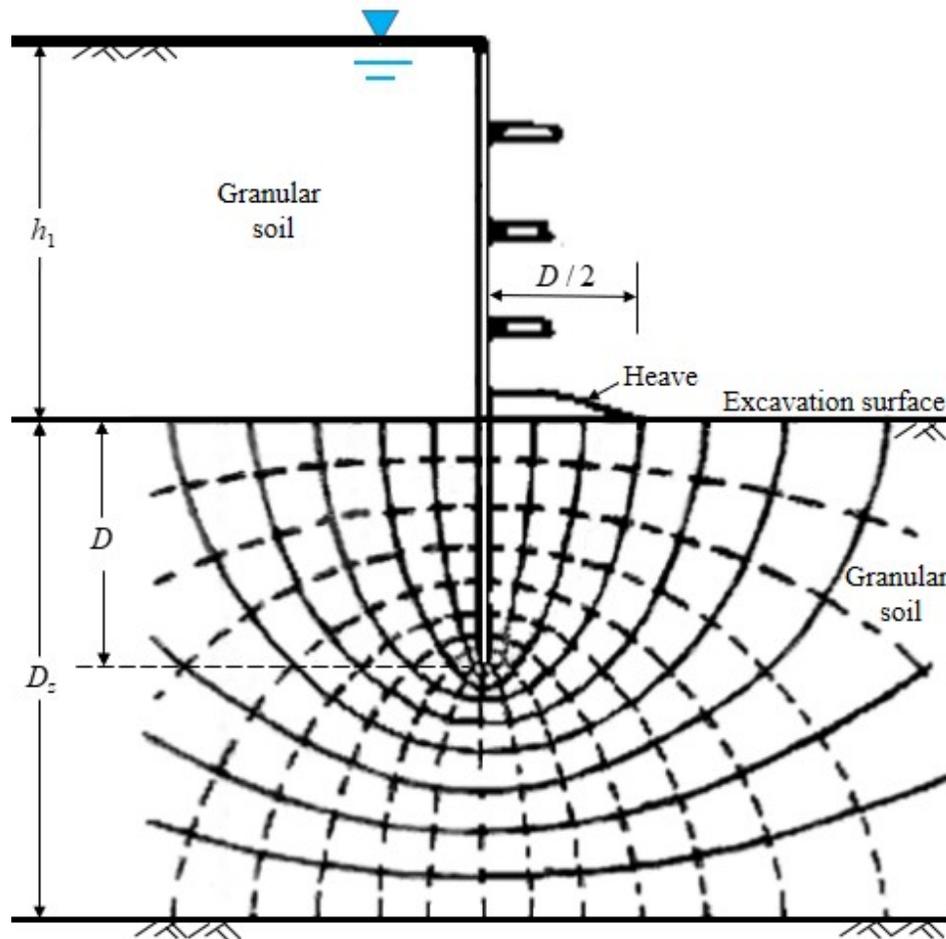
Figure 1. Grid of seepage flow lines and equipotential lines with sheet pile wall as excavation support (modified from Terzaghi, 1943).

Terzaghi (1943) adopted a net of seepage flow lines and equipotential

lines shown in Figure 1 to propose a piping failure mechanism. When the embedded depth of the sheet pile wall under the excavation surface is  $D$ , Terzaghi (1943) proposed that the excavation surface within  $D/2$  range from the sheet pile wall will heave upwards due to piping failure.

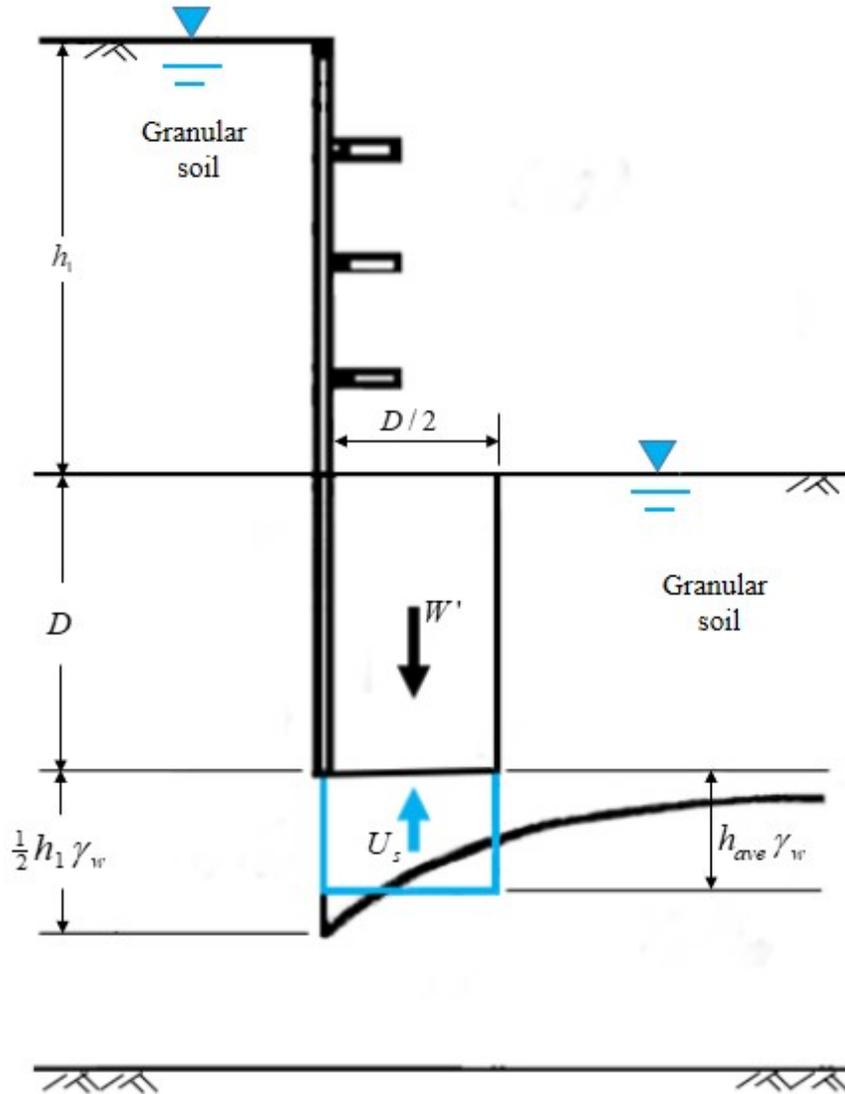
Figure 2.  $W'$  and  $U_s$  used to determine the safety factor against piping. (modified from Terzaghi, 1943).

to the soil column shown in Figure 2 in an analysis; thereafter, Terzaghi (1943) defined the safety factor against piping

as  $FS = W'/U_s$ , where  $W'$  is the effective weight of the soil column submerged in groundwater, that is,  $W' = (\gamma_{sat} - \gamma_w)D^2/2$ ; and  $U_s$  is the upward buoyancy acting on the bottom of the soil column, and its value can be determined by the average value of

water head  $h_{ave}$  for the equipotential lines passing through the bottom of the soil column, thus,  $U_s = h_{ave}\gamma_w D/2$ , and  $FS = (\gamma_{sat} - \gamma_w)D/(h_{ave}\gamma_w)$ . Therefore Terzaghi (1943) defined that the piping failure will occur when  $FS \leq 1.0$ .

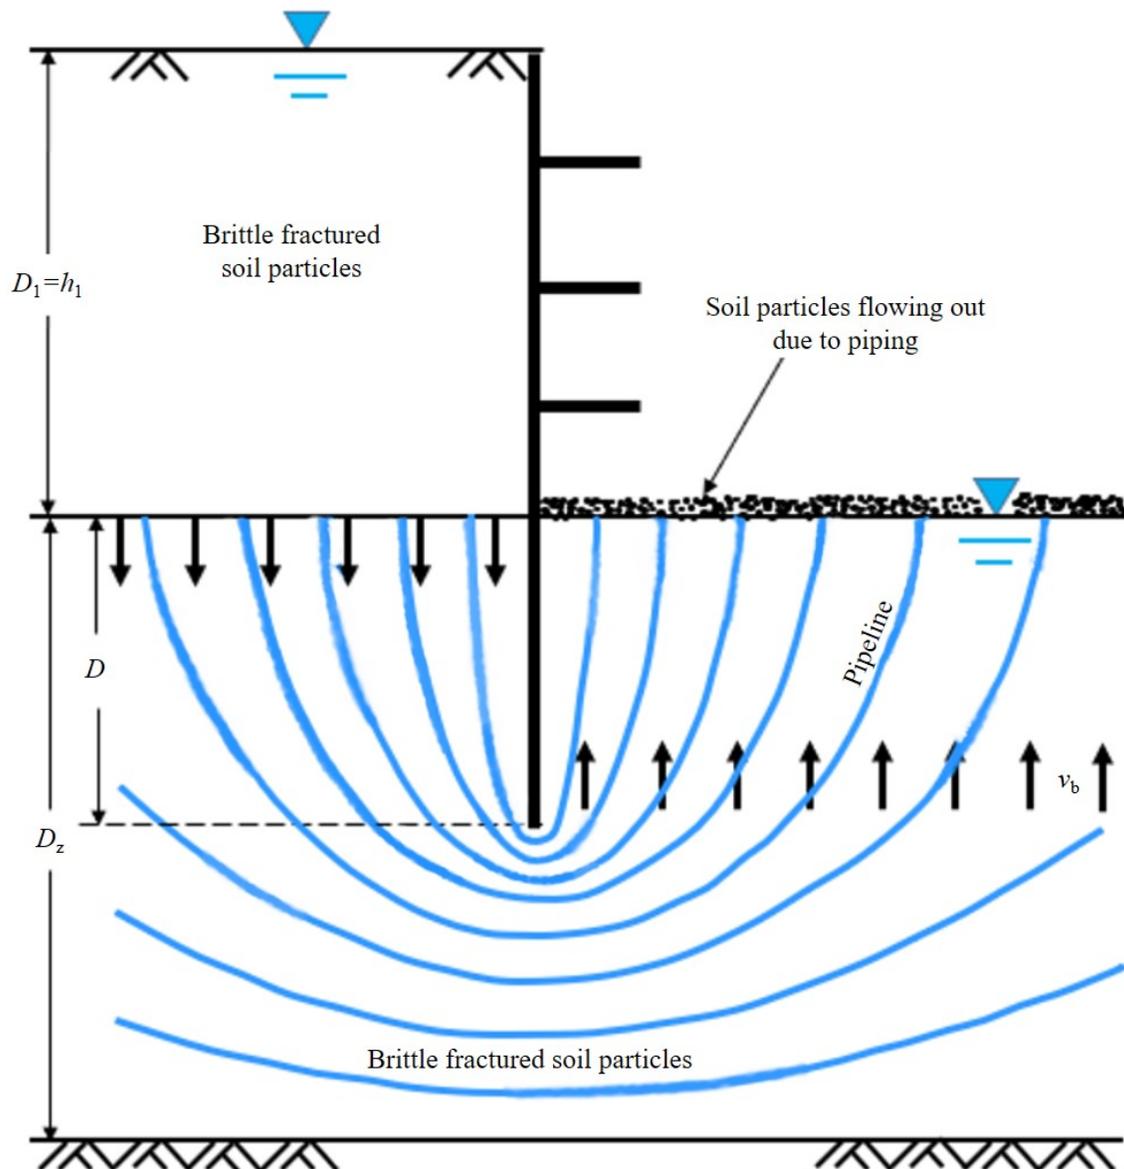
Figure 3. Schematic diagram of pipe flow in a shear band.

When the sheet pile wall is embedded in a shear band, because of the brittle-fractured effect, the pore space of the shear band will be connected in series to form pipelines, the flow pat-

tern in the shear band will change from seepage flow to pipe flow. In the pipe flow process, the groundwater will entrain soil particles and flow upwards along the pipelines. The soil particles that have flowed out will finally stay on the excavation surface (Figure 3).

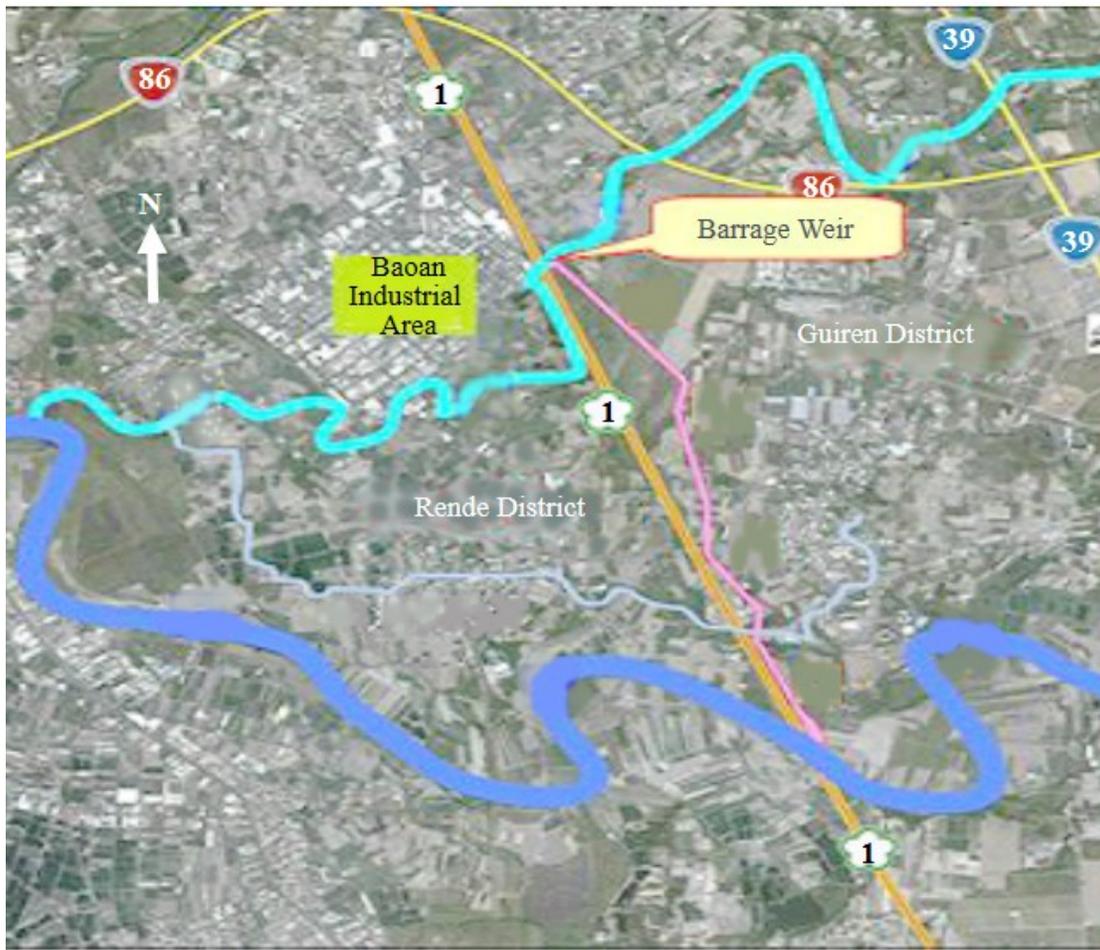
Figure 4. Geographical map of Gangweigou Creek Floodway (epaper.wra.gov.tw, 2015).

Figure 4 shows the original drainage system of Baoan Industrial Area, Guiren District, and Rende District of Tainan, Taiwan, which includes Gangweigou Creek, Erren Creek, Zhongzhou Drainage Ditch, etc.

Figure 4 shows that Gangweigou Creek Floodway is located on the east side of National Highway No. 1. It was hoped that after the completion of the plan, the flood of Erren Stream in the Guiren District can directly pass through the Gangweigou Creek Floodway to the Gangweigou Creek in the north. Under this circumstance, the flood will no longer flow westwards into the Rende District and Baoan Industrial Area; thus

Generally speaking, the meandering creek shown in Figure 4 clearly indicated that there are displaced landform features; and the displaced landform features originate from shear banding effect. Therefore, the higher the meandering degree of a creek, the more significant the shear banding effect that the creek has suffered in the past history.

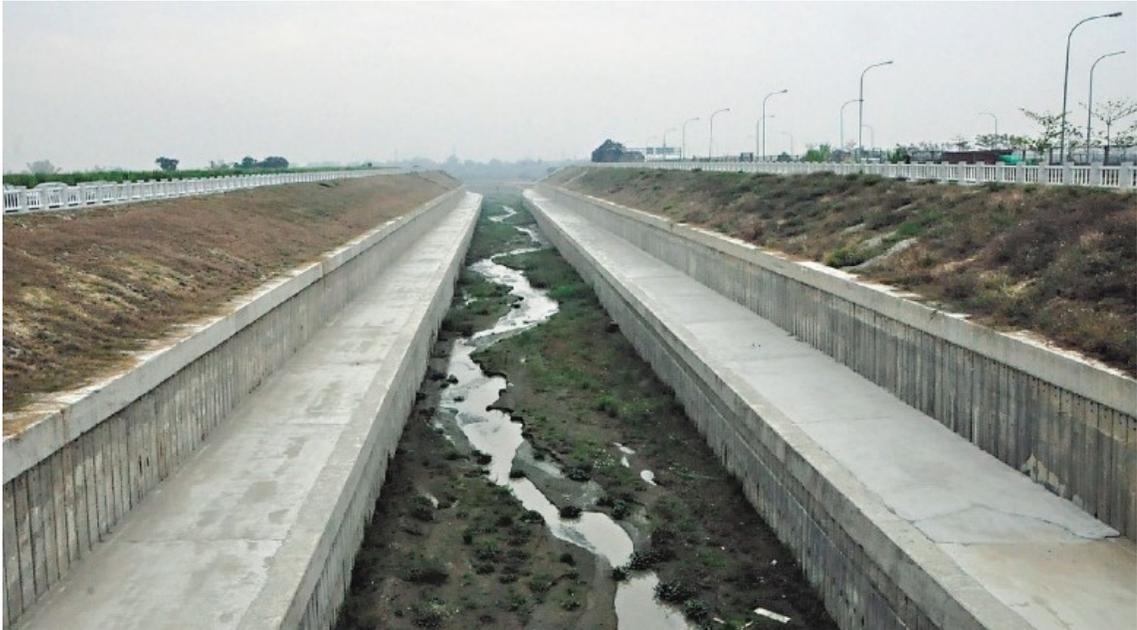
Figure 5. Gangweigou Creek Floodway just after completion (Qi, 2014).

Taking the Gangweigou Creek Floodway as an example, Figure 5 shows the floodway just after it was completed. It is revealed from Figure 5 that there are meandering deep grooves in Gangweigou Creek Floodway, and the shear bands that produces the grooves will extend outward to both sides of the floodway; therefore, when designing the sheet pile wall, the shear banding effect must be taken into account. Otherwise, the sheet pile walls on both sides of the floodway will collapse along with the occurrence of piping failure (Figure 6).

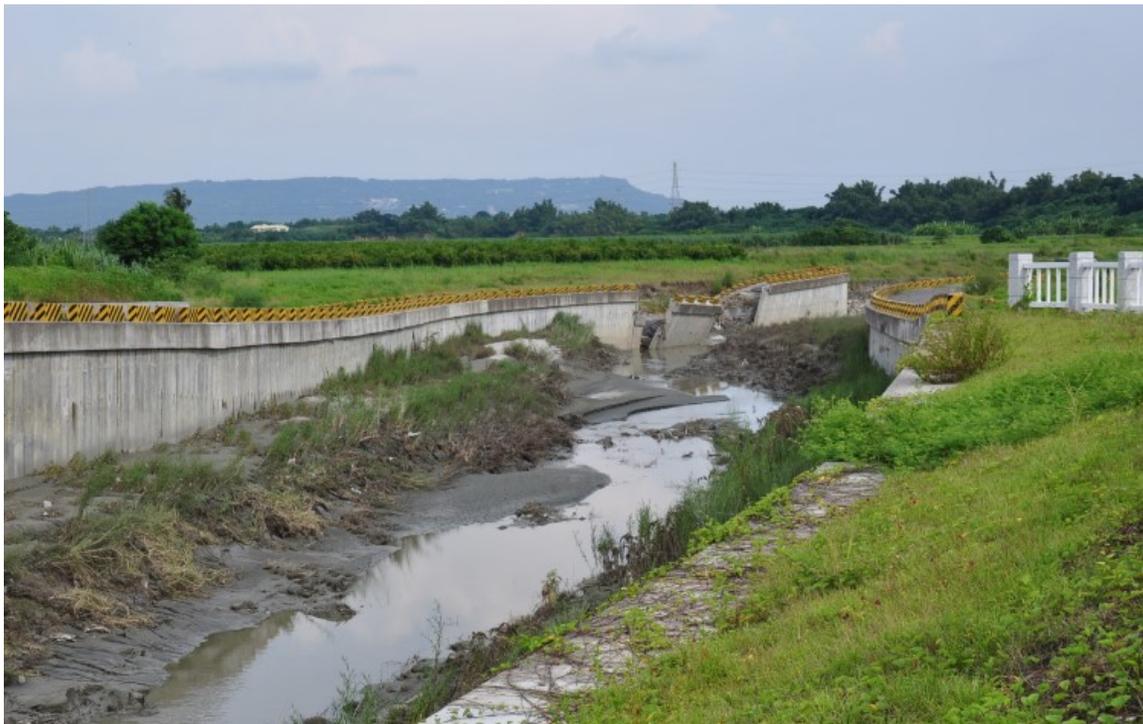
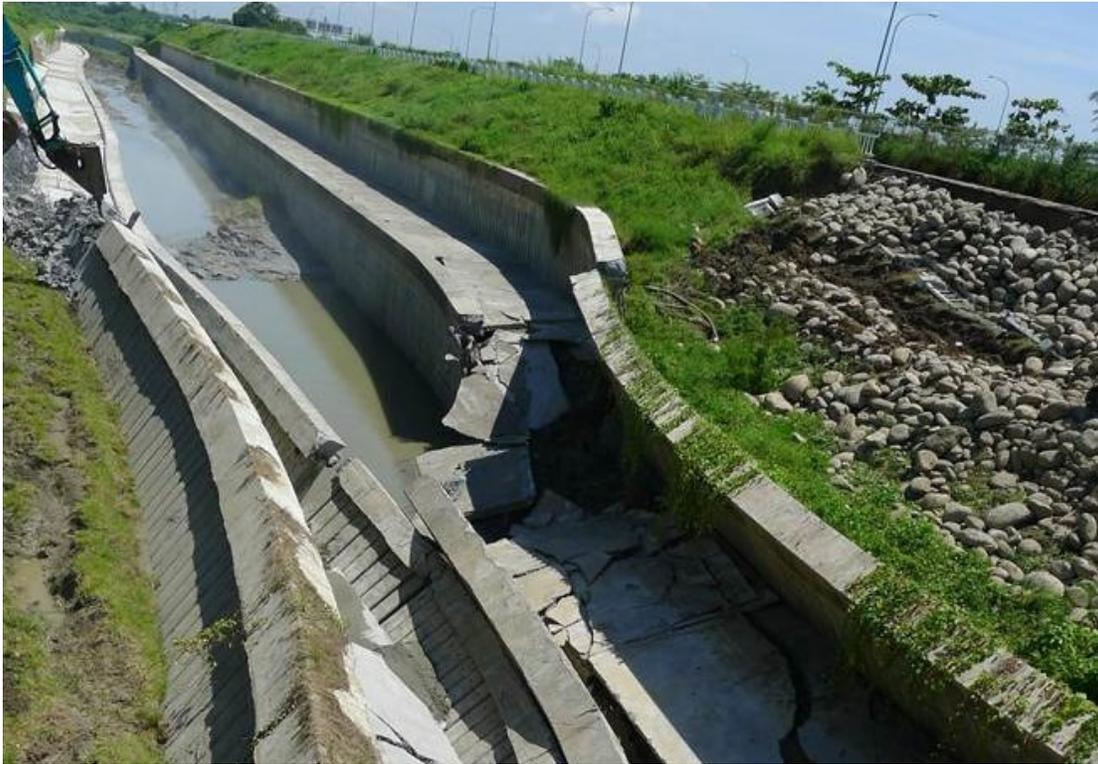
(a) One-step sheet pile wall

(b) Two-step sheet pile wall (Wu, 2016)

Figure 6. Gangweigou Creek Floodway just after the collapse.

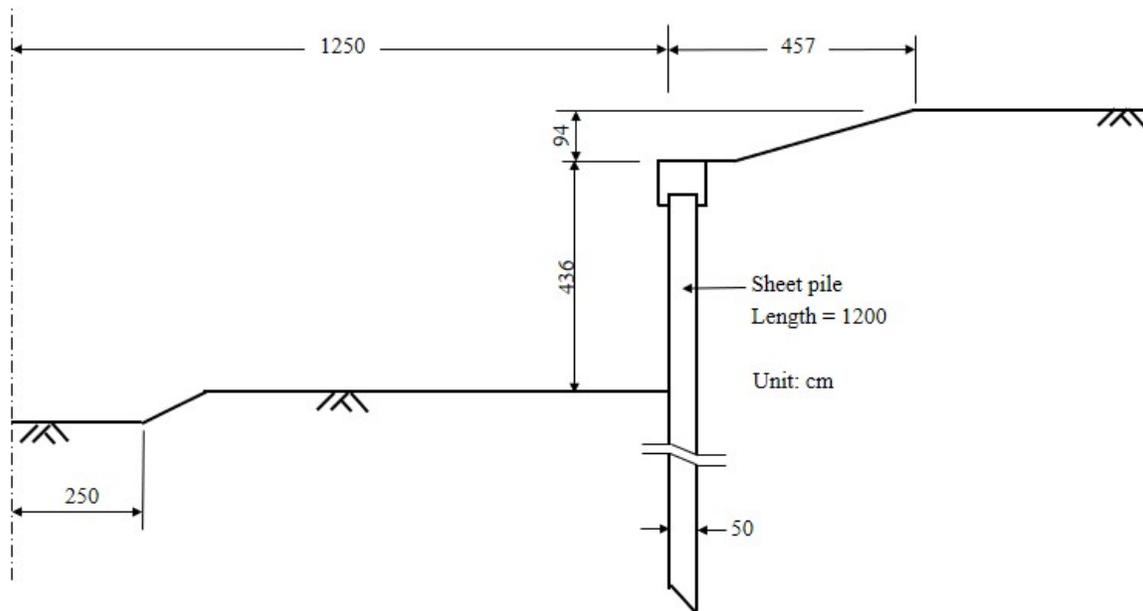
Figure 7. One-step sheet pile wall (epaper.wra.gov.tw, 2015).

For the one-step sheet pile wall of Gangweigou Creek Floodway shown in Figure 7, piping failure is likely to occur when the groundwater table of the soil behind the sheet pile wall is 436 cm above the creek bed (i.e.  $h_1 = 4.36$  m), the specific gravity of soil  $G_s$  is 2.65, the void

ratio  $e$  is 1.5, the unit weight of soil after submerged in the groundwater  $\gamma_{sub}$  is  $6.47\text{kN/m}^3$ , the embedding depth of sheet piles  $D$  is 7.64 m, and  $h_{ave}$  shown in Figure 2 is 1.64 m.

Then the calculated safety factor of piping resistance  $FS$  by using the formula proposed by Terzaghi (1943) is 3.07. Such a result indicates that the piping failure will not occur in the soil behind the one-step sheet pile wall.

For the one-step sheet pile wall of Gangweigou Creek Floodway shown in Figure 7, the piping failure is likely to occur when the groundwater table of the soil behind the sheet pile wall is 436 cm above the creek bed (i.e.  $h_1 = 4.36$  m), the soil specific gravity  $G_s$  is 2.65, the void ratio  $e$  is 1.5, and the inclination angle of the brittle-fractured soil deposition surface in the shear zone  $\beta$  is  $0^\circ$ . If the pore space of the shear

band will be connected in series to form pipelines, and the efficiency coefficient  $E$  of the flow velocity of water in the tubular outlet is only 1%, the calculated particle bottom velocity  $v_b = E\sqrt{2gh_1} = 0.092$  m/s. Under the above conditions, it is known from Table 1 that the bottom velocity  $v_b$  is greater than the critical bottom velocity  $v_{bc}$  for the brittle-fractured particles with particle sizes  $D_p \leq 0.5$  mm; so there is a slight piping failure problem.

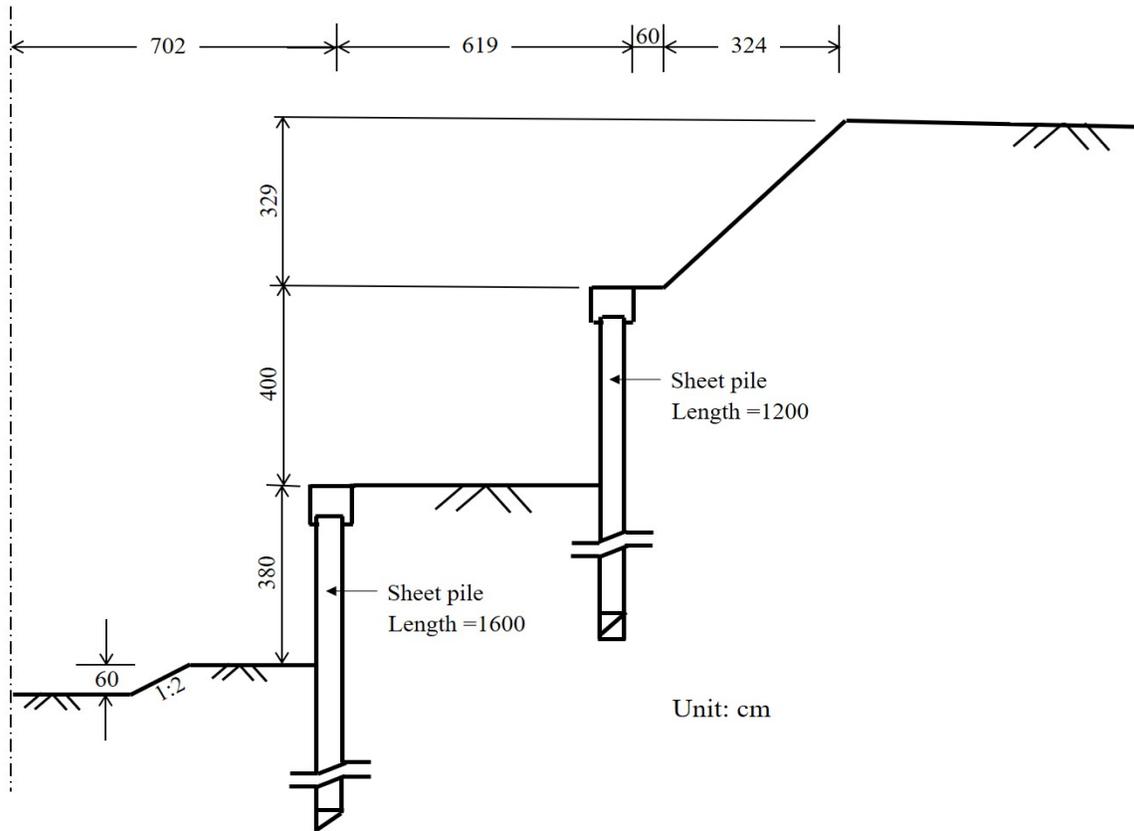
Figure 8. Two-step sheet pile wall (paper.wra.gov.tw, 2015).

For the two-step sheet pile wall of Gangweigou Creek Floodway shown in Figure 8, piping failure is most likely to occur at the upper-step sheet pile wall when the groundwater table of the soil behind the upper-step sheet pile wall is 400 cm above the upper-step creek bed (i.e.  $h_1 = 4$  m), the specific gravity of soil  $G_s$  is 2.65, the void ratio  $e$  is 1.5, and the unit weight of soil after

submerged in the groundwater  $\gamma_{sub}$  is  $6.47 \text{ kN/m}^3$ , the embedding depth of sheet piles  $D$  is 8 m, and  $h_{ave}$  shown in Figure 2 is 1.5 m. Then the safety factor of piping resistance  $FS$  calculated by using the formula proposed by Terzaghi (1943) is 3.52. Such a result also indicates that the piping failure will not occur in the soil behind the two-step sheet pile wall.

For the two-step sheet pile wall of Gangweigou Creek Floodway, as shown in Figure 8, the piping failure is most likely to occur when the groundwater table of the soil behind the sheet pile wall is 400 cm above the upper creek bed of Gangweigou Creek Floodway (i.e.  $h_1 = 4$  m), the specific gravity of soil  $G_s$  is 2.65, the void ratio  $e$  is 1.5, and the inclination angle  $\beta$  of the brittle-fractured soil deposition surface of

the shear band is  $0^\circ$ . If the pore space of the shear band will be connected in series to form a tubular outlet, and the efficiency coefficient  $E$  of the flow velocity of water in the tubular outlet is only 1%, the calculated particle bottom velocity  $v_b$  is 0.088 m/s. Under the above conditions, it is known from Table 1 that the bottom velocity  $v_b$  for the brittle-fractured particles with a particle size  $D_p \leq 0.5$  mm is greater than the critical bottom velocity  $v_{bc}$ ; so there is a slight piping failure problem.

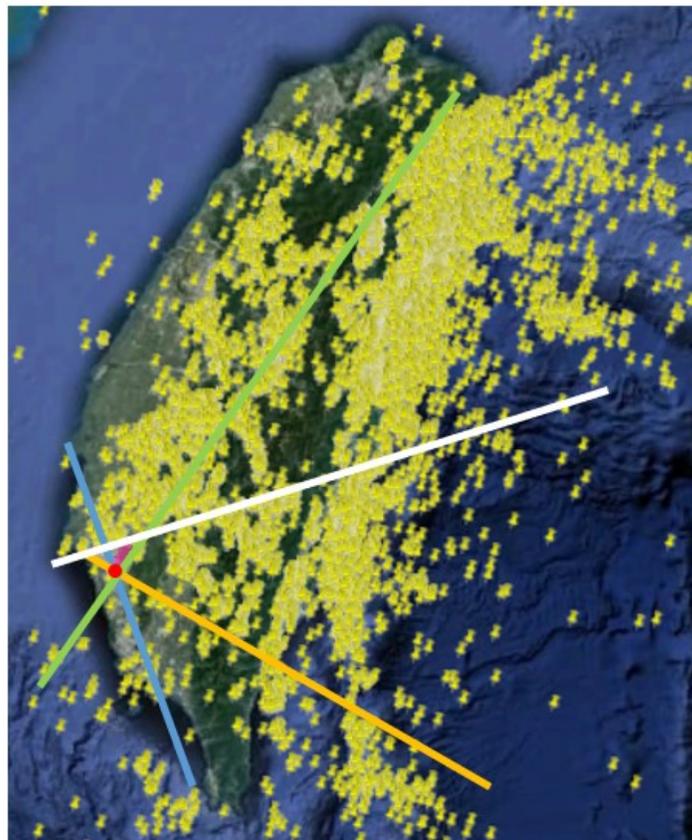
Note: The location of the red dot is the damage location of Gangweigou Creek Floodway

Figure 9. Shear bands identified by using the epicenter distribution map of historical earthquakes in Taiwan (Google Earth, 2020; Central Weather Bureau, 2020).

For the vicinity of Gangweigou Creek Floodway, the distribution map of epicenters of historical earthquakes in Taiwan shown in Figure 9 can be used to identify the shear bands. The identification results shown in Figure 9 reveal that there are four groups of shear bands in the area adjacent to Gangweigou Creek Floodway, and their strikes are  $N73^\circ E$  (white line),  $N35^\circ E$  (green line),  $N20^\circ W$  (blue line), and  $N60^\circ W$  (orange line), respectively.

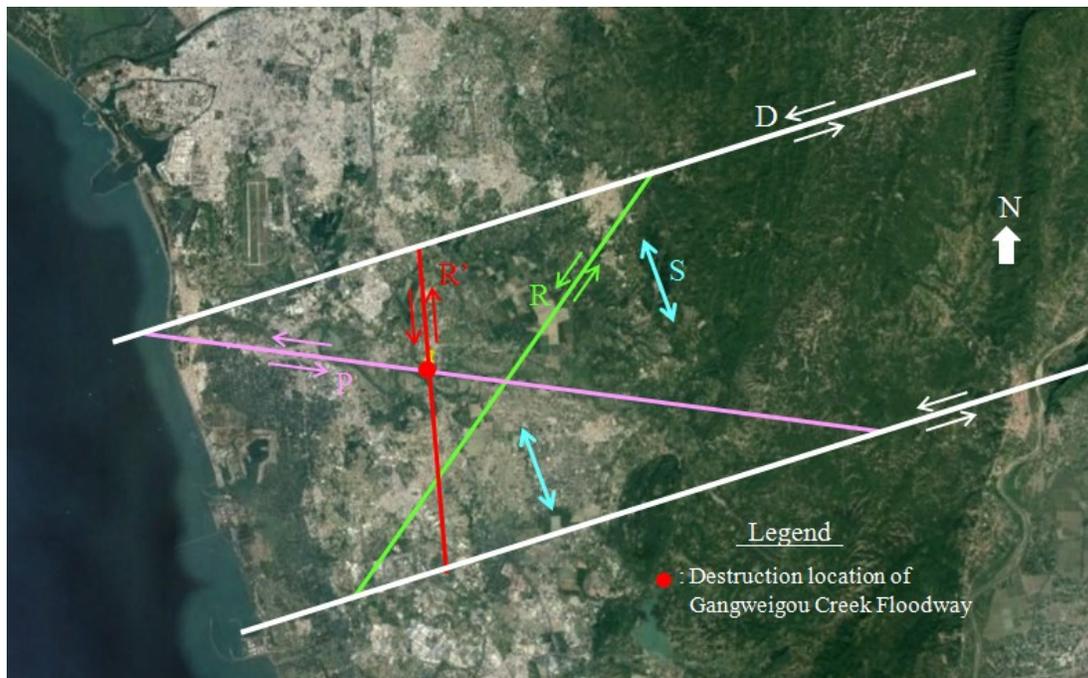
Figure 10. Using satellite imagery to identify the shear textures within the total width of a shear band (Background image from Google Earth, 2020).

For the area adjacent to Gangweigou Creek Floodway, the satellite image shown in Figure 10 can be used to identify the shear textures, and the identification results are also shown in Figure 10. There are four shear textures with different strikes in the total shear band width of principal displacement shear D in the area adjacent to Gangweigou

Creek Floodway, and the strike of the principal displacement shear D (white line) is  $N73^{\circ}E$ , the strike of the thrust shear P (pink line) is  $N82^{\circ}W$ , the strike of the Riedel shear R (green line) is  $N35^{\circ}E$ , the strike of the conjugate Riedel shear R' (red line) is  $N5^{\circ}W$ , and the strike of the compression texture S (blue line) is  $N20^{\circ}W$ .

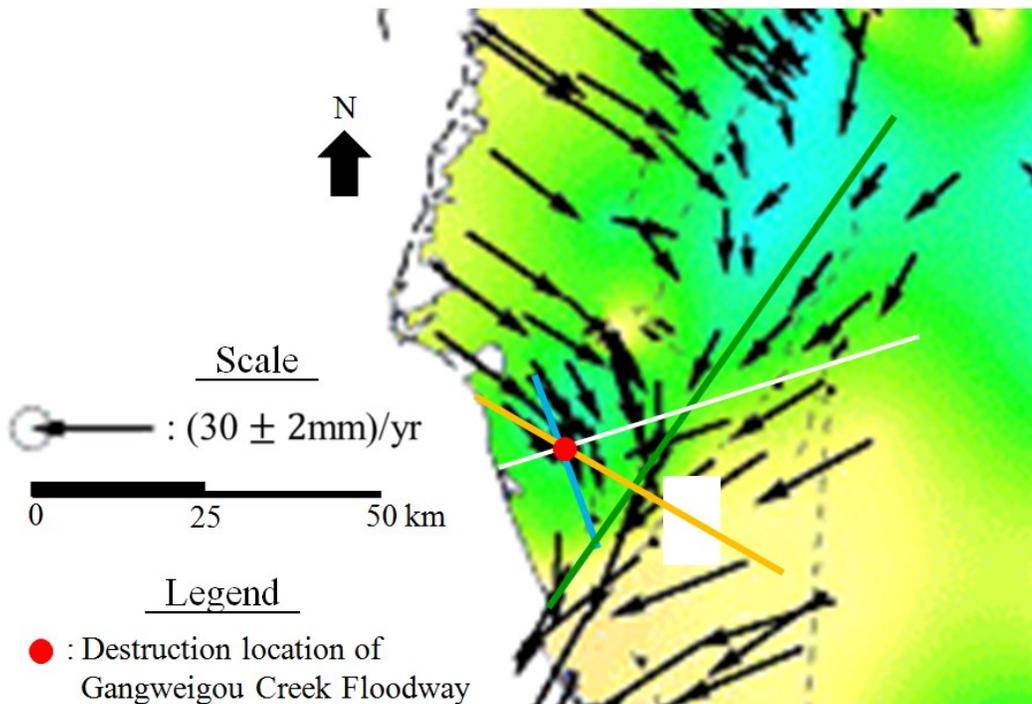
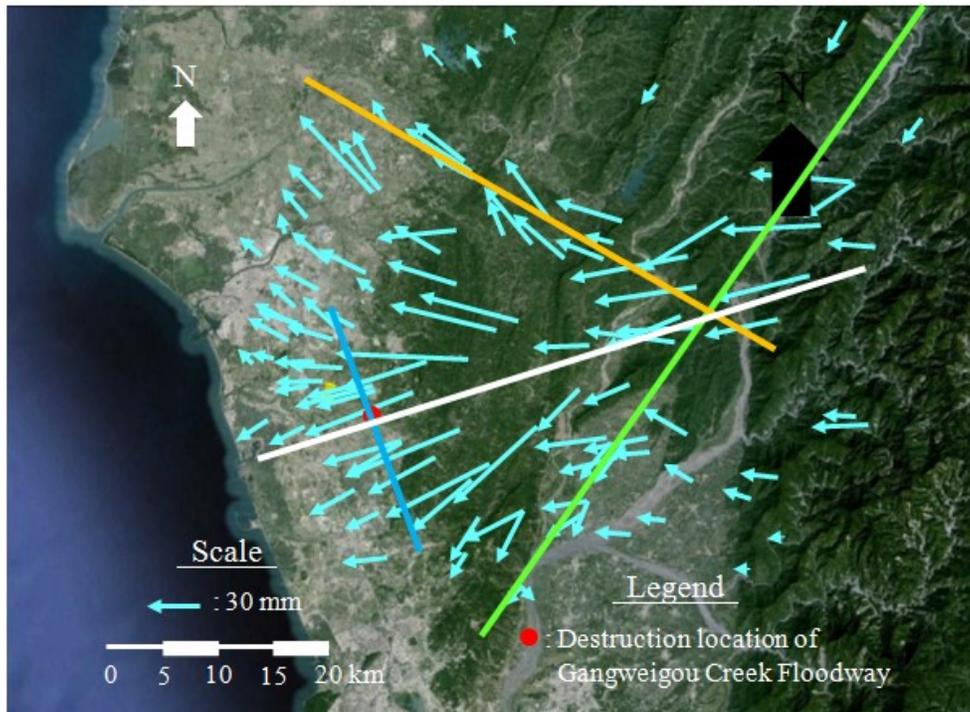
(a) GPS velocity vectors in 2007  
(GPSLAB, 2007)

(b) GPS velocity vectors of the 2016 Meinong Earthquake  
(Google Earth, 2020; Central Geological Survey, MOEA, 2017)

Figure 11. Using GPS velocity vectors to identify shear bands.

For the area adjacent to Gangweigou Creek Floodway, the GPS velocity vector distribution map shown in Figure 11 can be used to identify the shear bands, and the identification results are also shown

in Figure 11. There are four shear bands with different strikes in the vicinity of Gangweigou Creek Floodway, and their strikes are  $N73^{\circ}E$  (white line) \、  $N35^{\circ}E$  (green line) \、  $N20^{\circ}W$  (blue line) \、 and  $N60^{\circ}W$  (orange line), respectively.

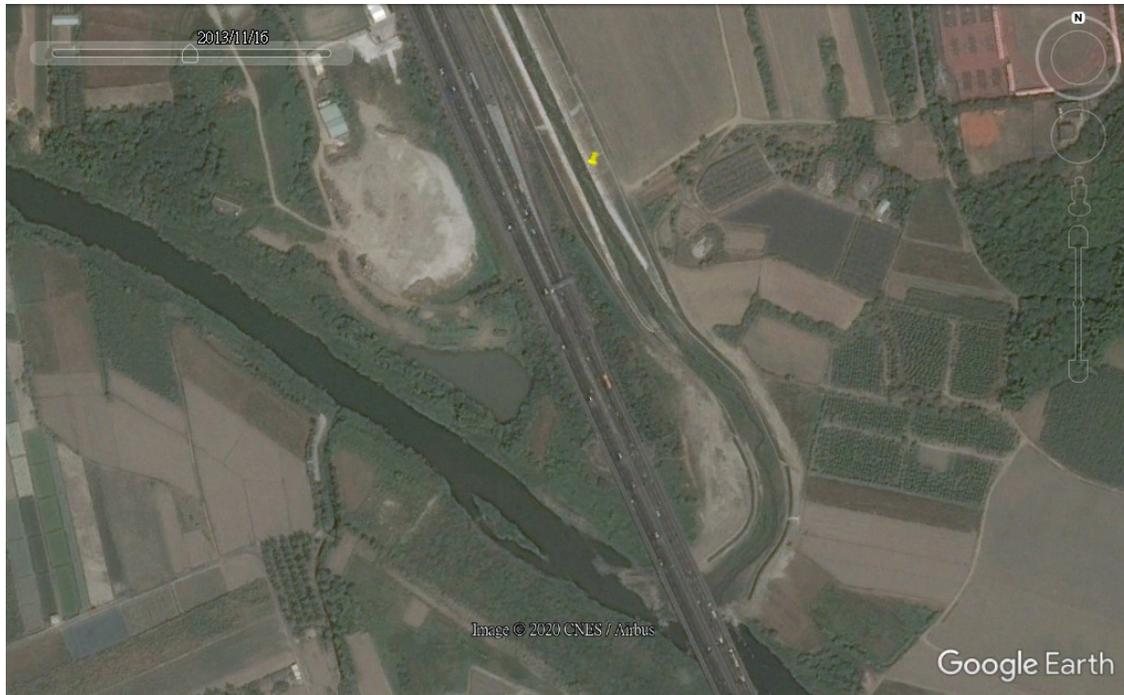
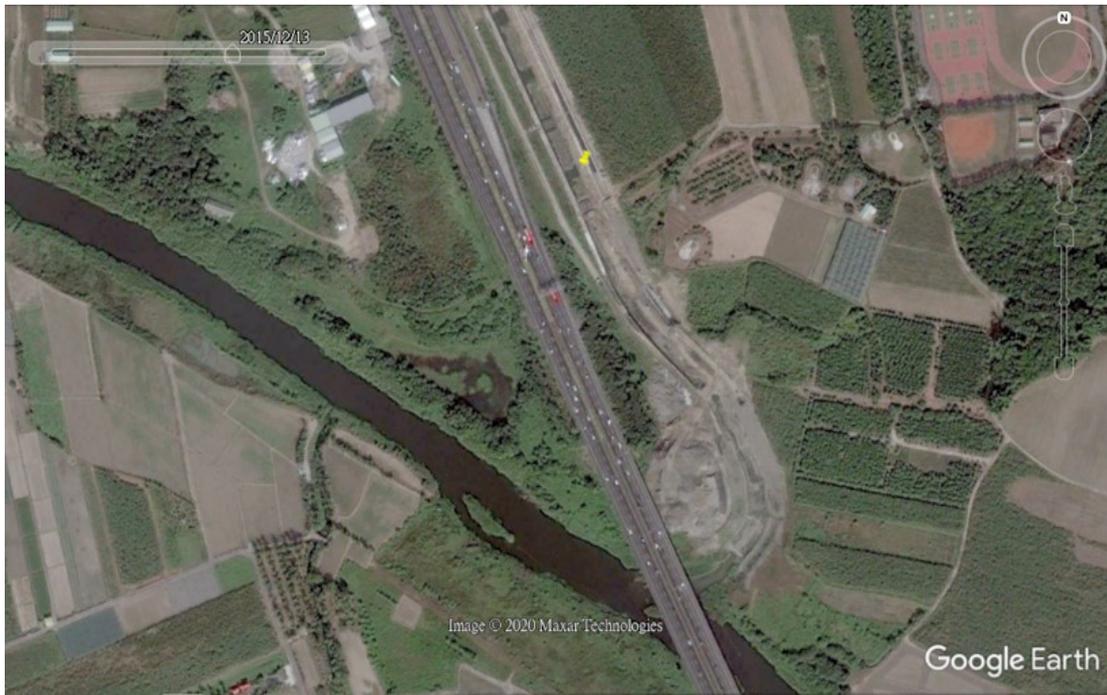
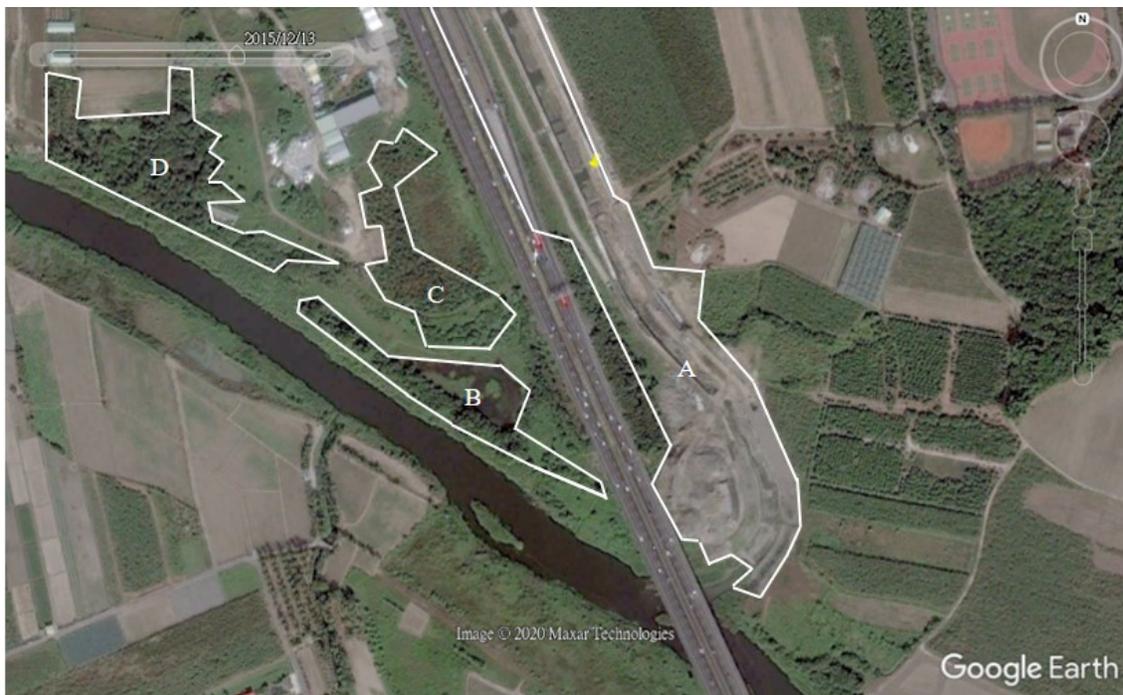
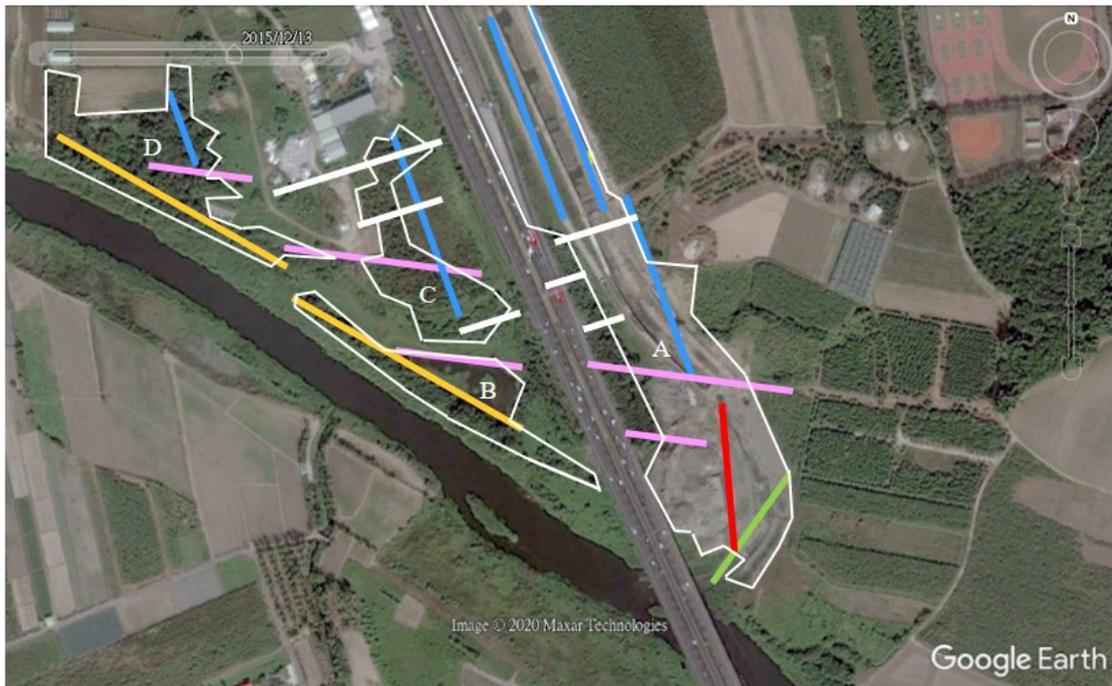
(a) Before the occurrence of piping failures (2013/11/26)

(b) After the occurrence of piping failures (2015/12/13)

(c) The piping-induced landslide areas A, B, C, and D

(d) Shear bands or shear textures existing in the areas A, B, C, D

Figure 12. Shear bands or shear textures identified in the piping-induced landslide areas.  
(Background image from Google Earth, 2020)

- 1) Figures 12a and 12b show the satellite historical image maps before and after the destruction of Gangweigou Creek Floodway, respectively. Figure 12c clearly shows the four piping-induced landslide areas A, B, C, and D on the two sides of Gangweigou Creek Floodway. The piping-induced landslide area A is along the Gangweigou Creek Floodway, and five groups of shear bands or shear textures can be identified and their strikes are  $N73^{\circ}E$  (white line),  $N5^{\circ}W$  (red line),  $N20^{\circ}W$  (blue

line),  $N60^{\circ}W$  (orange line), and  $N82^{\circ}W$  (pink line), respectively; the piping-induced landslide area B is located on the southeast side of the piping-induced landslide area A, two groups of shear bands or shear textures can be identified and their strikes are  $N60^{\circ}W$  (orange line) and  $N82^{\circ}W$  (pink line), respectively; the piping-induced landslide area C is located in the north of the piping-induced landslide area B, three groups of shear bands or shear textures can be identified and their strikes are  $N73^{\circ}E$  (white line),  $N20^{\circ}W$  (blue

line), and  $N82^{\circ}W$  (pink line), respectively; the piping-induced landslide area D is located in the northwest of the piping-induced landslide area C, three groups of shear bands or shear textures can be

identified and their strikes are  $N20^{\circ}W$  (blue line),  $N60^{\circ}W$  (orange line), and  $N82^{\circ}W$  (pink line), respectively.

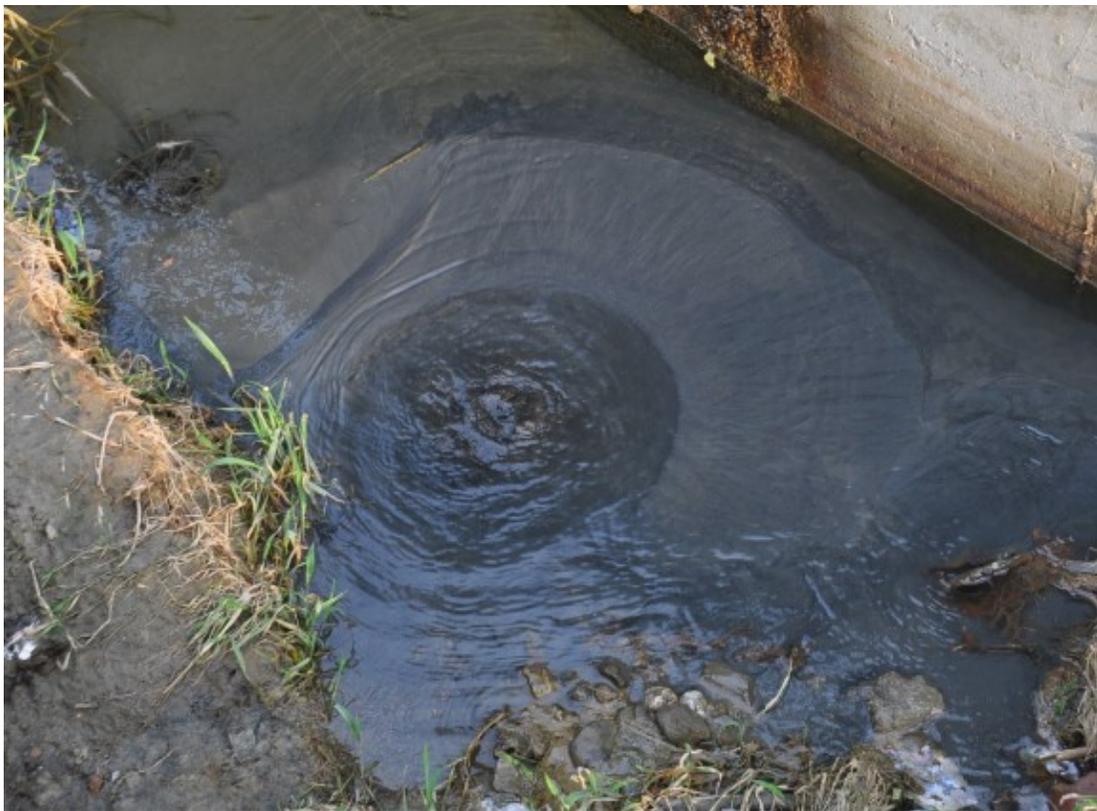
Figure 13. The outflow of silt occurred in the early stage of piping failure (Hsu, 2018).

- 4) The total length of Gangweigou Creek Floodway is 3769 m, and the length of local piping failure is only 170 m. During the early stage of piping failure, small particles, such as silt-like and fine-sand-like particles will first flow out, as shown in Figure 13; then the size of the pipeline

and the efficiency coefficient of the pipe flow will increase. Larger particles, such as coarse-sand-like or gravel-like particles, may have the chance to flow out. Therefore, the piping failure mechanism proposed by the authors is consistent with the actual phenomenon of piping failure.
