AN IMPORTANT FACTOR NEGLECTED IN THE SEISMIC REINFORCEMENT PERFORMANCE DESIGN OF SCHOOL BUILDINGS: SHEAR BANDING

Ching-Chang Lin, Tsai-Fu Chuang, Da-Jie Lin
Associate Professors, Feng-Chia University, Taiwan

Abstract

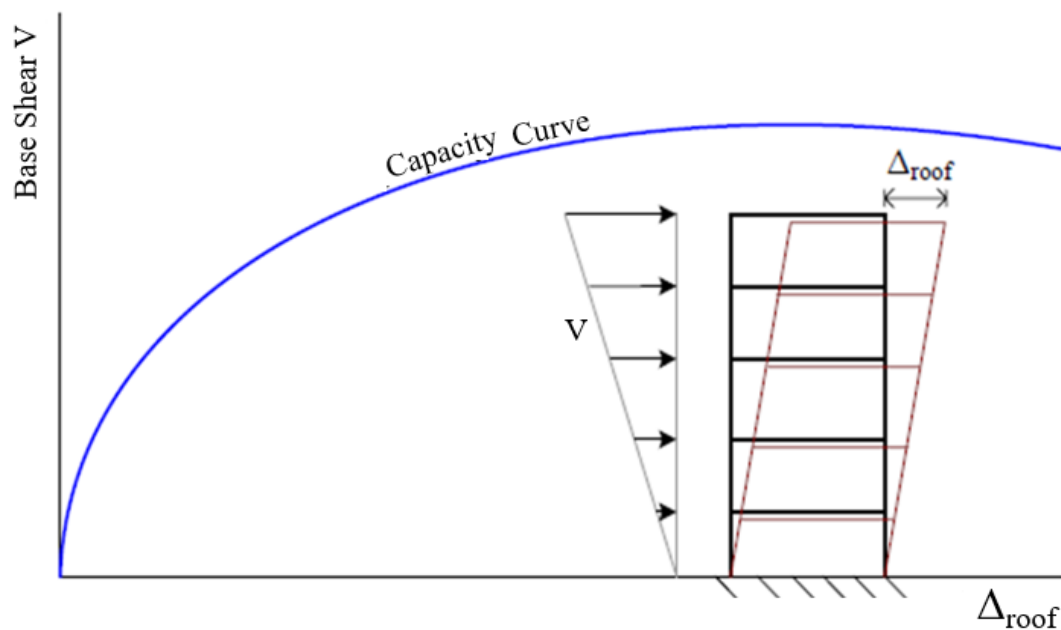
In the pushover analysis, the NCREE recommends using structural analysis programs such as ETABS, MIDAS, or PISA3D to obtain the relationship curve between the base shear V and the roof lateral displacement Δ , which is the structural capacity curve shown in Figure 1 (Zhong, *et al.*, 2009).

Figure 1. Schematic diagram of the structure capacity curve (Zhong, *et al.*, 2009).

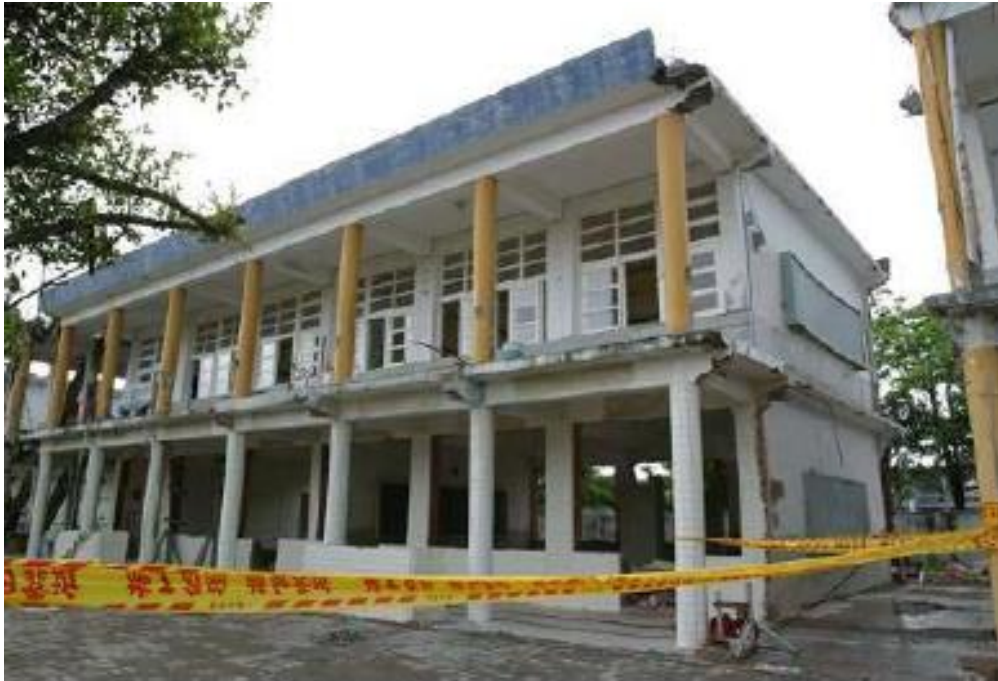
The NCREE carried out the traditional pushover test for this project. The school building selected for the pushover test was Kouhu Elementary

School in Yunlin County, Taiwan (Figure 3), which was undamaged by the

Figure 3. The undamaged school building after the 921 Jiji earthquake (Taiwan Yunlin Kouhu Elementary School) (Zhong, *et al.*, 2013).

2) For the buildings of Kouhu Elementary School in Yunlin, Taiwan (shown in Figure 3) and Sanmin Senior High School in Hualien, Taiwan (shown in Figure 11), since no shear band was present on the original site, the bottom ends of the horizontal plane of the original coplanar columns remained horizontal, the continuous ground remained

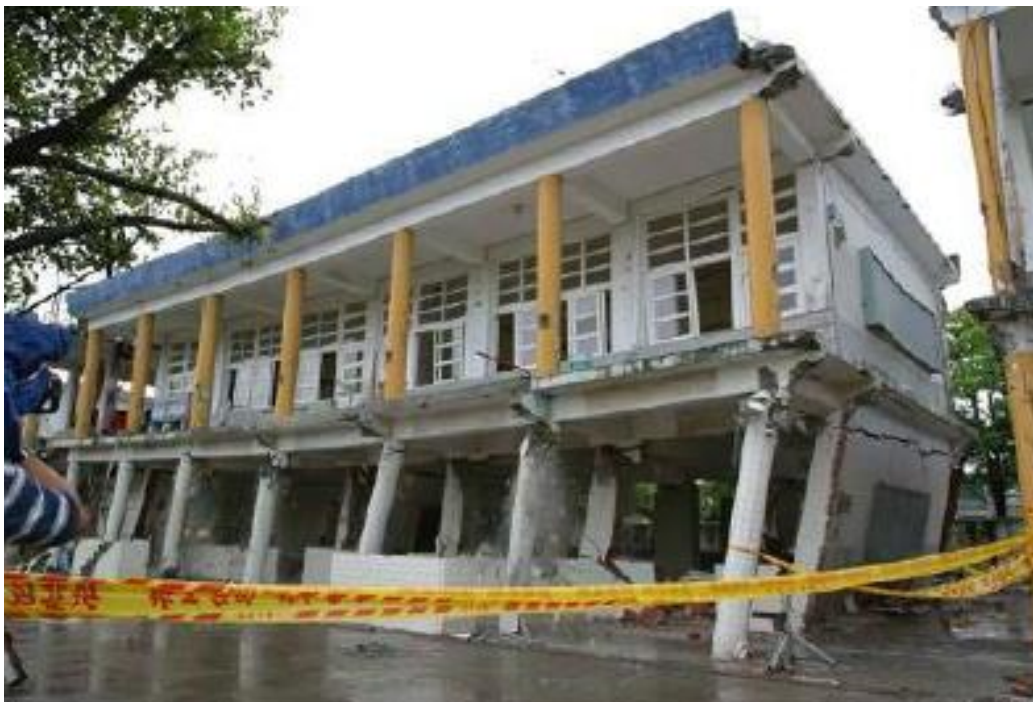
diagram of the deformed structural model obtained by the pushover analysis is shown in Figure 4; the deformed structure after the pushover test is shown in Figure 5; and the structure capacity curve obtained by the pushover analysis and test is shown in Figure 6.

Figure 5. The deformed school building after the traditional pushover test (Kouhu Elementary School, Yunlin, Taiwan) (Zhong, *et al.*, 2013).

3) For the traditional pushover analysis and test of Kouhu Elementary School, Figures 4 and 5 respectively

show the bottom ends of all the columns that were originally coplanar in the structural analysis model and the actual school building. After the analysis and the test, it was evident that the horizontal plane had remained horizontal, the continuous plane had remained continuous, and the rigid geology had remained rigid. The school building structure is reinforced according to the traditional pushover analysis and test results in order to prevent the school building from collapsing in the shear banding

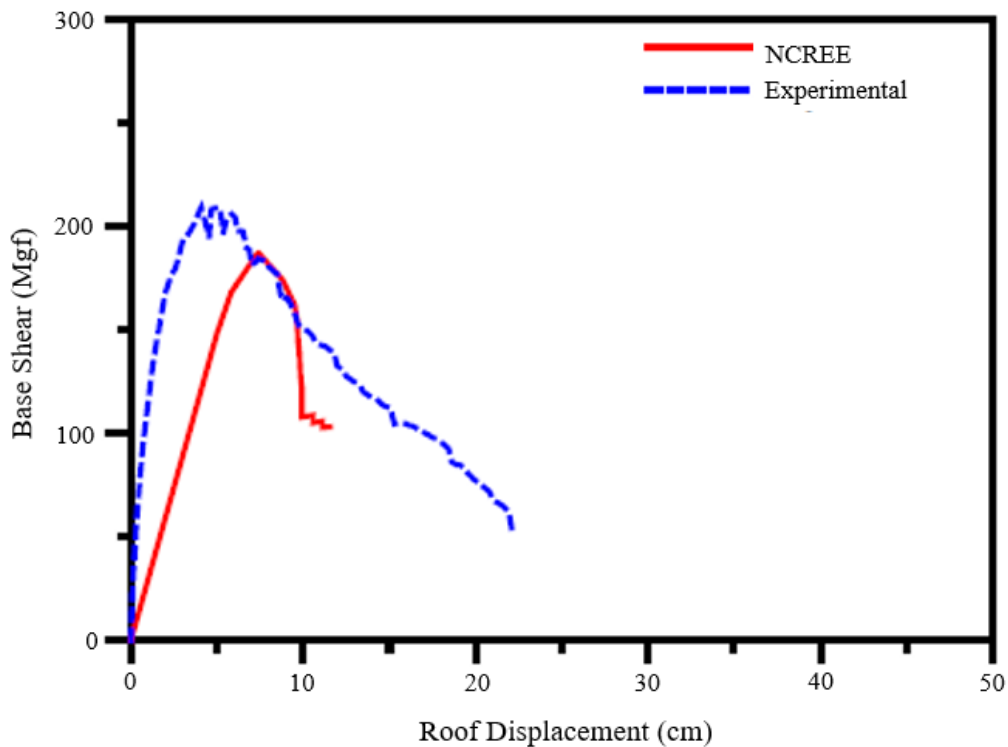
Figure 6. Comparison chart of the structure capacity curve obtained from analysis and experiment (Kouhu Elementary School, Yunlin, Taiwan) (Zhong, *et al.*, 2013).

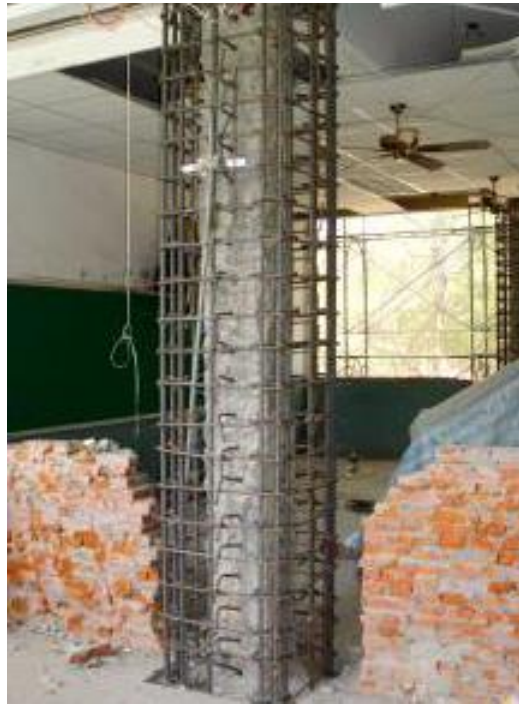
recommended by the NCREE include RC expansion column reinforcement (Figure 7), RC wing wall reinforcement (Figure 8), RC shear wall reinforcement (Figure 9), and composite column reinforcement (Figure 10).

Figure 7. RC expansion column reinforcement method (Zhong, et al., 2009).

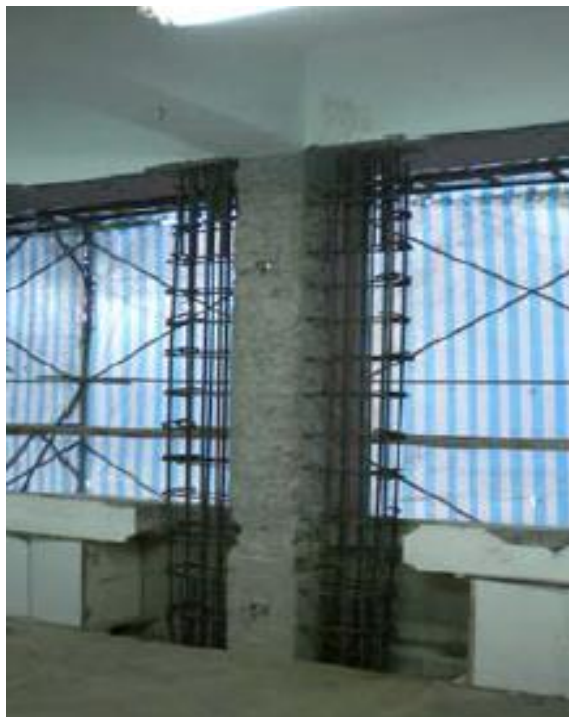
Figure 8. RC wing wall reinforcement method (Zhong, et al., 2009).

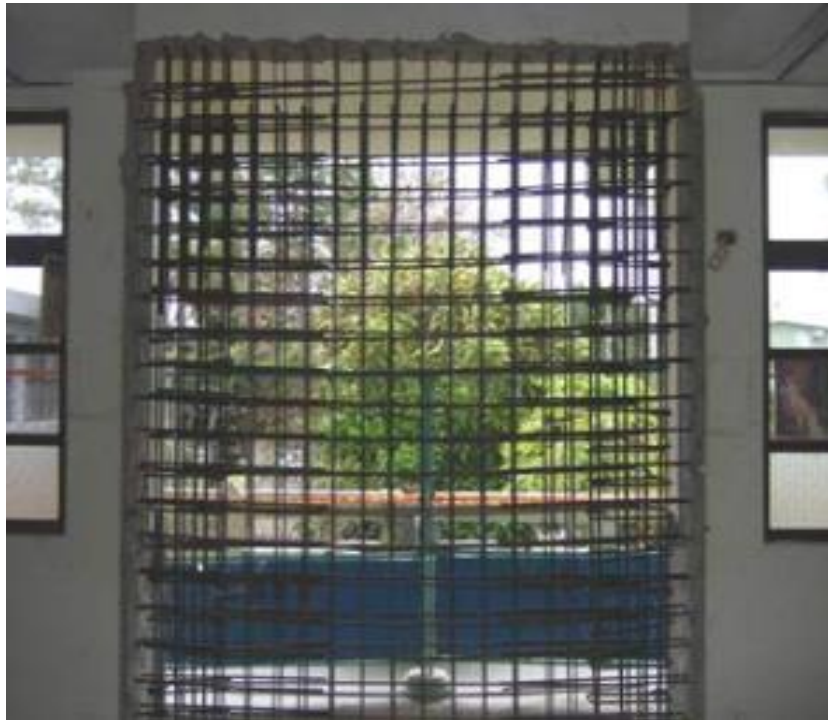
Figure 9. RC shear wall reinforcement method (Zhong, et al., 2009).

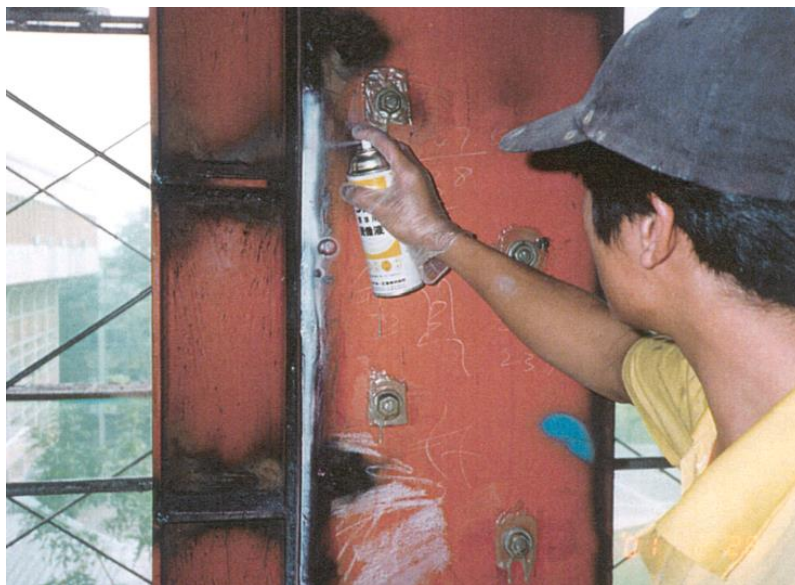
Note: In the picture, the engineer was conducting a welding bead quality inspection test

Figure 10. Composite column reinforcement method (Hsu, 2001).

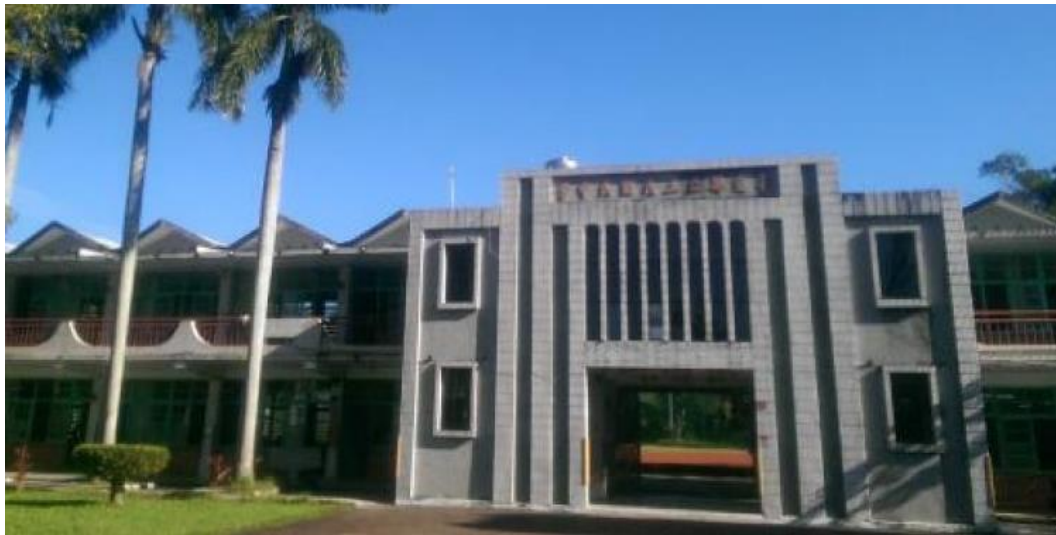
Taiwan extended its compulsory education from six years to nine years in 1968. During this period, a large number of school buildings were constructed with wavy roofs as shown in Figure 11. The design of these school buildings met the relevant regulations

Figure 11. Sanmin Junior High School, Hualien, which remained stable during the 0206 Hualien earthquake in 2018 (Standard School Building of Hualien Sanmin Junior High School, 2016).

and the continuous stratum surface remaining continuous. This is the main reason that the building of the Sanmin Junior High School, Hualien (shown in Figure 11) and the school building shown schematically in the center of Figure 13 remains stable during earthquakes. However, when shear banding occurring during earthquakes induces local tilted uplift and strain softening, the conditions for the school building to become unstable and therefore be considered non-earthquake resistant include the rigid stratum being unable to remain rigid, the horizontal stratum surface being unable to remain horizontal, and the continuous stratum sur-

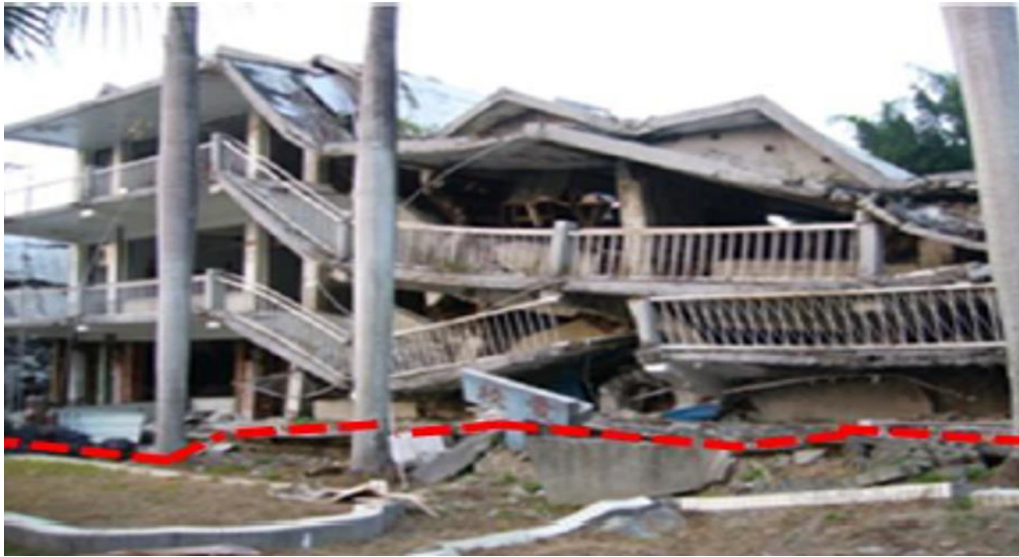
Note: The red line is the connection of the first floor.

Figure 12. Guangfu Junior High School, Taichung, which collapsed during the 921 Jiji Earthquake in 1999 (Hsu, 2018).

face being unable to remain continuous. This was the main cause of collapse of the Guangfu Senior High School building, Taichung (Figure 12) and

1) For the building of Guangfu Senior High School, Taichung, which collapsed in the 921 Jiji Earthquake (as shown in Figure 12), two step shear banding tilted slopes existed on the original site (shown in detail in Figure 14(a)) (Hsu, 2018). Before the school building was constructed, the site was backfilled during site preparation to achieve a horizontal

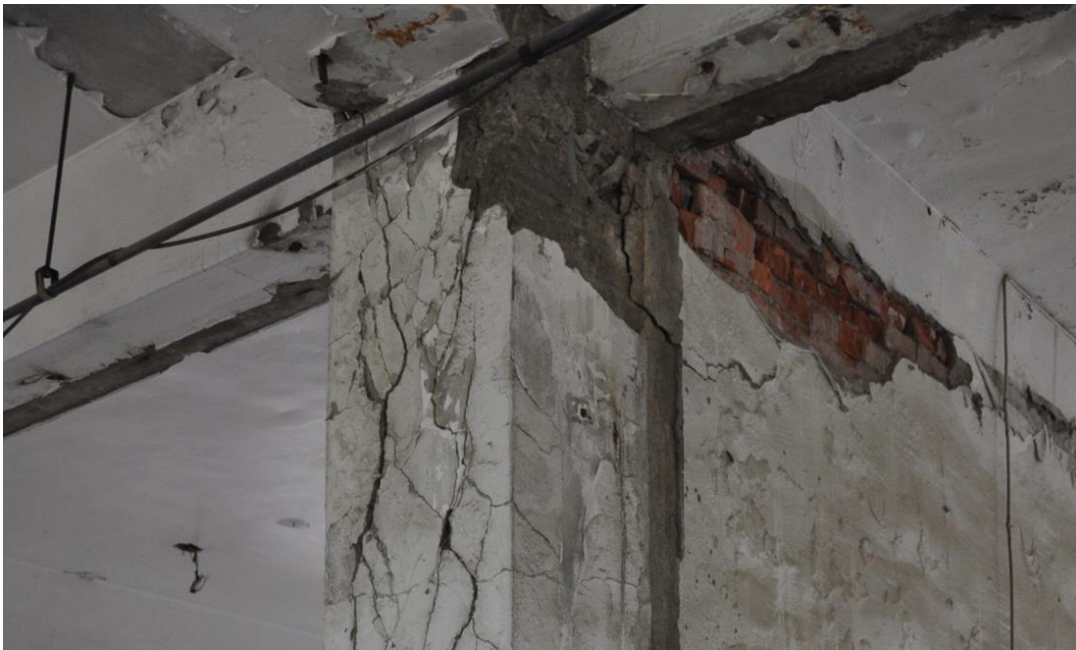
- 4) For the columns and girders of Taiwan's school buildings, the cross-section design has not been previously optimized. Therefore, the joints between columns and girders are prone to cracks (see Figure 15) or breakage (Figure 16) under excessive stress due to insufficient cross-sectional areas during an earthquake.

Figure 15. Cracks at the joint of a column and girder during an earthquake.

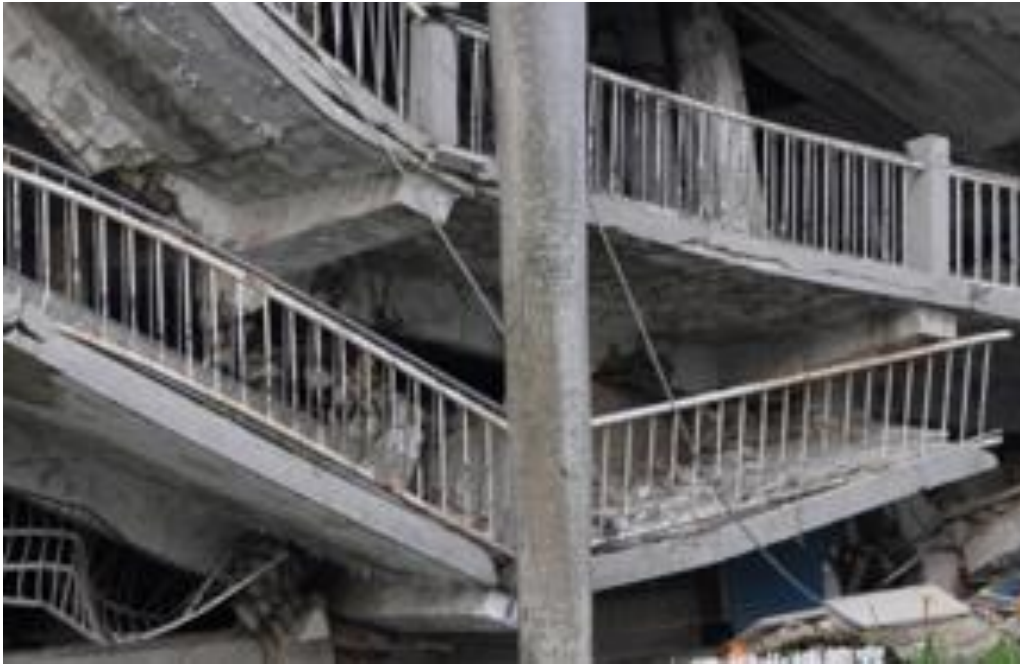
Figure 16. Break in the joint of a column and girder after an earthquake.

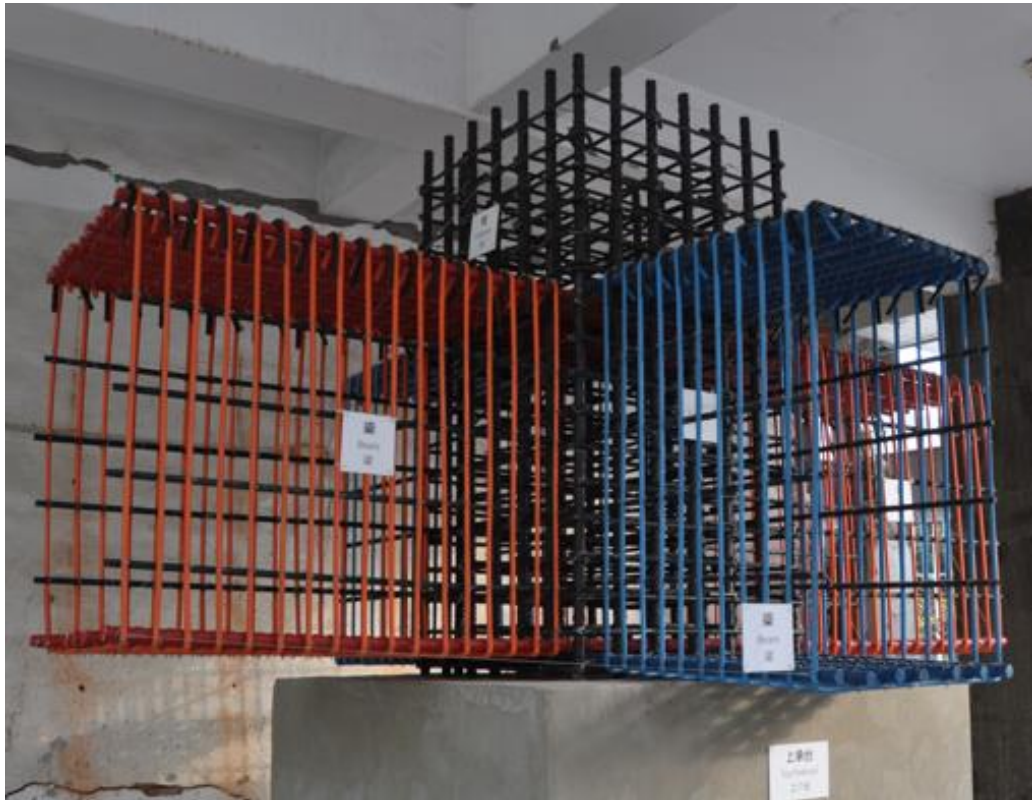
mic design codes that have been continuously revised have increased the vibration fortification levels of superstructure elements, with the result that design of cross-sectional areas and the amount of reinforcement at joints between columns and girders have been excessive (Figure 17).

Figure 17. Excessive cross-sectional area and excessive steel reinforcement resulting from revised seismic design code after the 921 Jiji earthquake.
