## EVALUATING THE SEISMIC REINFORCEMENT OF EXISTING SCHOOL BUILDINGS USING SEISMIC CONDITIONS

Tse-Shan Hsu

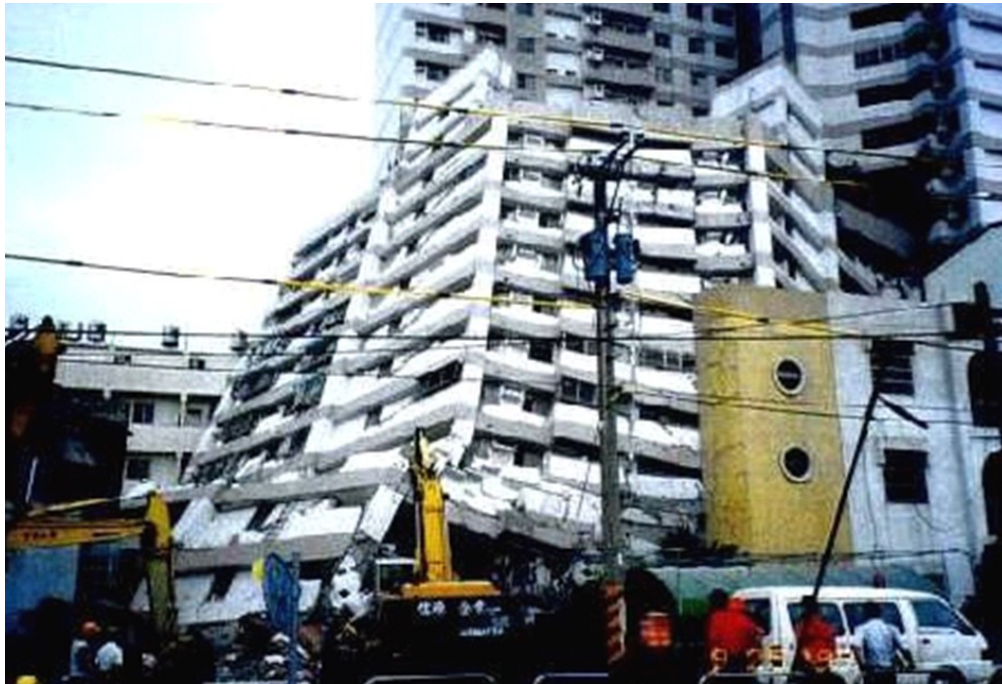
Figure 1. Building failure phenomena due to the 1999 Jiji earthquake (magnitude 7.3) (Hsu *et al.*, 2020).

(a) Tilt and fall failure (Taiwan Yunlin Fugui Mingmen Building).

(b) Collapse failure (Wanfo Temple, Taichung, Taiwan).

damage (Su, 2016), an example of which is shown in Figure 1. It was initially expected that the latest code for seismic design of buildings would ensure that a building would not be damaged during a tectonic earthquake of magnitude 7.3. However, even newly constructed buildings were left severely tilted after the 0206 Meinong earthquake that struck Taiwan in 2016, which had a magnitude of only 6.4 (see Figure 2 for details).

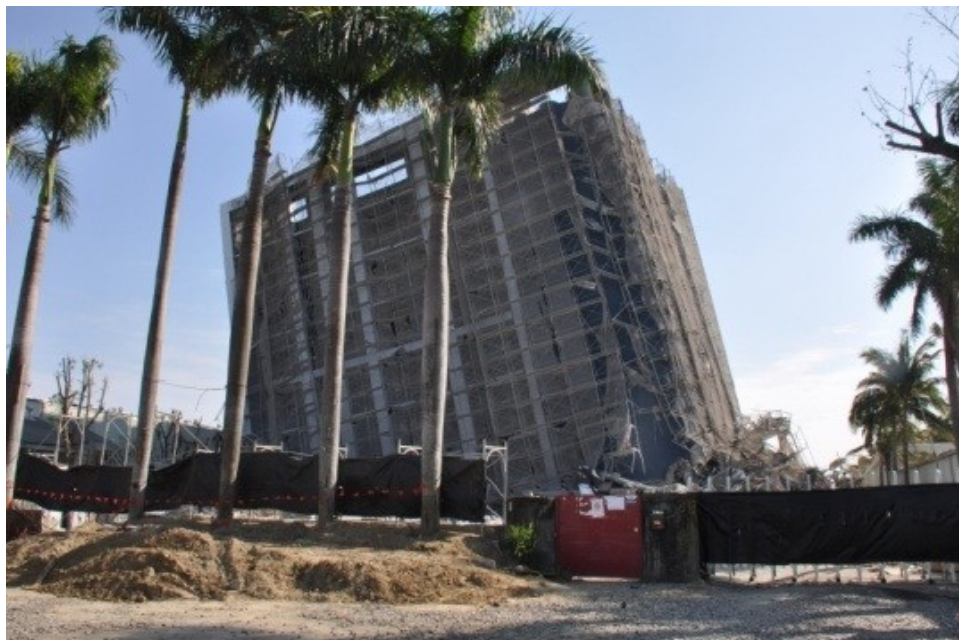
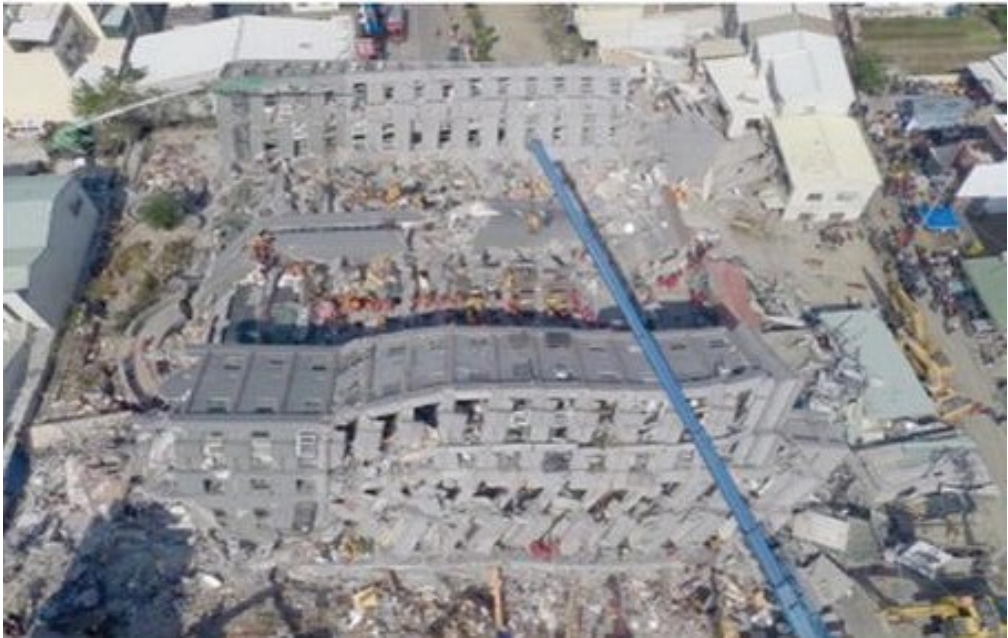
Figure 2. Building failure phenomena due to the 2016 Meinong earthquake (magnitude 6.4) (Hsu, 2018).

(a) Severe tilt failure (New Wanglin Building, Tainan, Taiwan) (Hsu and Ho, 2016).

(b) Overturning failure (Weiguan Building, Tainan, Taiwan).

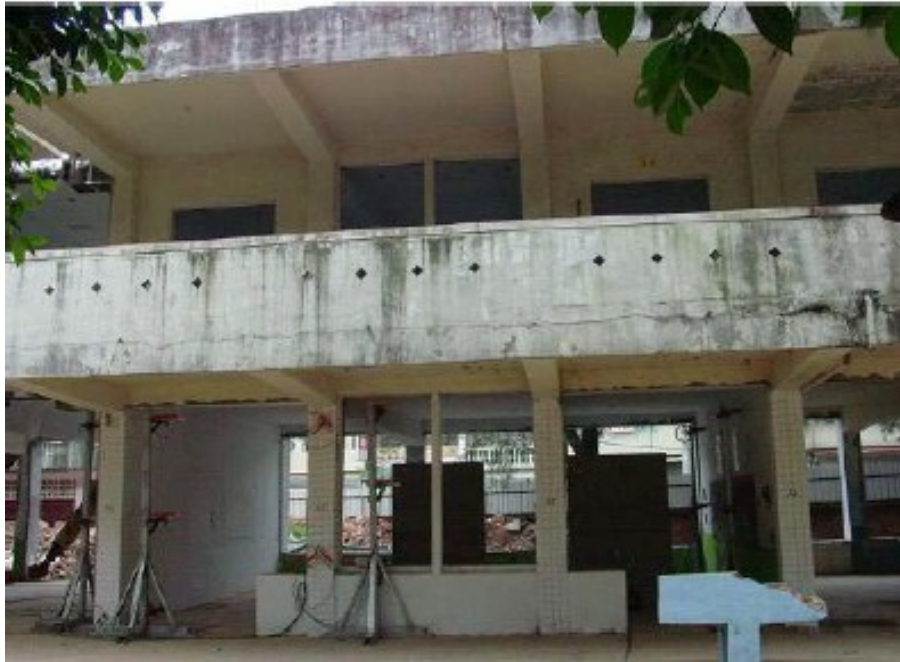
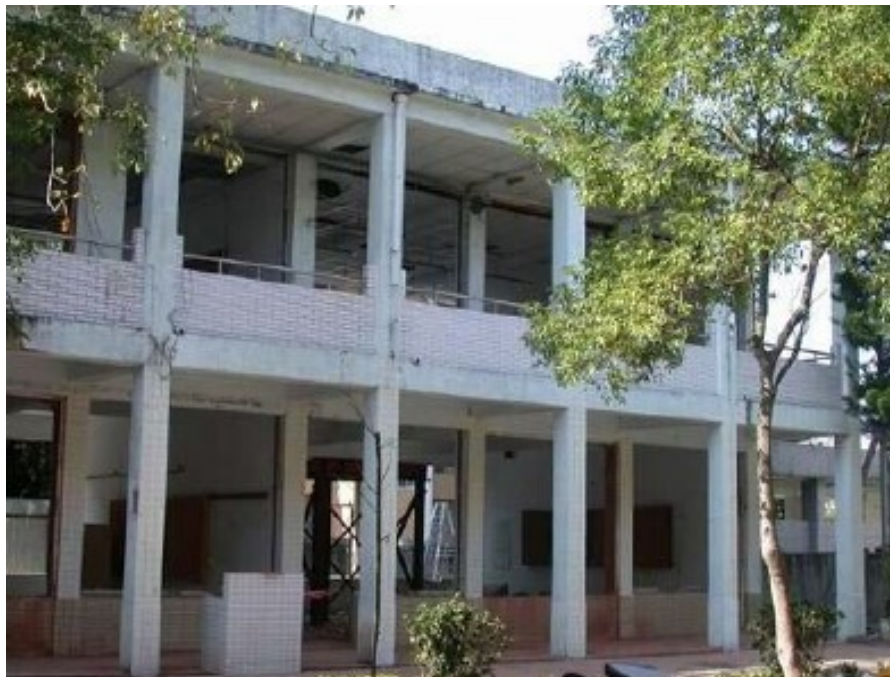
Figure 6. School buildings after the 921 Jiji earthquake (Zhong, *et al.*, 2013).

(a) Ruipu Elementary School in Taoyuan

(b) Sincheng Junior High School in Hualien

Figure 6 shows that neither Ruipu Elementary School nor Sincheng Junior High School were damaged during the 921 Jiji earthquake, and the planes on which the bottom column ends are located maintained the level and continuity set in the original design. Therefore, they satisfy the earthquake resistance conditions and both buildings are deemed to be earthquake-resistant.

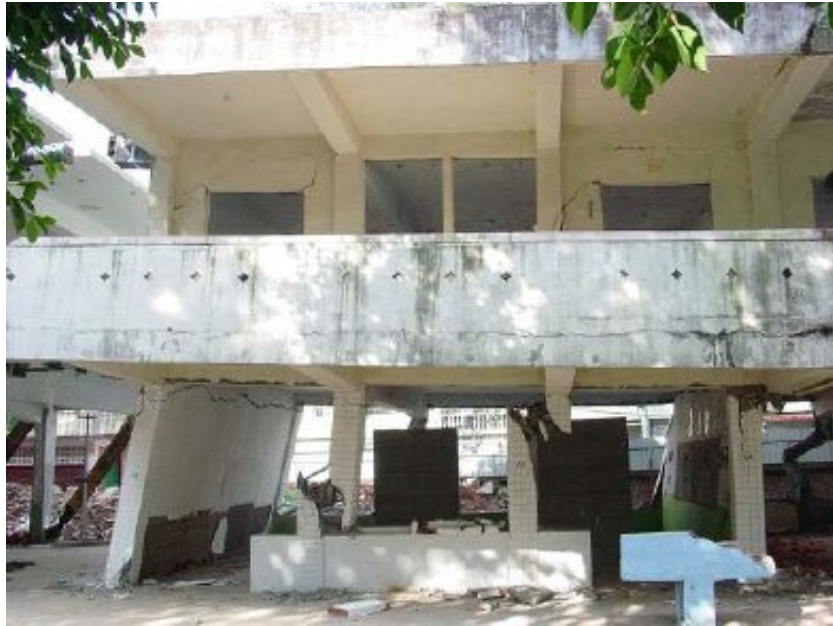
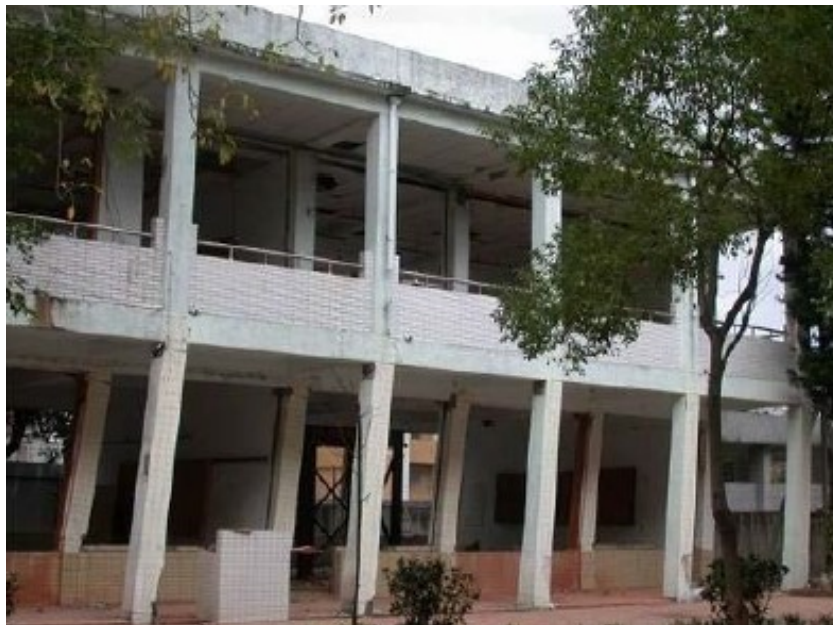
Figure 7. School buildings after the implementation of the lateral pushover tests (Zhong, *et al.*, 2013).

(a) Ruipu Elementary School in Taoyuan

(b) Sincheng Junior High School in Hualien

This is confirmed by results of the lateral pushover tests and analyses shown in Figures 7 and 8, respectively, which also show that the planes on which the bottom column ends are located remained horizontal and continuous. Therefore, these two school buildings meet the earthquake-resistant conditions and are again both deemed to
