EFFECT OF SHEAR BANDING ON BRIDGES EQUIPPED WITH SEISMIC ISOLATION PADS

Abstract

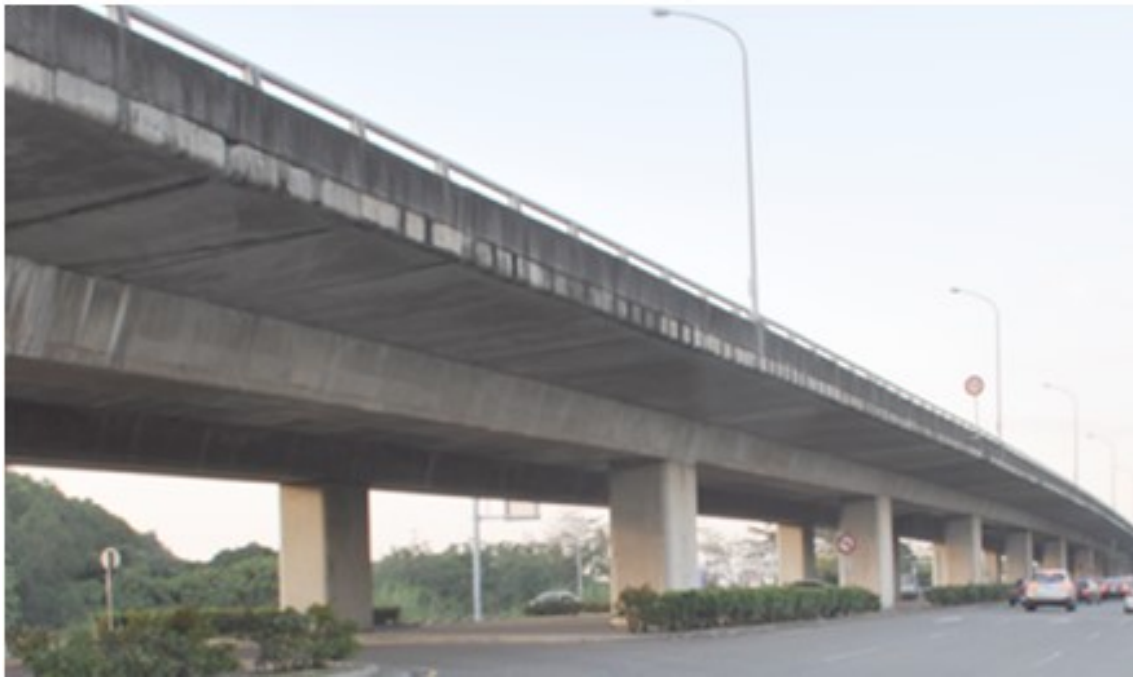
Figure 1. Land bridge on Highway Tai-86 in Tainan, Taiwan.

Figures 1 through 3 depict a land bridge on Highway 86 in Tainan, Taiwan, comprising a caisson foundation, piers, box girders, and decks. The majority of box girders are directly placed atop pier caps, while seismic isolation pads are installed between some girders and piers. Prior to the 1999 Jiji

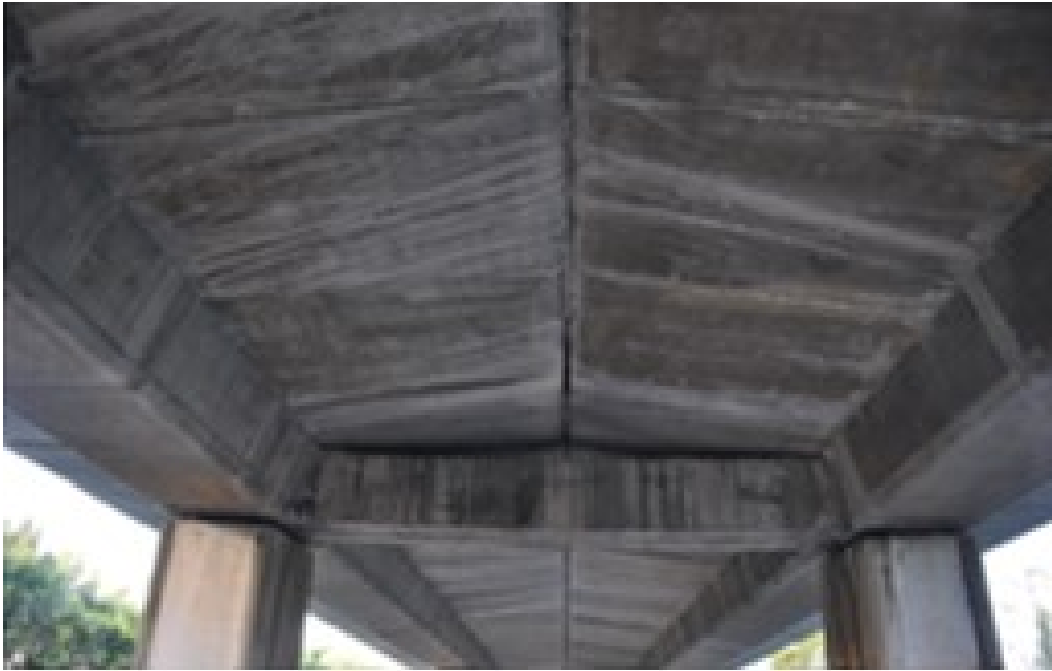
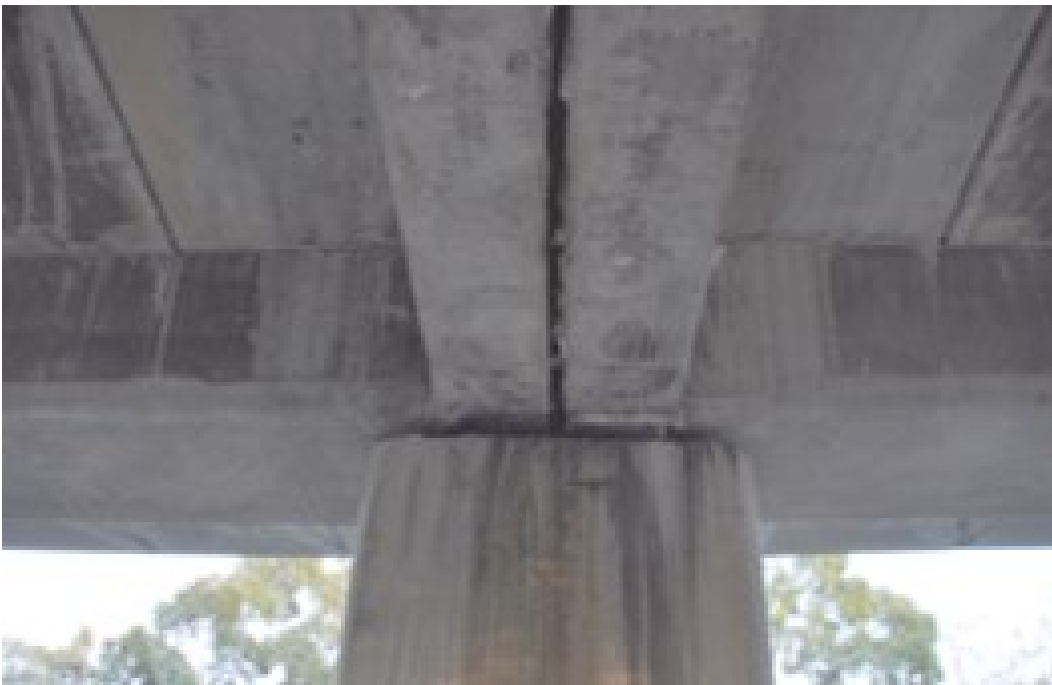
(a) Longitudinal view of the bridge.

(b) Transverse view of the bridge.

Figure 2. Box girders placed directly atop the bridge piers.

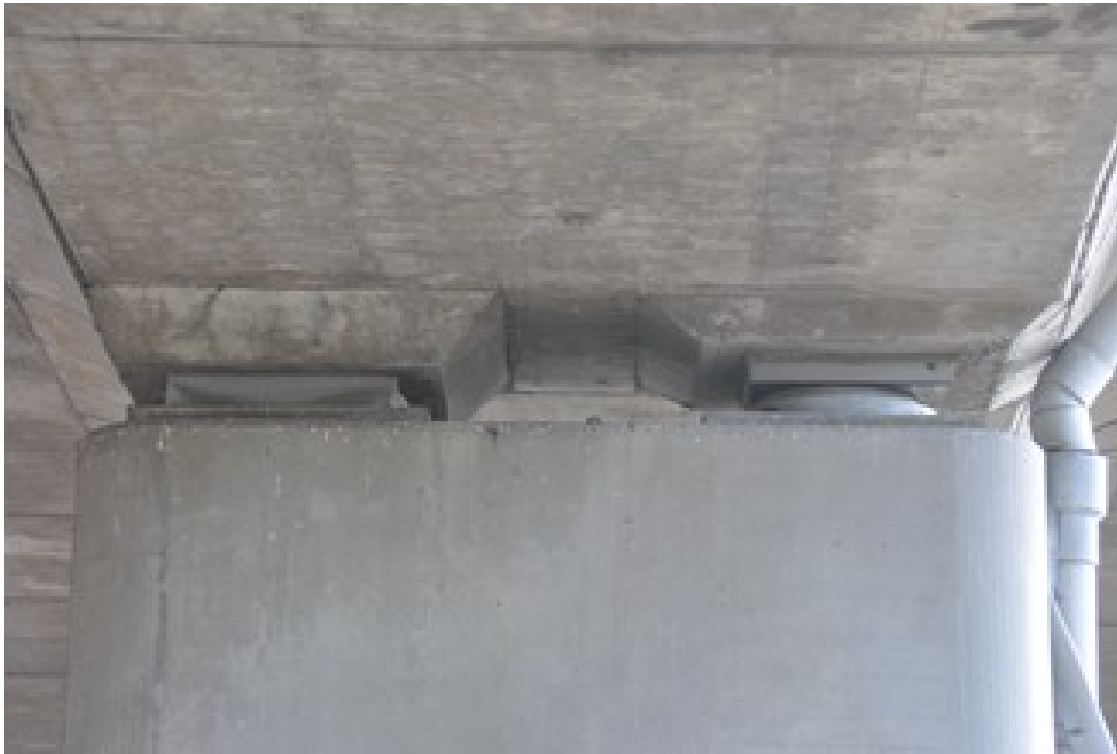
Figure 3. Seismic isolation pad positioned between the bridge pier and the box girder.

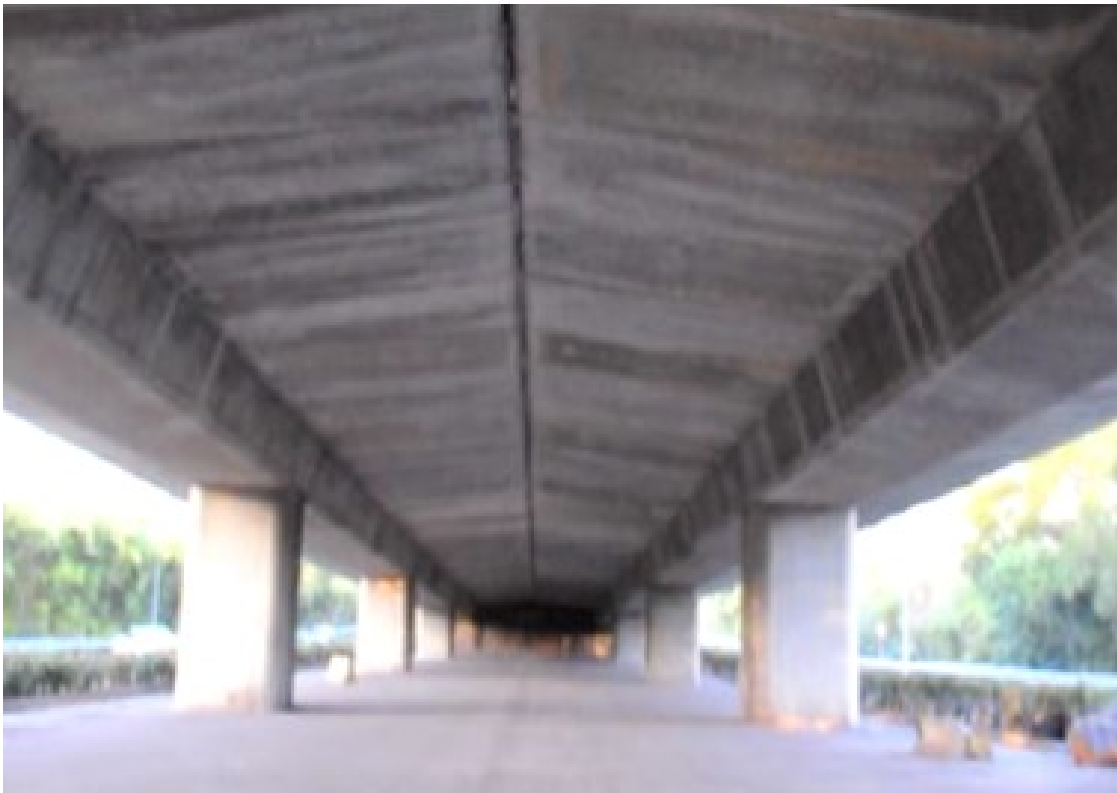
Figure 4. Absence of shear banding on the ground adjacent to the piers of the land bridge without isolation pads.

During the 1999 Jiji earthquake, a land bridge without isolation pads, unaffected by shear banding but subjected to ground vibrations, retained its box girders atop the piers (Figure 4). However, the absence of sufficient expansion joints between adjacent box girders led to mutual compression during the earthquake, resulting in fractures (Figure 5).

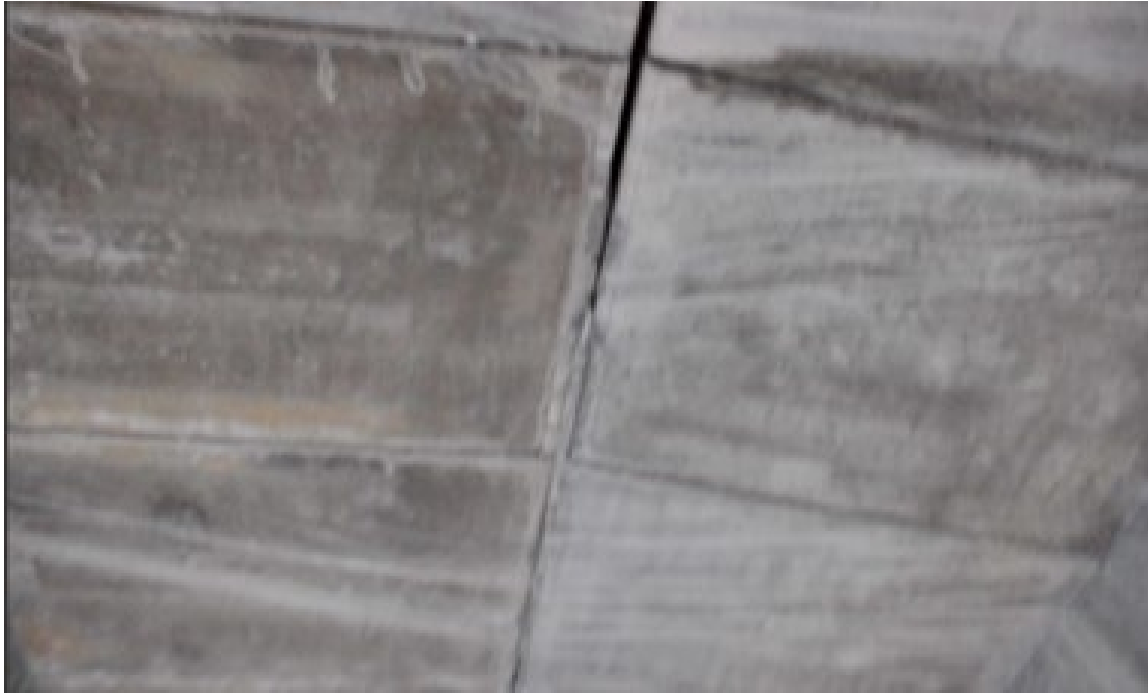
Figure 5. Fracture of the box girders on two adjacent land bridges without seismic isolation pads, resulting from excessive mutual compression.

Before the Jiji earthquake, the lateral distance between decks of adjacent box-girder bridges was minimal (Figure 5). Post-

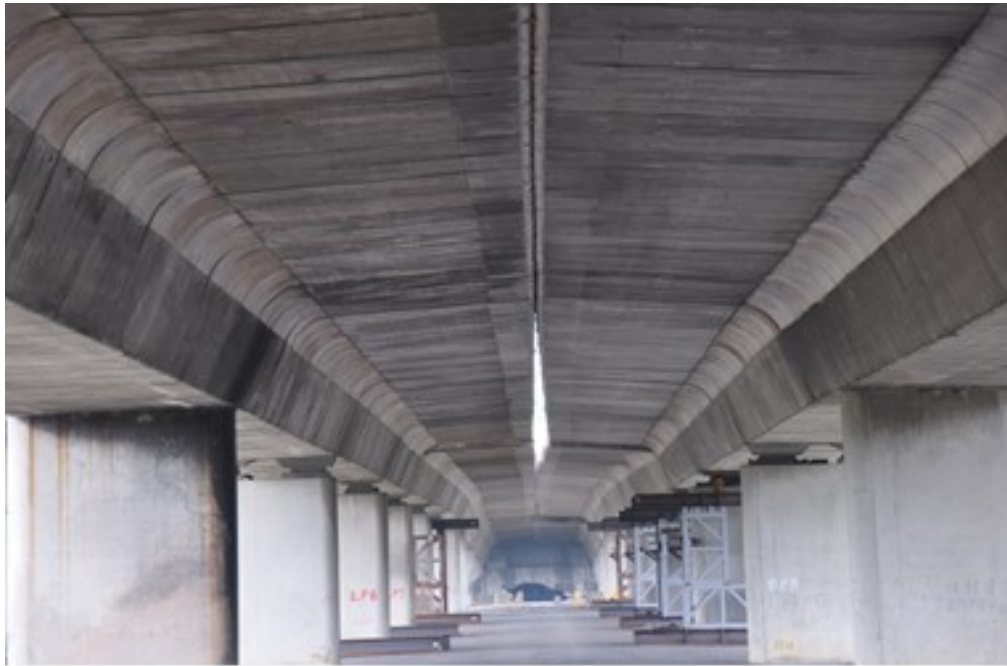
Figure 6. Maximum lateral displacement of 55 cm in the bridge deck and box girders of the left bridge equipped with seismic isolation pads, relative to the corresponding elements of the right bridge.

earthquake, bridges without isolation pads retained this distance, whereas bridges with isolation pads experienced a lateral displacement of up to 55 cm (Figure 6), leading to an uneven gap and road bending (Figure 7).

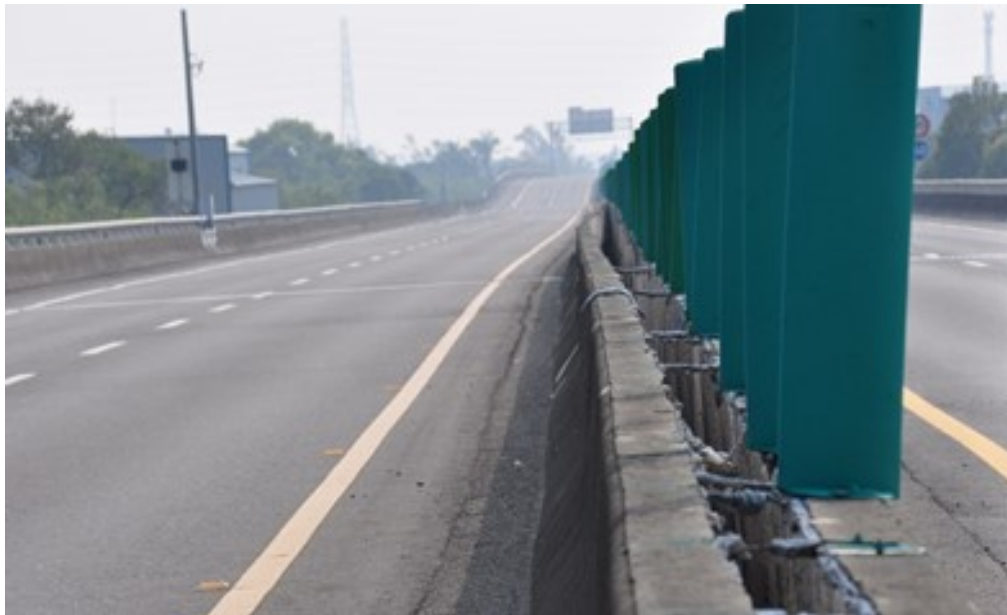
Figure 7. The uneven opening depicted in Figure 6, which leads to road surface bending on the left.

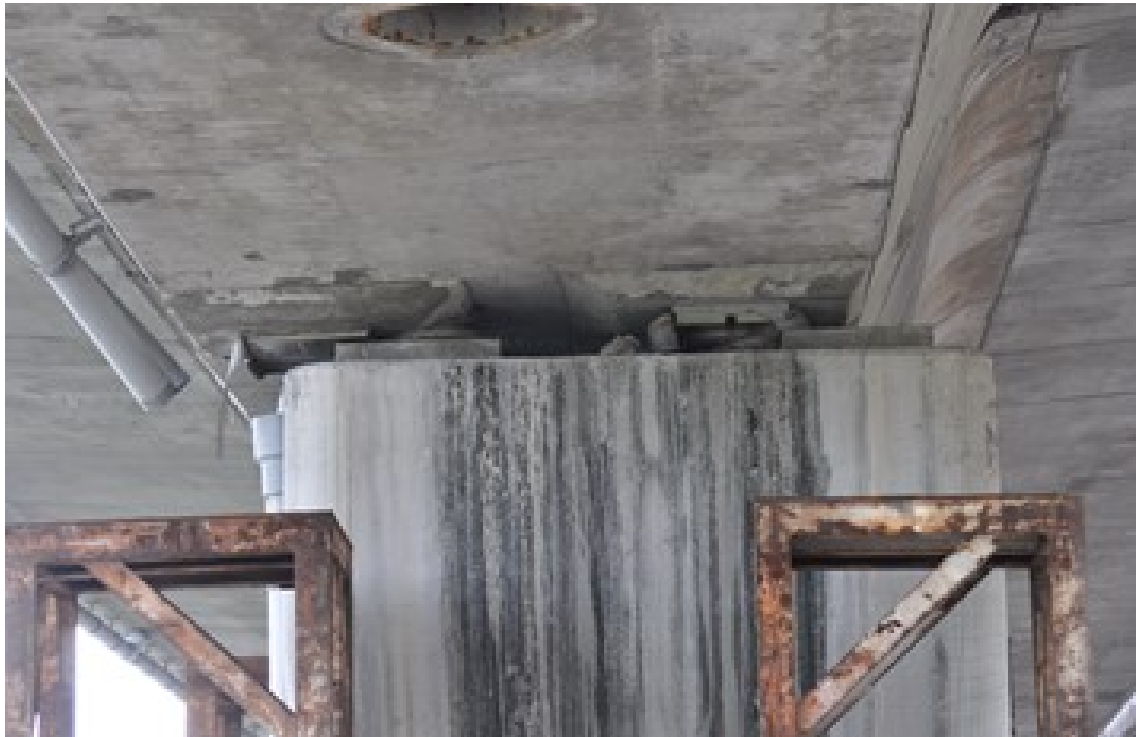
Figure 8. Shear failure of the isolation pad, causing the bridge deck to shift 55 cm to the left relative to the bridge piers.

Shear failure of the isolation pads caused a 55 cm lateral displacement of the box girder and

deck relative to the pier center (Figure 8). This displacement induced a severe eccentric load on the pier, resulting in tilting and fracturing under excessive flexural shear forces (Figure 9).

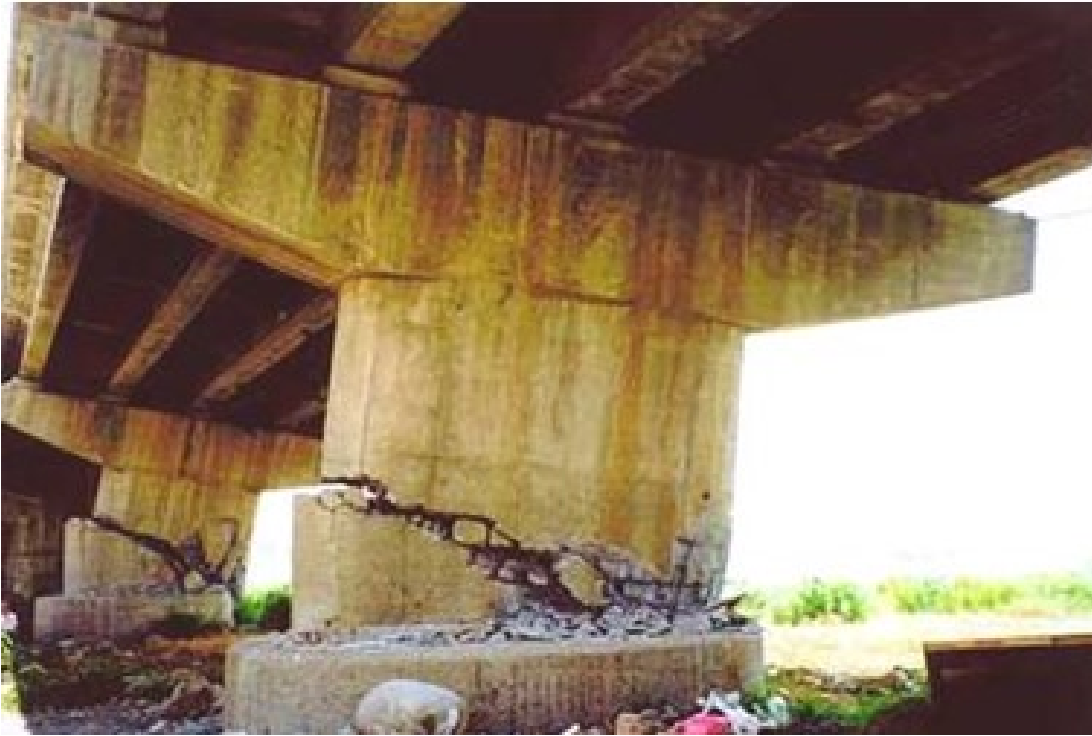
Figure 9. Tilting and failure of the piers of Wu Creek Bridge during the 921 Jiji Earthquake (National Center for Research on Earthquake Engineering, 2020).

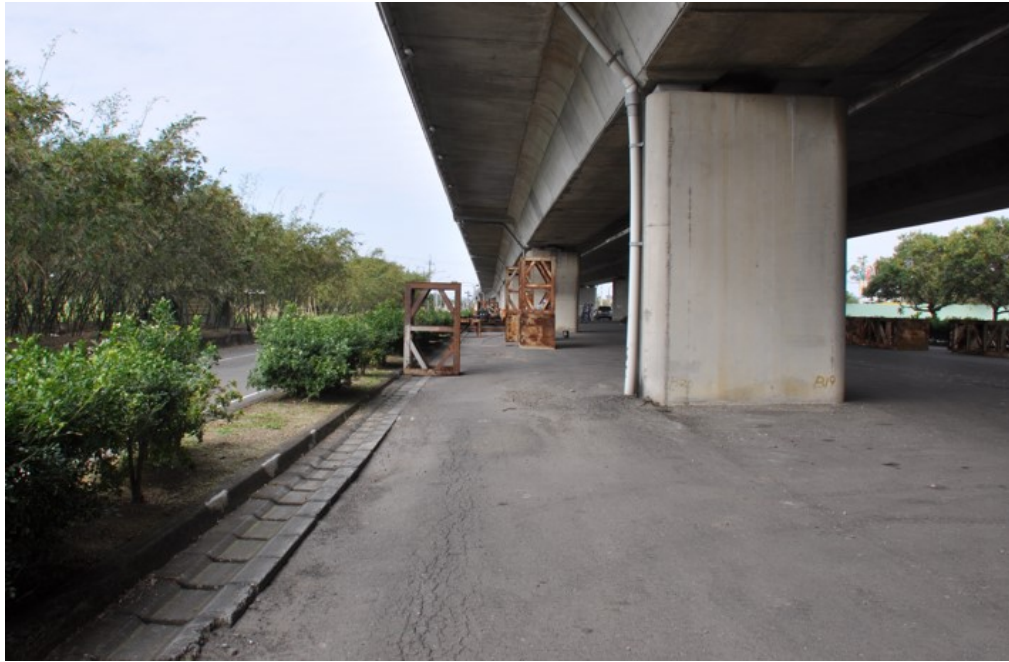
(a) Before illustrating shear textures.

(b) After illustrating shear textures.

Figure 10. Shear banding of the ground near the bridge pier, corresponding to the shear failure of the seismic isolation pad.

Shear failure of the isolation pads corresponded with shear banding of the ground near the bridge pier, attributed to shear textures such as principal displacement shear (D), thrust shear (P), Riedel shear \otimes , conjugate Riedel shear (R'), and compression texture (S)

(Figure 10). On-site investigations confirmed the presence of these shear textures near the piers with lateral displacements, indicating a moderate shear banding effect. This effect induced the shear failure of isolation pads and the significant lateral displacement of the bridge deck and box girders, up to 55 cm.
