## INVESTIGATION OF THE EFFECTIVENESS OF EARTHQUAKE DISASTER MITIGATION FOR TECHNOLOGIES OF VIBRATION ISOLATION, ABSORPTION AND EARTHQUAKE-RESISTANCE

Tse-Shan Hsu

Kuang-Chi Liao

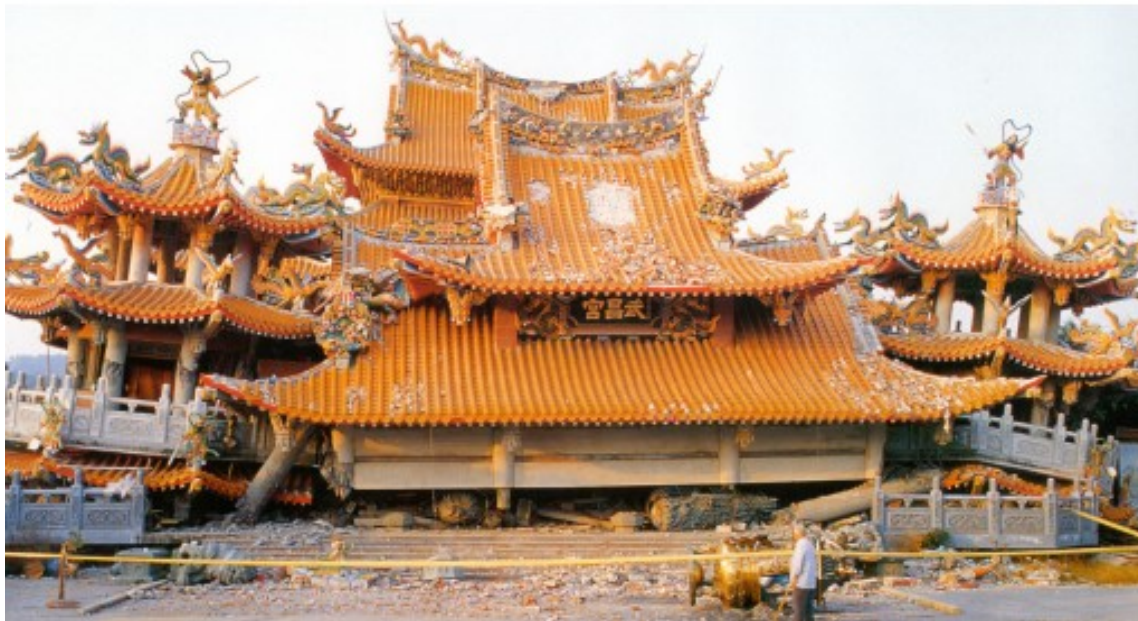
Figure 1 illustrates various structural failures caused by significant earthquakes: Figure 1(a) shows the collapse of a temple during the 921 Jiji earthquake in 1999. Figure 1(b) depicts the fall failure of a high-rise building during the 0206 Meinong earthquake in 2016. Figure 1(c) illustrates the collapse of a large hotel building during the 0206 Hualien earthquake in 2018.

(a) Jiji Earthquake in 1999 (Nantou, Taiwan)

Since earthquakes with a magnitude greater than 6.0 are likely to occur in Taiwan every ten years, if the identification results of the above-mentioned causes of building failures were accurate, then the buildings shown in Figure 1 would fail within ten years of completion. Additionally, if there were buildings similar to those shown in Figure 1 in the same area, these buildings should also experience failure during the same tectonic earthquake. However, this is not the case. Therefore, it is crucial to explore the effectiveness of technologies for vibration isolation, absorption, and earthquake-resistance in earthquake disaster mitigation.

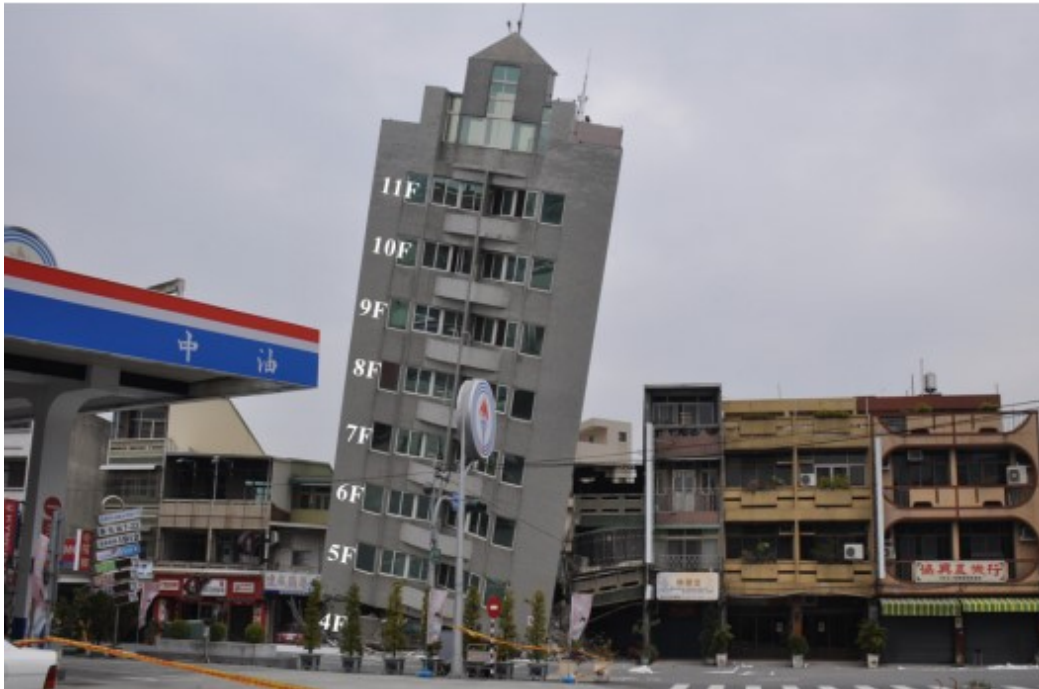
(b) Meinong Earthquake in 2016 (Tainan, Taiwan)

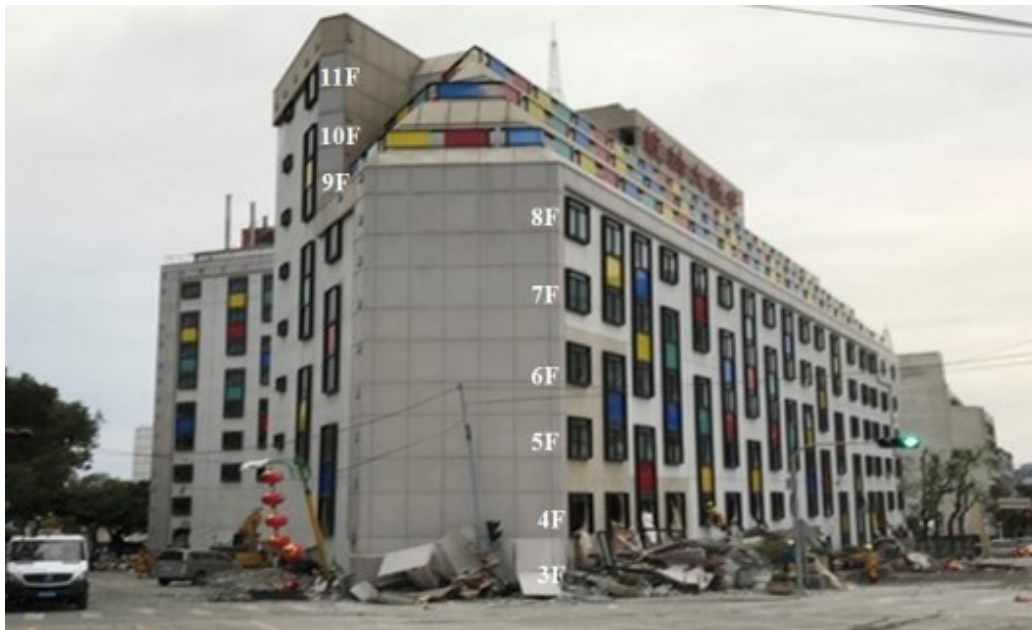
(c) Hualien Earthquake in 2018 (Hualien, Taiwan)

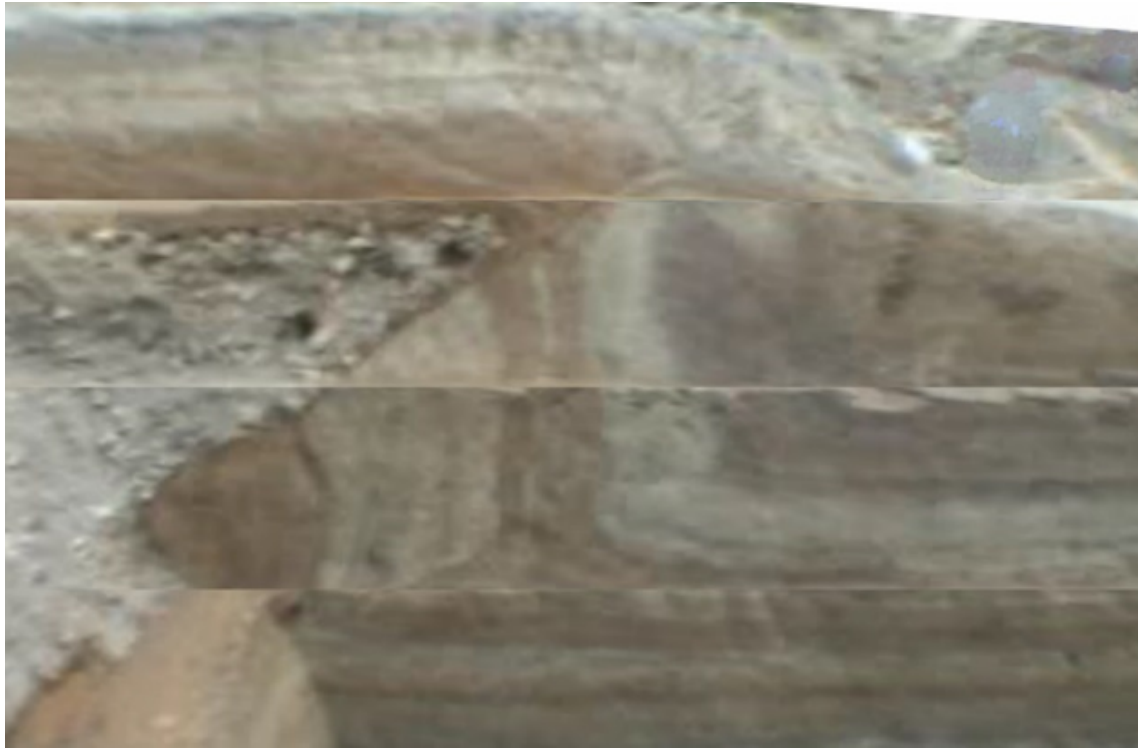
Figure 2 shows the Chelongpu fault excavated in Zhushan after the 921 Earthquake, where the academic term for commonly known faults is shear bands. As seen in Figure 3, shear banding induces the uplift-tilting effect.

Figure 2. Shear bands appearing in Zhushan of Taiwan during the 921 Jiji Earthquake (Hsu, 2018).
