THE MAJOR CAUSE OF THE WANFO TEMPLE COLLAPSE IN THE 1999 JIJI EARTHQUAKE: SHEAR BANDING

Tse-Shan Hsu

Abstract

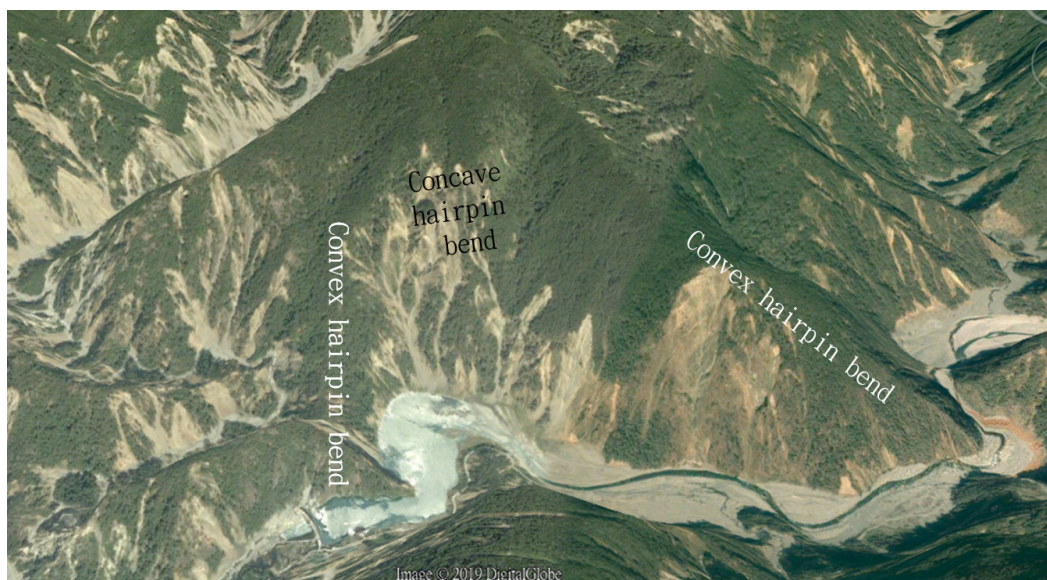
Figure 1. Temples are often selected in a concave hairpin bend located in the mountain area (Background image is from Google Earth, 2019).

Figure 1 shows the concave hair-pin bend of the mountain, which is the intersection of various shear bands with different strikes. In large-magnitude tectonic earthquakes, when shear banding occurs, brittle rock fracture of the shear banding tilted slope will greatly increase, which also induces delamination and sliding failure of the side slopes.
