## THE MAJOR CAUSE OF BRIDGE COLLAPSES ACROSS ROCK RIVERBEDS: SHEAR BANDING

### Abstract

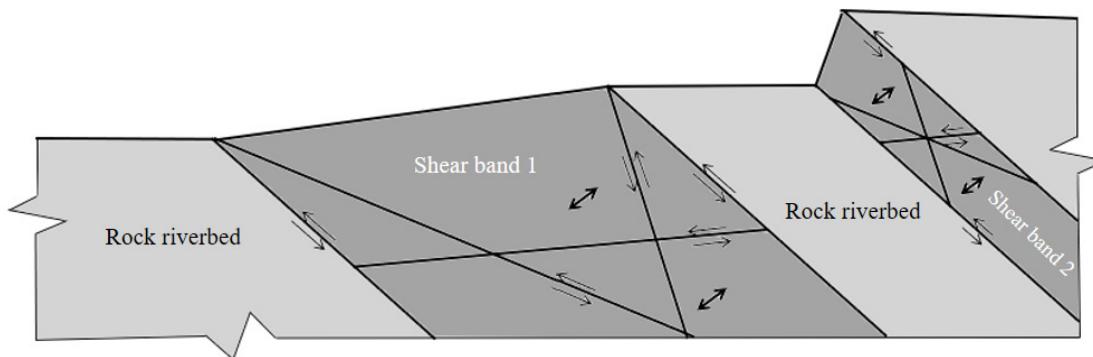
Figure 7. A high shear strength rock riverbed with localized shear bands.

earthquakes, resulting in localized shear bands (see Figure 7).

Note: Shear band 1 is highly brittle fractured; and shear band 2 is slightly brittle fractured.

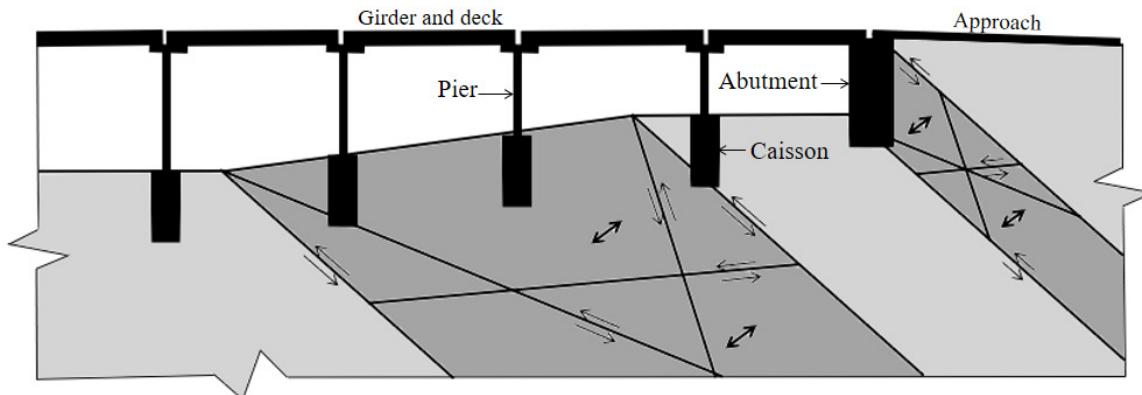
Figure 8. Bridge with abutments and caissons embedded in a rock riverbed.

band effect) is completely neglected in the design, the bridge abutments and a part of the caisson foundations will be embedded in the shear bands (see Figure 8).

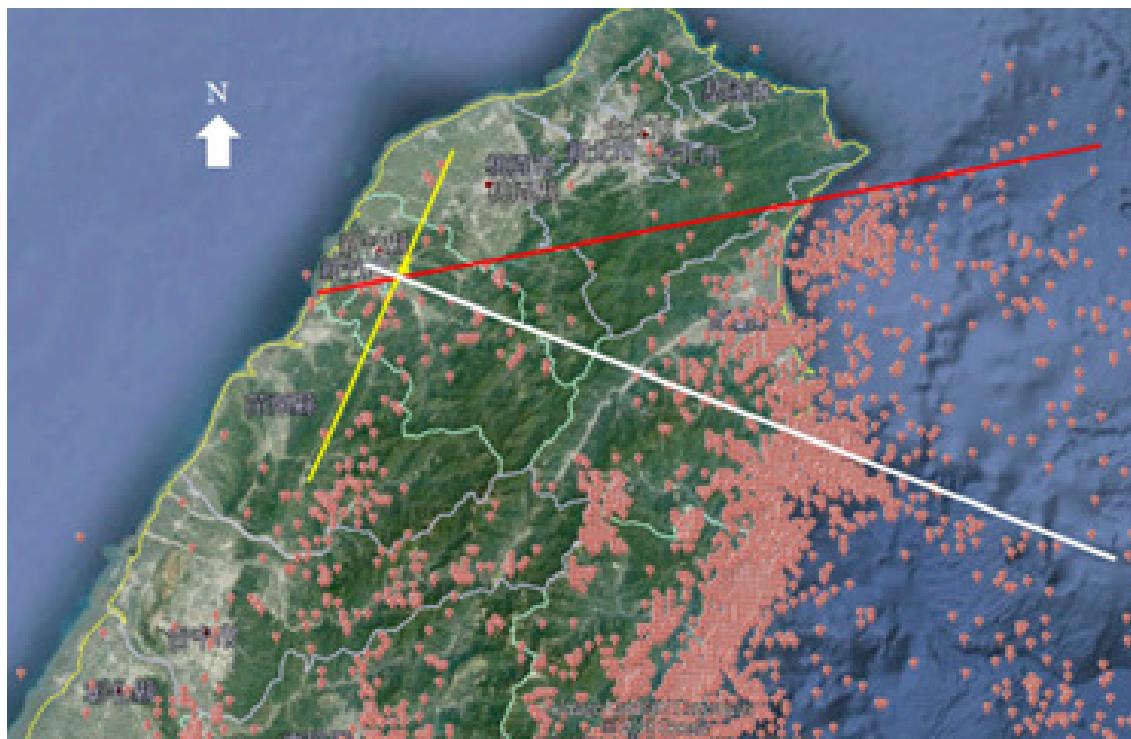
Figure 18. Shear bands with different strikes through the rock riverbed of the Zhongzheng Bridge as identified by the distribution of epicenters (background map from Google Earth, 2020, and epicenter data from the Central Weather Bureau, 2020)

distribution map from 1995 to 2017. From this epicenter distribution map, three shear bands passing through the rock riverbed in the Zhongzheng Bridge can be identified, and their strikes are N65°W (white line), N25°E (yellow line), and N65°E (red line).

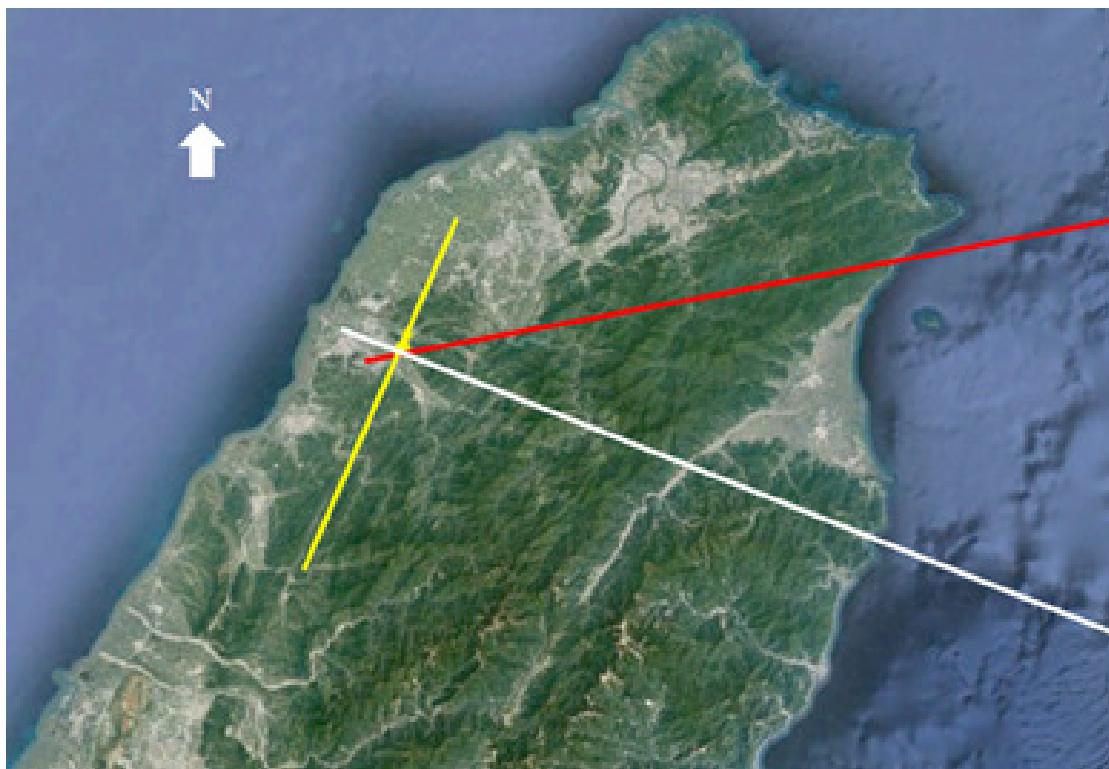
Figure 19. Shear bands identified by displacement landform features  
(background image from Google Earth, 2020).

passing through it can be identified from displacement landform features, and their strikes are N65°W (white line), N25°E (yellow line), and N65°E (red line).

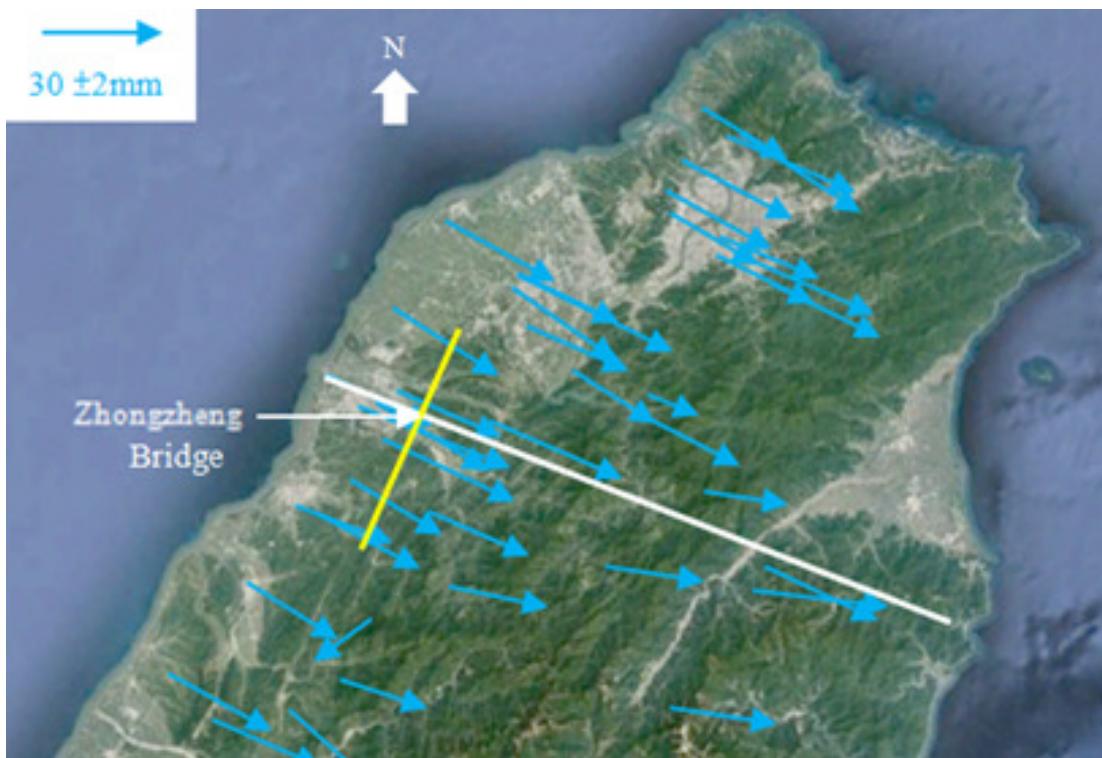
Figure 20. Shear bands identified from the GPS velocity-vector distribution map (background image from Google Earth, 2020, and GPS velocity vectors from GPS LAB, 2007).

GPS velocity-vector distribution map, two shear bands across the rock riverbed at the Zhongzheng Bridge can be identified, and their strikes are N65°W (white line) and N25°E (yellow line).

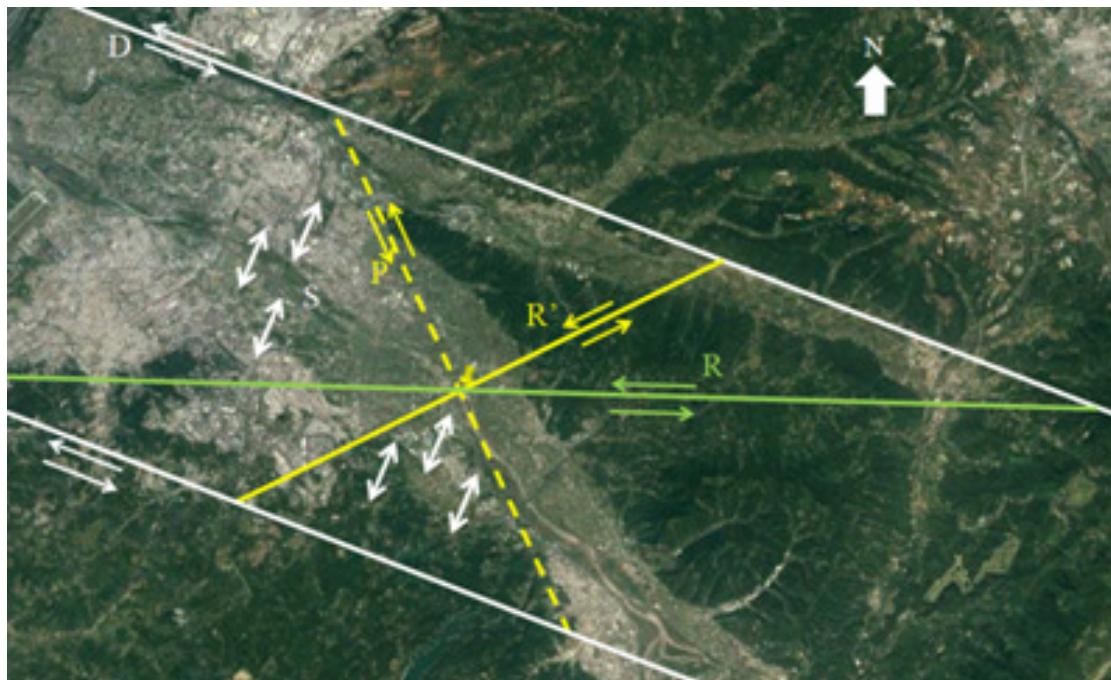
Figure 21. Various shear textures identified within the overall shear band width (background image from Google Earth, 2020).

the overall shear band width, a thrust shear with a N25°W strike (yellow dotted line), a Riedel shear with a N80°W strike (green line), a conjugated Riedel shear with a N65°E strike (yellow line), and a compression texture with a N25°E strike (double arrow line) are identified.

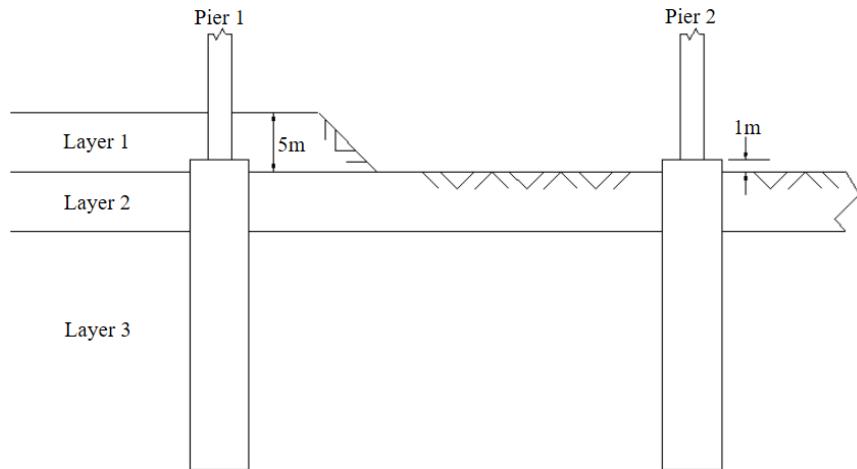
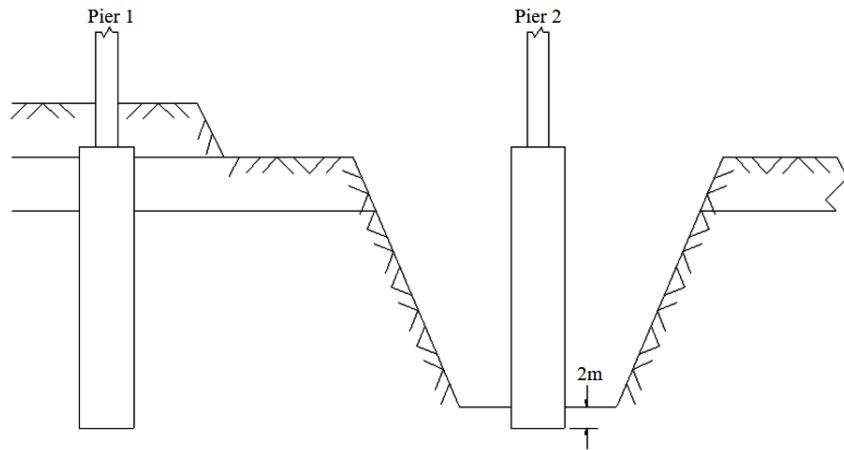
Figure 25. Distribution of very stiff soil layers adjacent to piers and caissons, with partial deep grooving effect of the riverbed.

Figure 25, based on different analysis conditions. In Case 1, except for the riverbank, the riverbed has a grooving of 1m under the top of the caisson

foundations. In Case 2, some portions of the riverbed have deep grooving effect down to 2m above the bottom of the caisson foundations.

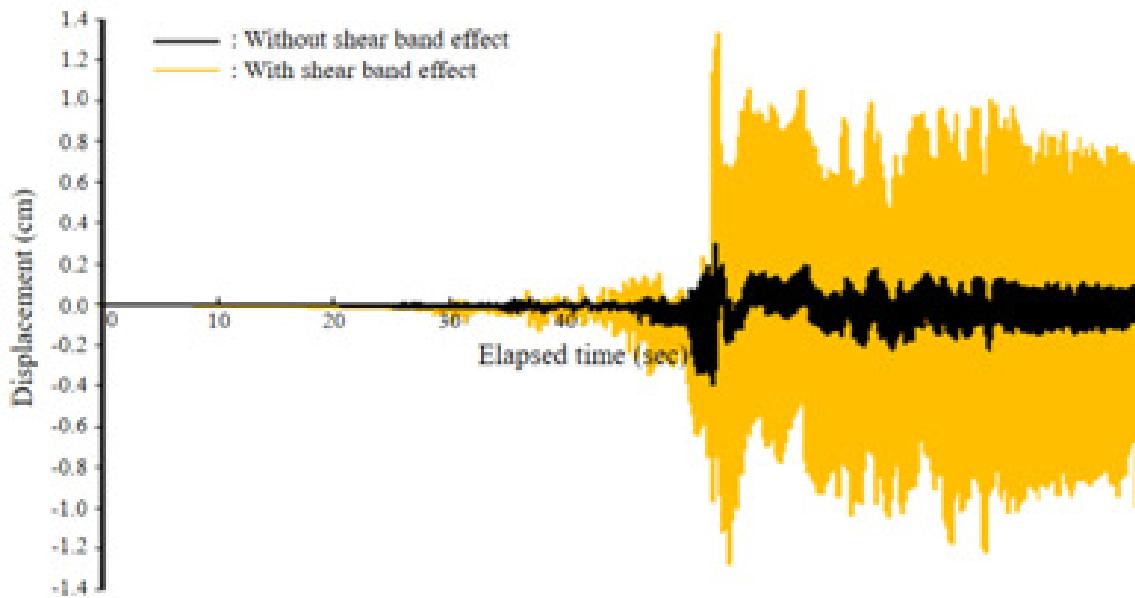
Figure 27. Influence of shear band effects on the  $x$ -direction seismic displacement response curve at the top of Pier 2.

For the top of the piers at the severely grooved riverbed under shear band effects, the seismic displacement, velocity, and acceleration and corresponding accelerogram in the x-direction are as shown in Figures 27 through 29. Figure 27 shows a maximum seismic displacement of 0.379 cm under no shear band effects, occurring at 52.485 s, and a maximum seismic displacement of 1.326 cm under shear band effects, occurring at 52.995 s. Figure 28 shows a maximum seismic velocity of 9.530 cm/s for the top of the piers at the severely grooved riverbed under shear band effects, and a maximum seismic velocity of 31.337 cm/s, occurring at 53.205 s. Figure 29 shows a maximum seismic acceleration

By comparing analysis results with and without shear band effects, it is found that the stiffness of the entire bridge significantly decreased under shear band effects. This resulted in a 250% increase of the maximum displacement at the top of Pier 2 in the  $x$ -direction, from 0.379 cm to 1.326 cm, a 229% increase of the maximum velocity, from 9.530 cm/s to 31.337 cm/s, and a 87% increase in maximum acceleration, from 0.520 g to 0.972 g. The maximum displacement time of occurrence increased from 52.485 s to 52.995 s, the maximum velocity from 51.925 s to 53.205 s, and the maximum acceleration from 53.075 s to 79.475 s.

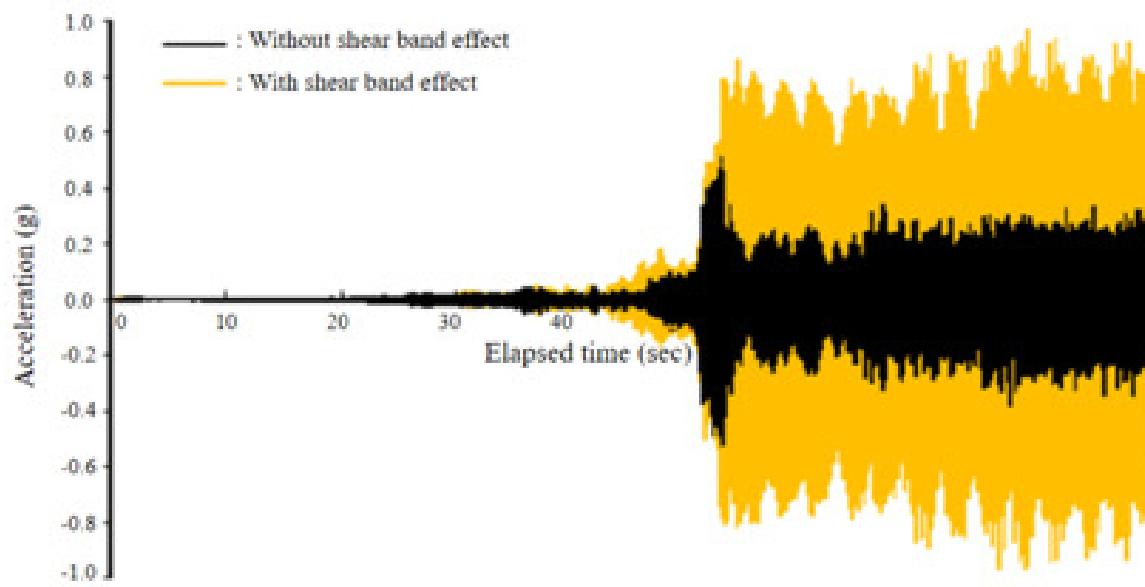
Figure 29. Influence of shear band effects on the  $x$ -direction seismic accelerogram at the top of Pier 2.

of 0.520 g under no shear band effects, occurring at 53.075 s, and a maximum

seismic acceleration of 0.972 g, occurring at 79.475 s of the elapsed time.
