## THE MAJOR CAUSE OF ANCHOR BLOCK SLOPE FAILURES

Currently, a large number of anchors are used in Taiwan to stabilize slopes. The design specifications have been continuously revised after the occurrence of anchor block slope disasters. However, disasters at anchor block slope that meet design specifications have become more and more serious, even in the absence of wind, rain, and earthquakes. This proves that the current design specifications do not include the major cause that induces anchor block slope failures. In view of this, this paper takes the anchor block slope disaster happened at 3.1km mark of the Formosa Freeway as an example. By comparing the endoscope inspection results and those

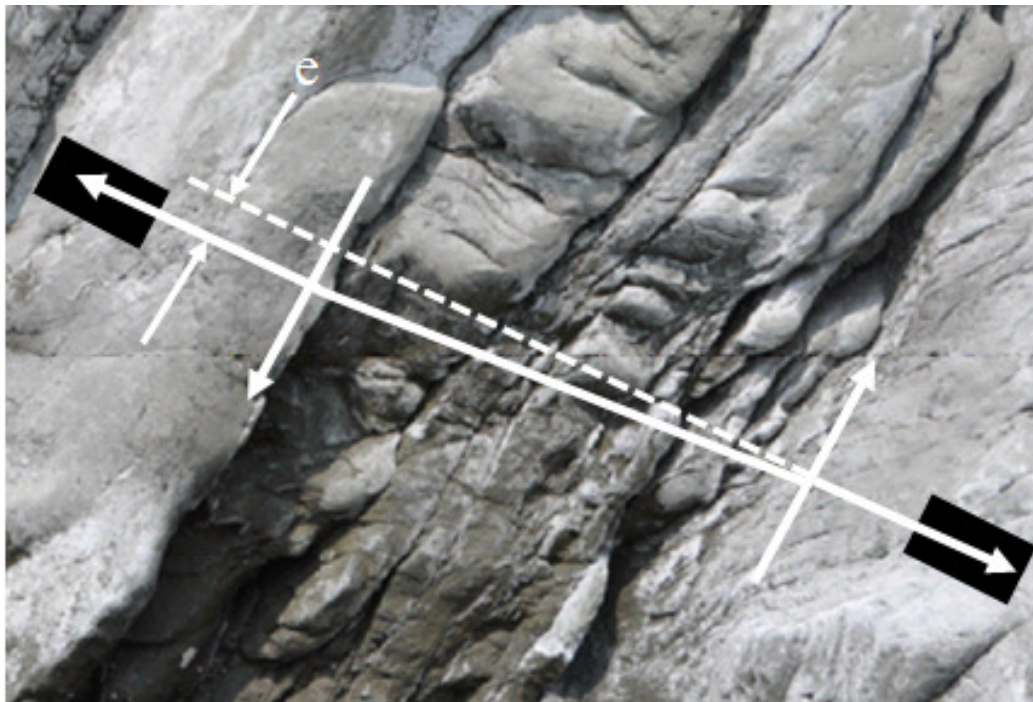
Figure 12. Schematic diagram of the anchor through the shear banding rock (redrawn from Hsu et al., 2017)

been installed, the amount of shear banding for the rock slope shown in Figure 12 is  $e = 0$ . After the anchors are installed for a period of time, the amount of shear banding for the rock slope is  $e > 0$ .

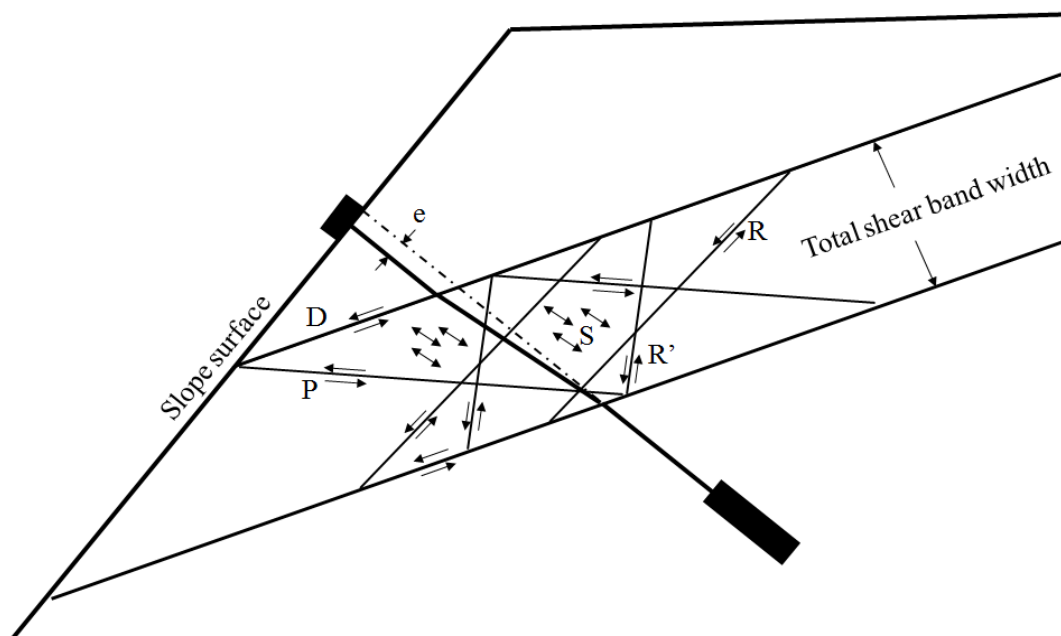
Figure 13. Schematic diagram of the anchor passing through the shear band with a displacement of  $e$

For the anchor block slope shown in Figure 13, if the anchor diameter is  $D_A$ , its section area  $A = \pi D_A^2 / 4$ , and its section modulus  $S = \pi D_A^3 / 32$ .

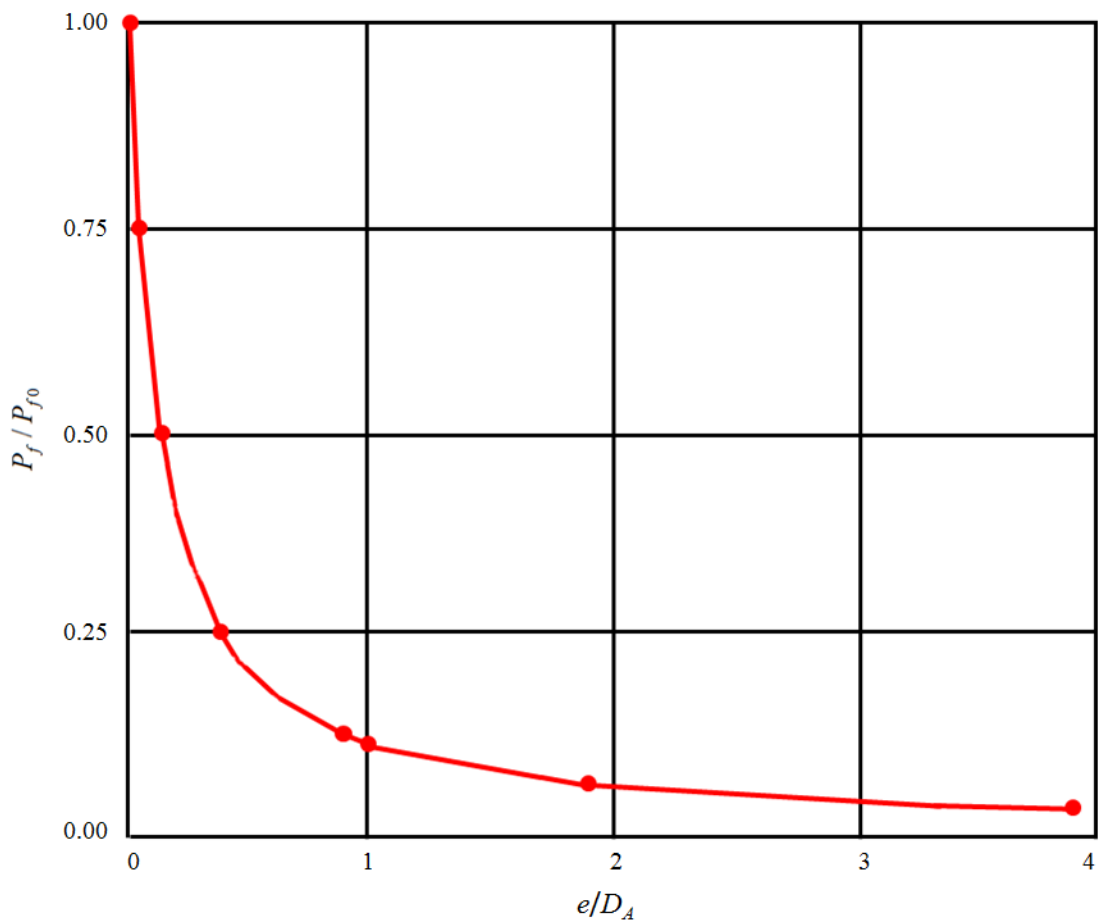
Figure 14. Relationship between  $P_f/P_{f0}$  and  $e/D_A$

Using Equation 2, the relationship of  $P_f / P_{f0}$  changing with  $e / D_A$  can be drawn (shown in Figure 14). When  $e / D_A$  increases from 0 to 1,  $P_f / P_{f0}$  decreases dramatically; when

$e / D_A$  continues to increase above 1, the  $P_f / P_{f0}$  reduction tends to slow down. Eq. 2 can be used to calculate that, as  $e / D_A$  continues to increase from 0 to 1/24, 1/8, 1, 16/9, and 32/9,  $P_f$  decreases to  $0.75P_{f0}$ ,  $0.5P_{f0}$ ,  $0.25P_{f0}$ ,  $0.125P_{f0}$ ,  $0.111P_{f0}$ ,  $0.0657P_{f0}$ , and  $0.034P_{f0}$ , respectively.

Taking the anchor block slope located at the 3.1km mark of Formosa Freeway as an example, since the anchor diameter  $D_A$  is 9cm and  $P_{f0}$  is 1285kN, it can be calculated from Eq. 2 that: (1) when  $e=0.375$ cm and  $e/D_A = 1/24$ ,  $P_f$  is 963.8kN; (2) when  $e=1.125$ cm and  $e/D_A = 1/8$ ,  $P_f$  is 642.5kN; (3) when  $e=9$ cm and  $e/D_A = 1$ ,  $P_f$  is 142.6kN; (4) when  $e=16$ cm and  $e/D_A = 16/9$ ,  $P_f$  is 84.4kN; and (5) when  $e=32$ cm and  $e/D_A = 32/9$ ,  $P_f$  is 43.7kN.

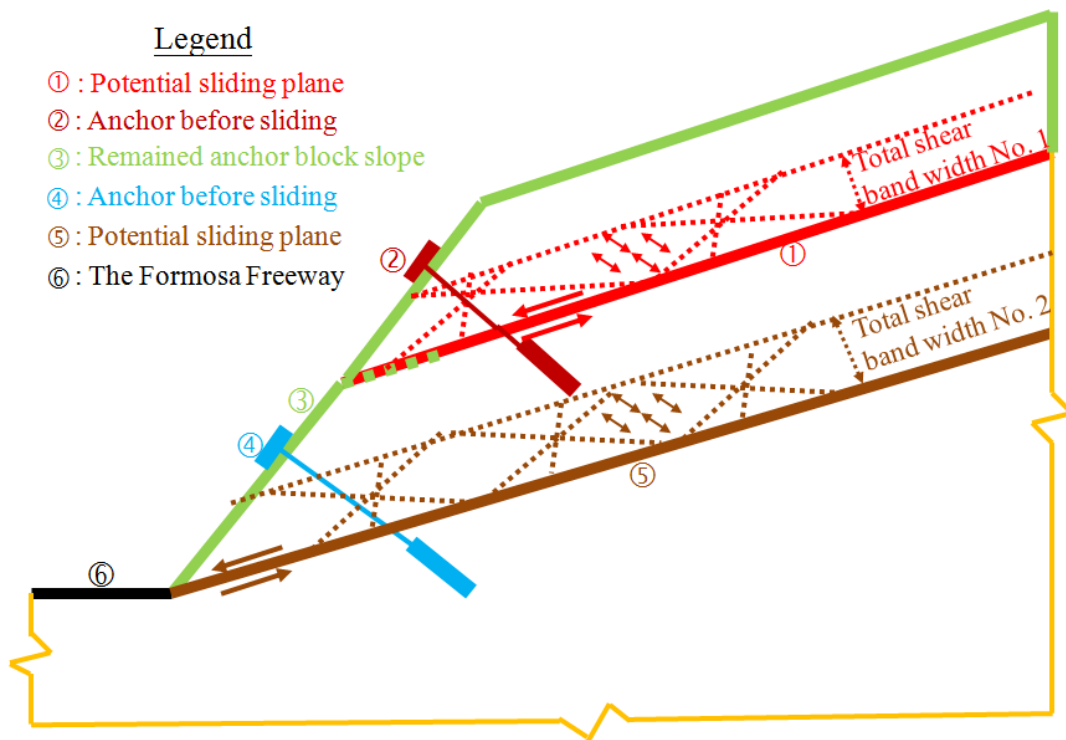
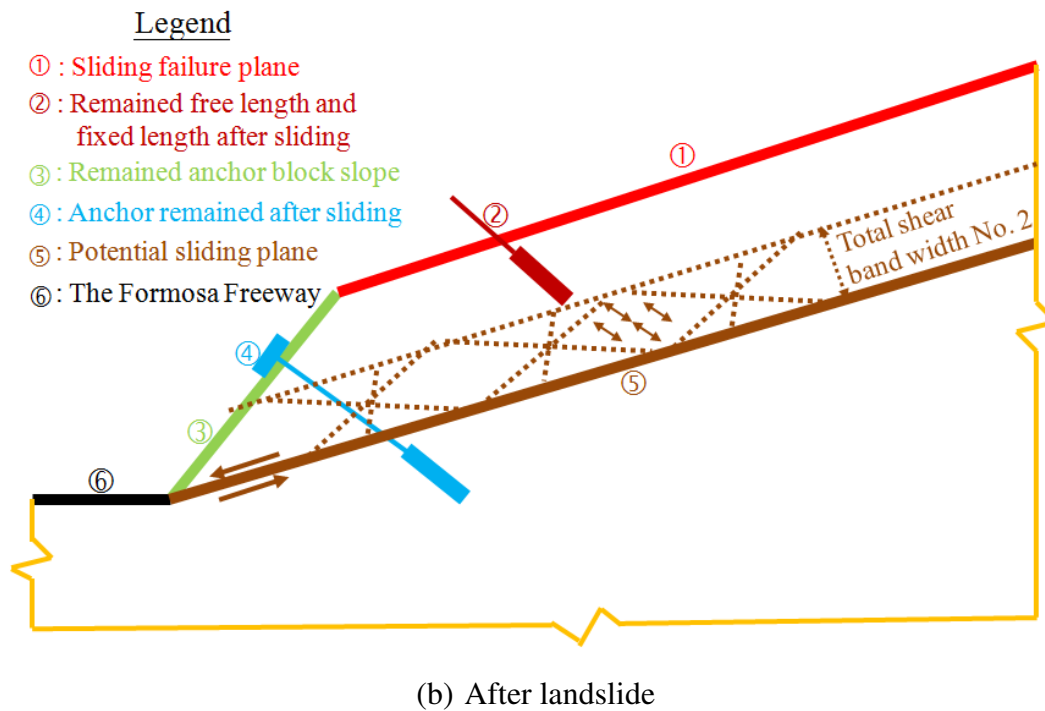
Figure 16. Schematic diagram of anchors, anchor components, and shear textures existing in the total shear band width that exists on the anchor block slope and sliding failure plane

For the snapped anchor remaining on the sliding failure plane as shown in Figure 3 or Figure 5b, since the block sliding on the potential sliding plane, shown in Figure 16a①, is disappeared, all shearing textures located within the total shear band width No. 1 no longer exist. Therefore, the anchor (Figure 16b②) remaining on the sliding failure plane shown in Figure 16b① is actually not affected by the total shear band width No. 1. In

For the anchor in the residual anchor block slope below the sliding failure plane after the disaster shown in Figure 7 and Figure 16b④, the effect of the total shear band width No. 2 on all five anchors are shown in Figure 12, Figure 13, and Figure 16. In other

words, the tensile strength test results of the second set of anchors shown in Table 2 are derived from  $e > 0$ ; therefore, after the tensile force is applied at 920kN, 883kN, 618kN, 588kN, and 490kN, the five anchors are pulled off respectively. Equation 2 can inversely calculate the amount of shearing banding  $e$  of the five anchors, equal to 0.446cm, 0.5125cm, 1.2143cm, 1.3313cm, and 1.8225cm, respectively.

The amount of shear banding  $e$  obtained by the above-mentioned back calculation can be achieved when the slope is in a very slow sliding state; therefore, it is known that when the in-situ anchor block slope is in a very slow sliding state, the anchor tensile strength  $P_f$  will decrease due to the increase of the amount of shear banding  $e$ . The value reaches zero after breaking.
