## COMPARISON OF REPAIR METHODS FOR CRACKED EARTH DAMS BASED ON DIFFERENT TECTONIC EARTHQUAKE EFFECTS

Tse-Shan Hsu

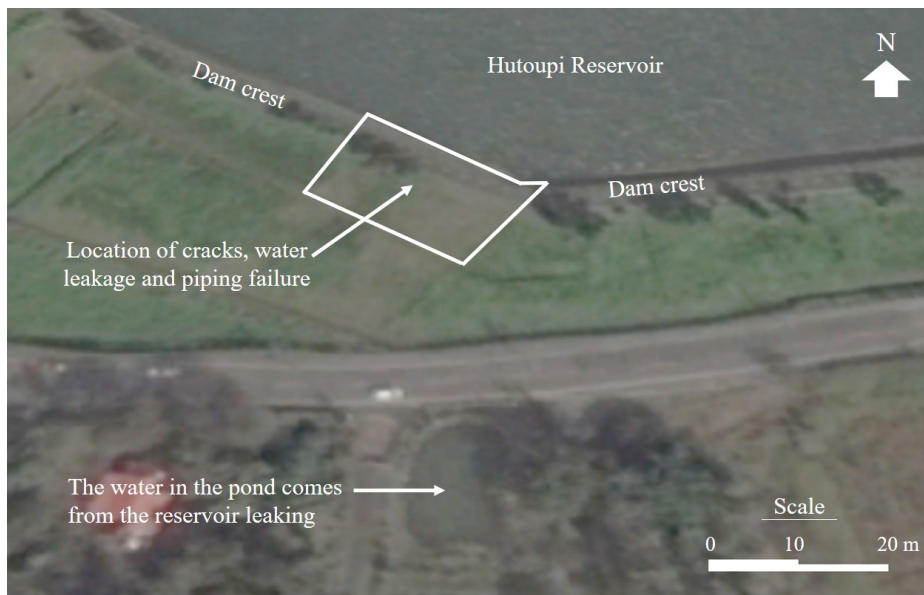
tectonic earthquake tests. Between 1863, when the Hutoupi Earth Dam in Taiwan was completed, and 2000, several tectonic earthquakes caused cracks or piping failures at the turning area (Jianan Farmland Water Conservancy Association, 2012) shown in Figure 1.

Figure 1. The location of the Hutoupi Earth Dam, in which cracks, water leakage, and piping failure have repeatedly occurred (the background picture is from Google Earth, 2021).

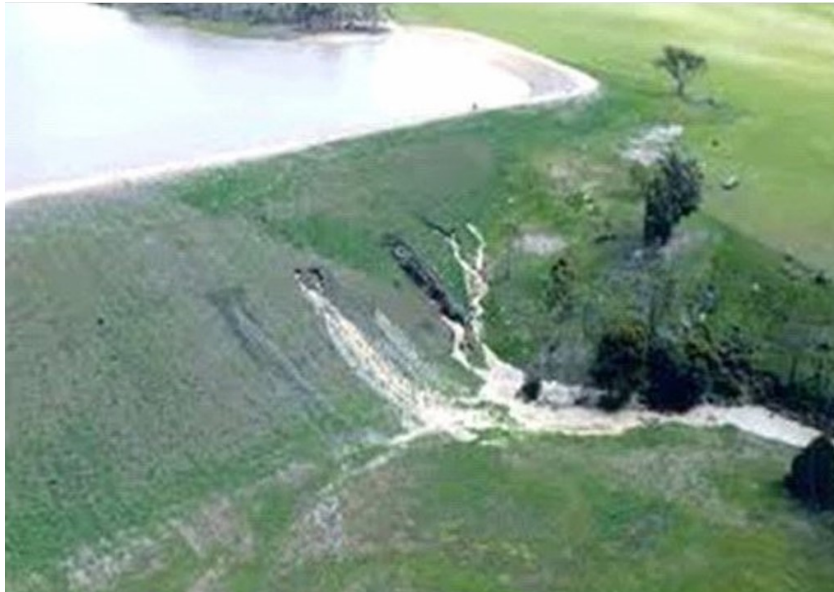
Figure 2. Example of piping failure at the turn of an earth dam (Wendy Fisher, 2021).

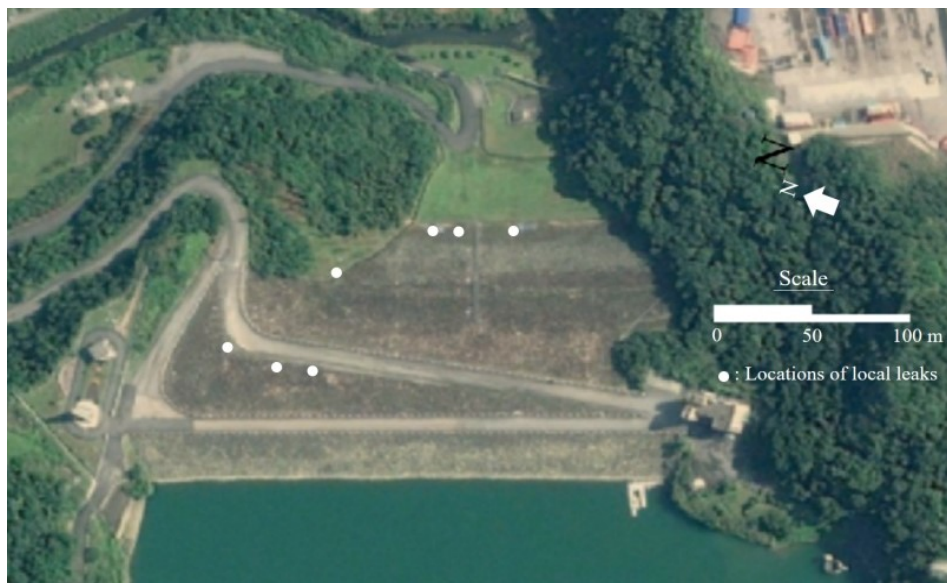
(b) The location of the leak in the earth dam (Google Earth, 2021; Data from Lin, 2009).

Figure 3. Water leakage induced by the extension of shear bands into the earth dam (Xinshan Earth Dam, Taiwan; Lin, 2009).

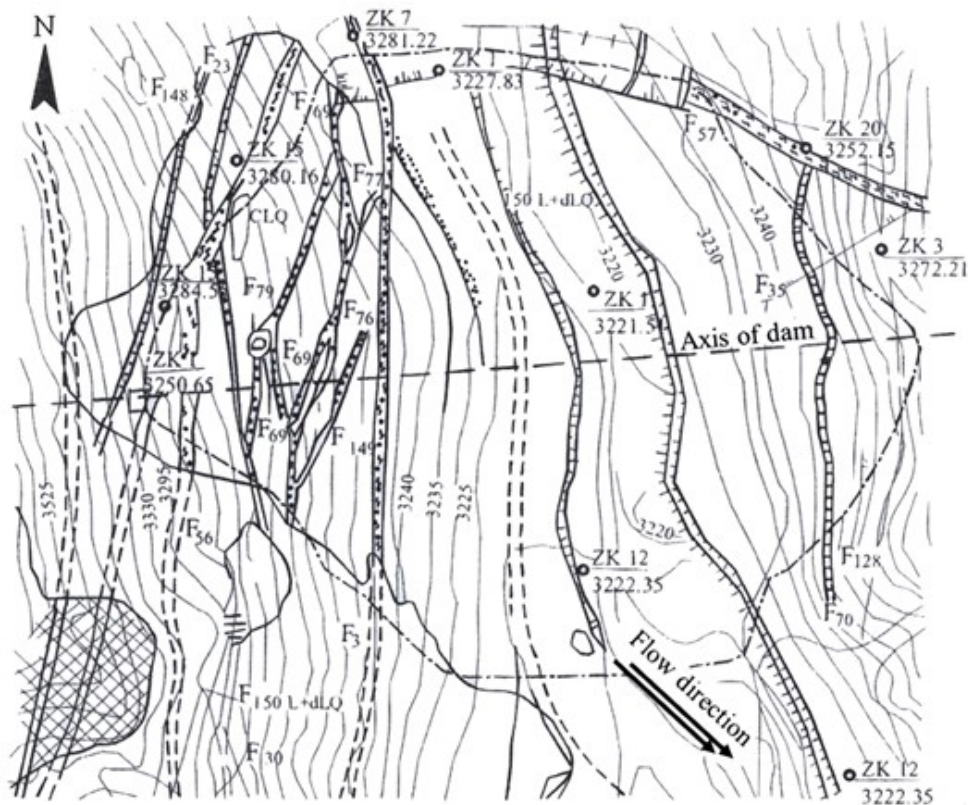
(a) Plan view of the shear bands in the river valley and river bank.

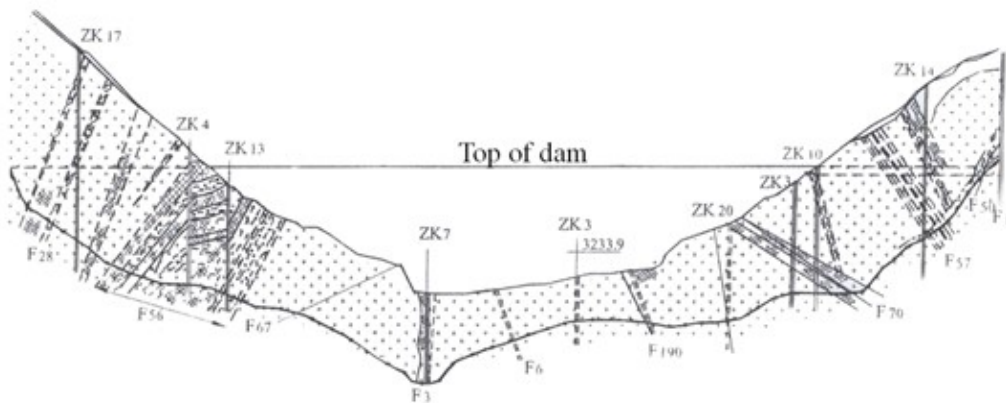
(b) Sectional view of shear bands in the river valley and river bank.

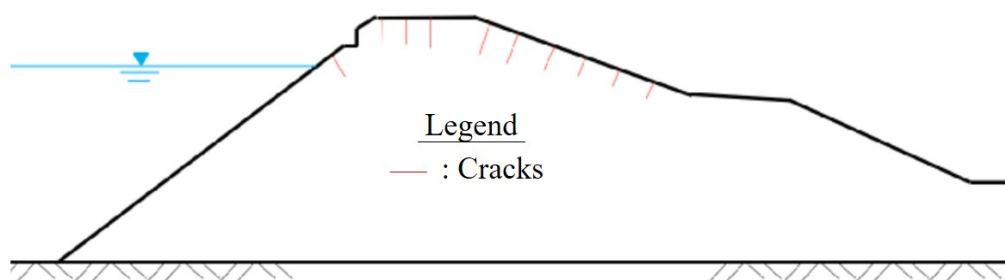
Reclamation, 2012; Water Resources Agency, MOEA, 2003; Water Resources Agency, MOEA, 2008) only fortify the dam against ground vibrations. Furthermore, as the acceleration increases with increased dam elevation during the ground vibrations, cracks in the earth dam from ground vibrations are believed to only appear locally on the top of the dam and on the surface of the downstream slope near the top of the dam (see Figure 5).

Figure 5. The mechanism for earth dam cracking inducement by ground vibrations (redrawn from Jianan Farmland Water Conservancy Association, 2012).

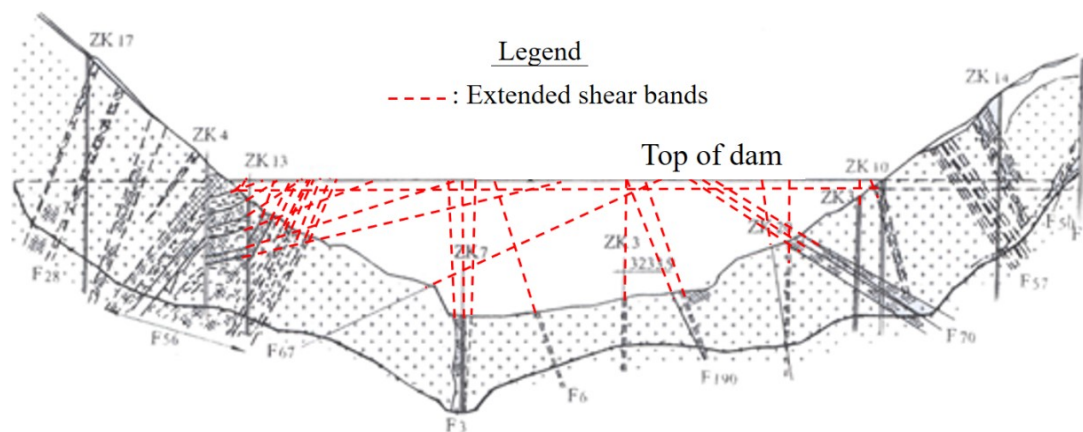
code only fortifies the dam against ground vibration, it is impossible to prevent the occurrence of earth dam cracking caused by shear banding. Thus, a mechanism is proposed that could explain how the shear bands in the river valley and river bank extend into the earth dam (see Figure 6).

Figure 6. The mechanism for the extension of shear bands into the earth dam (the base map is from Sinotech Foundation for Research and Development of Engineering Sciences and Technologies, 2008).

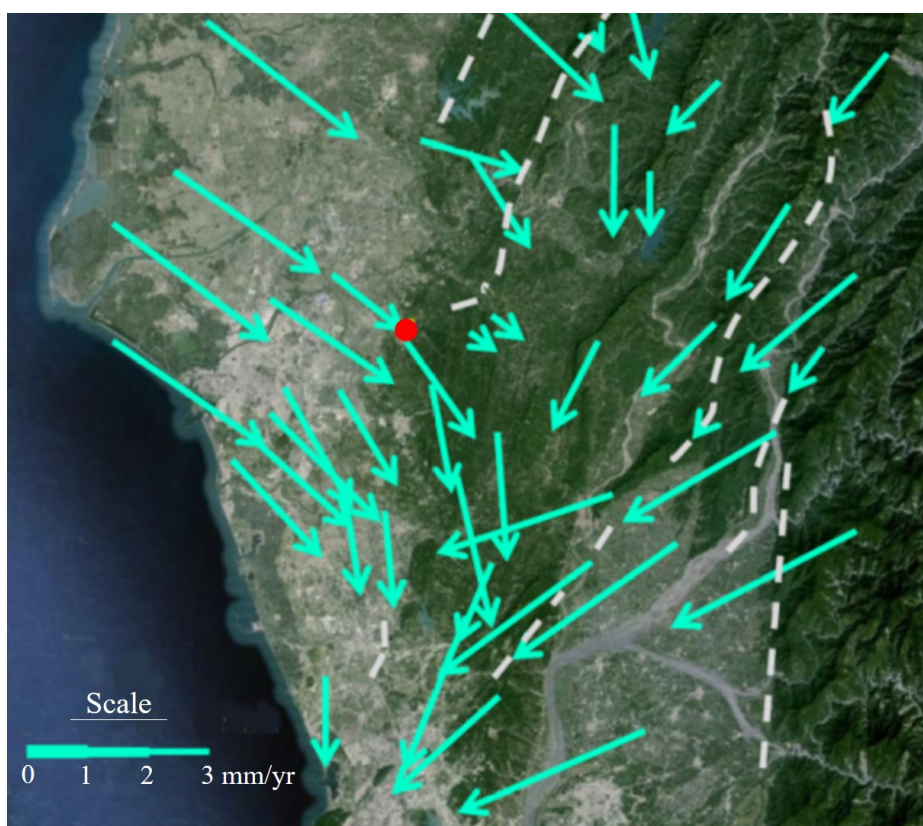
First, a GPS velocity vector distribution map was used for the area surrounding the Hutoupi Earth Dam turn (shown in Figure 11a), supplemented by the definition of shear bands (Hsu, 1987), to identify some of the shear bands in the Hutoupi Earth Dam turn (Figure 11b). The strike of the slip-type shear band (white line) is

(a) GPS velocity vector distribution map.

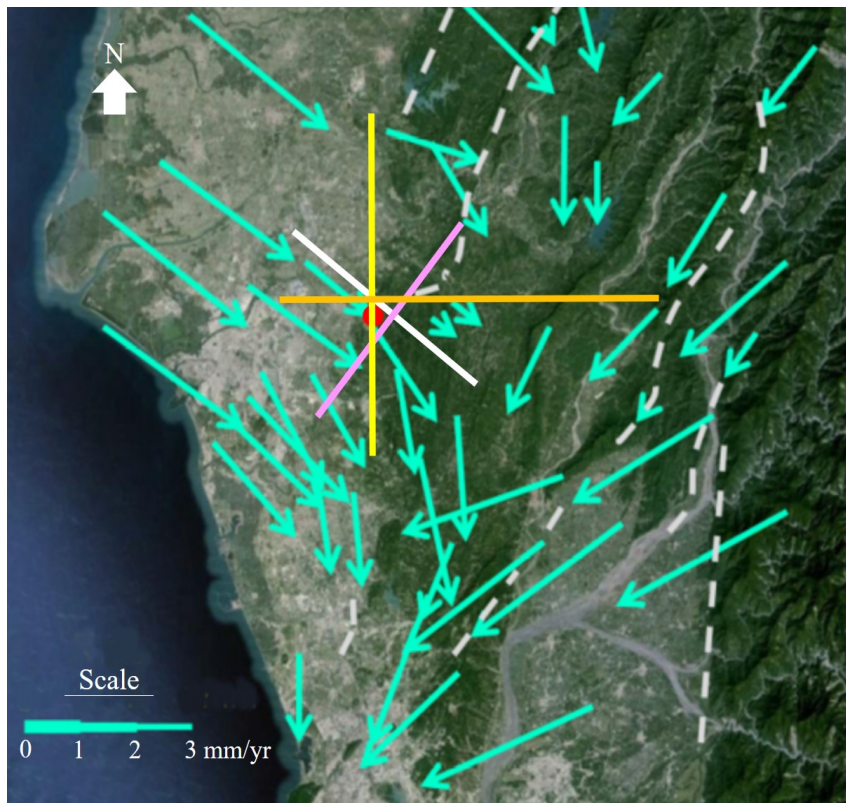
$N51.7^{\circ}W$ , the strike of the conjugate slip-type shear band (purple line) is  $N38.3^{\circ}E$ , the strike of the twinning-type shear band (yellow line) is  $N0.2^{\circ}E$ , and the strike of the conjugate twinning-type shear band (orange line) is  $89.8^{\circ}W$ .

(b) Identified shear bands.

Note: The center of the red circle represents the turning point of the Hutoupi Earth Dam.

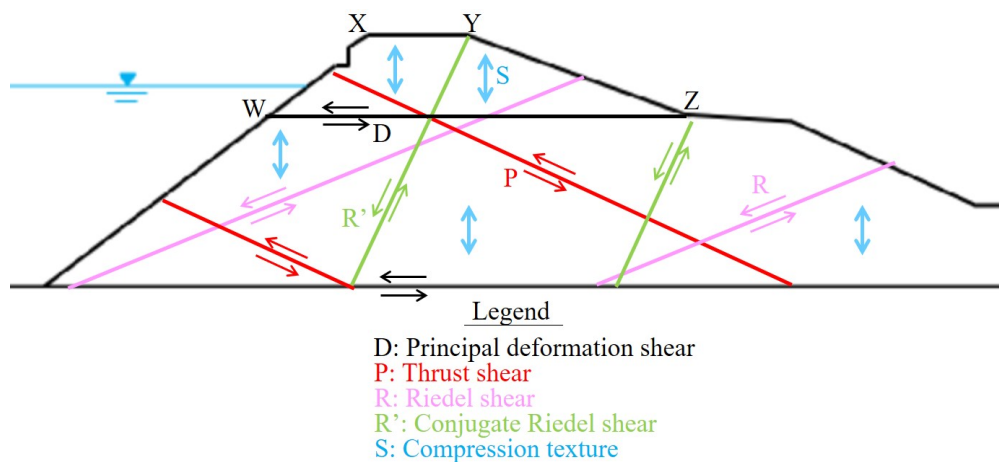
tures of a shear band extend into the earth dam (Figure 12).

Figure 12. A schematic diagram of the shear textures of a shear band extending into the Hutoupi Earth Dam.

cross-sectional repair range is shown in Figure 12 as the  $\overline{WXYZ}$  range.

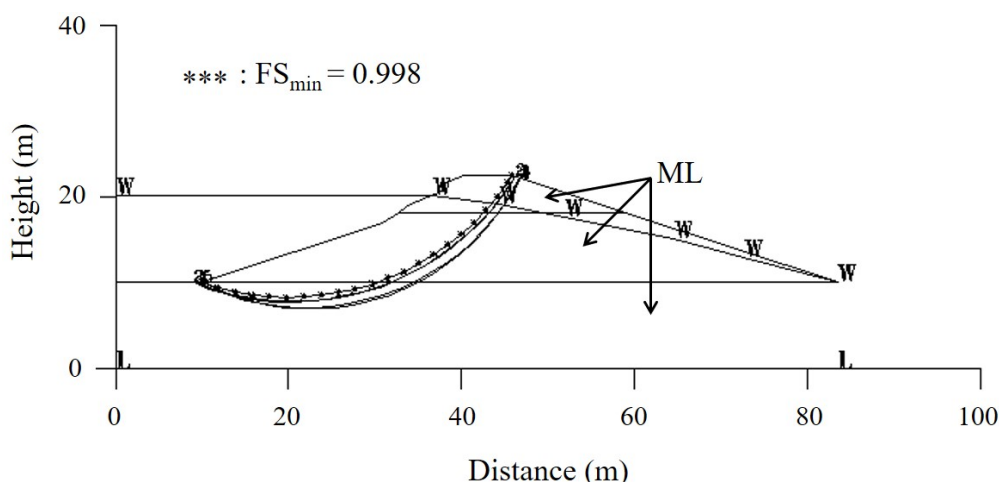
est slope stability safety factor after the Jiaxian earthquake. The slope stability safety factor for the sliding surface marked with \* is the minimum value of 0.998.

Figure 17. The slope stability analysis results for the restoration project using vibration records from the Jiaxian earthquake.

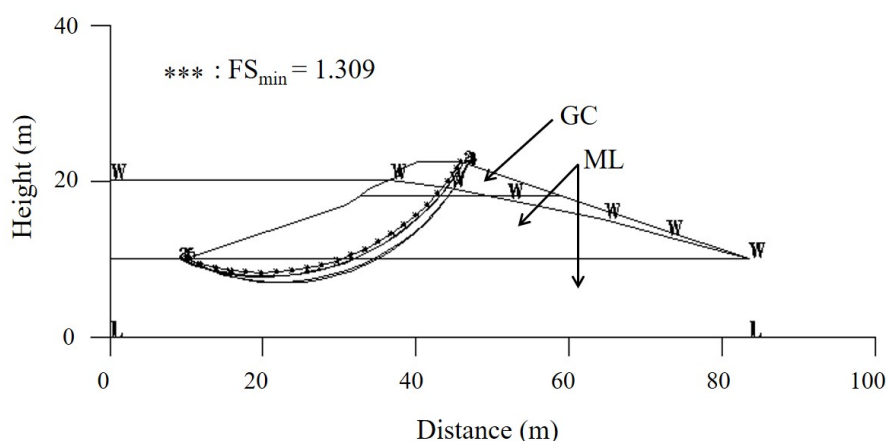
after the Meinong earthquake. The slope stability safety factor for the sliding surface marked with \* is the minimum value of 1.309.

Figure 18. The slope stability analysis results of the restoration project using vibration records from the Meinong earthquake.

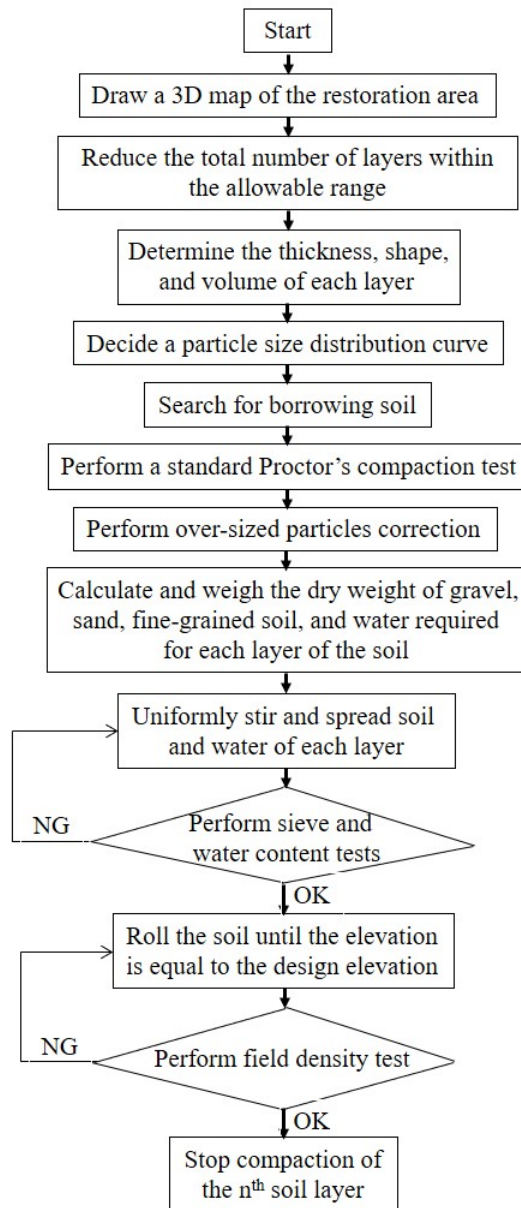
Figure 20. Workflow chart of comprehensive quality management for compacted soil of restoration area.

To address the shortcomings of conventional quality management and to uniformly distribute the moisture content and the field density of the compacted soil, a total quality management approach was adopted for the first time for the restoration of the Hutoupi Earth Dam's turn after the Meinong earthquake, so that the entire area of the restoration project met the construction specifications. The following workflow chart describes the execution procedure:
