A NEW METHOD FOR DAM FAILURE POTENTIAL
EVALUATION BASED ON SHEAR BAND
DISPLACED LANDFORM FEATURES

Keywords: tectonic earthquakes, shear banding, ground vibration, safety evaluation, failure potential evaluation.

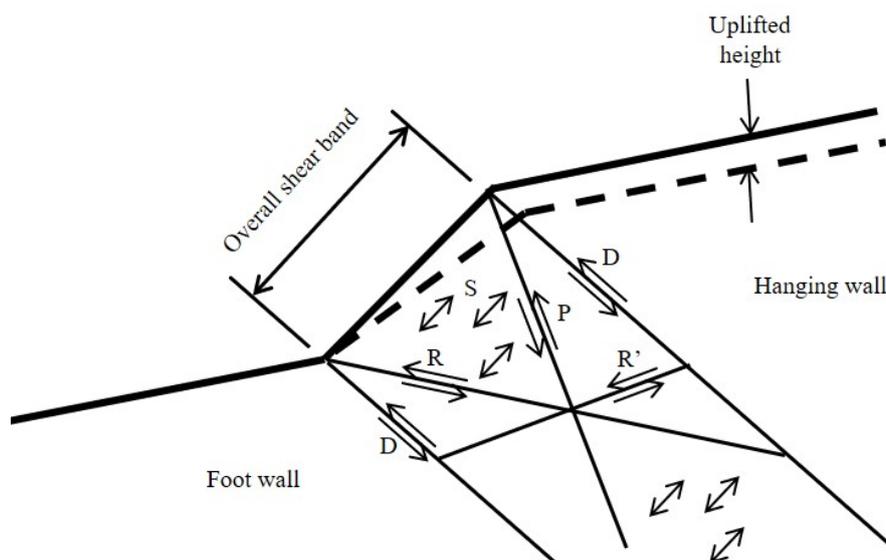
have a local tilting effect, and a local tilted slope will appear (Figure 2).

Figure 2. A shear-band tilted slope derived from a tectonic earthquake (Hsu et al., 2021).

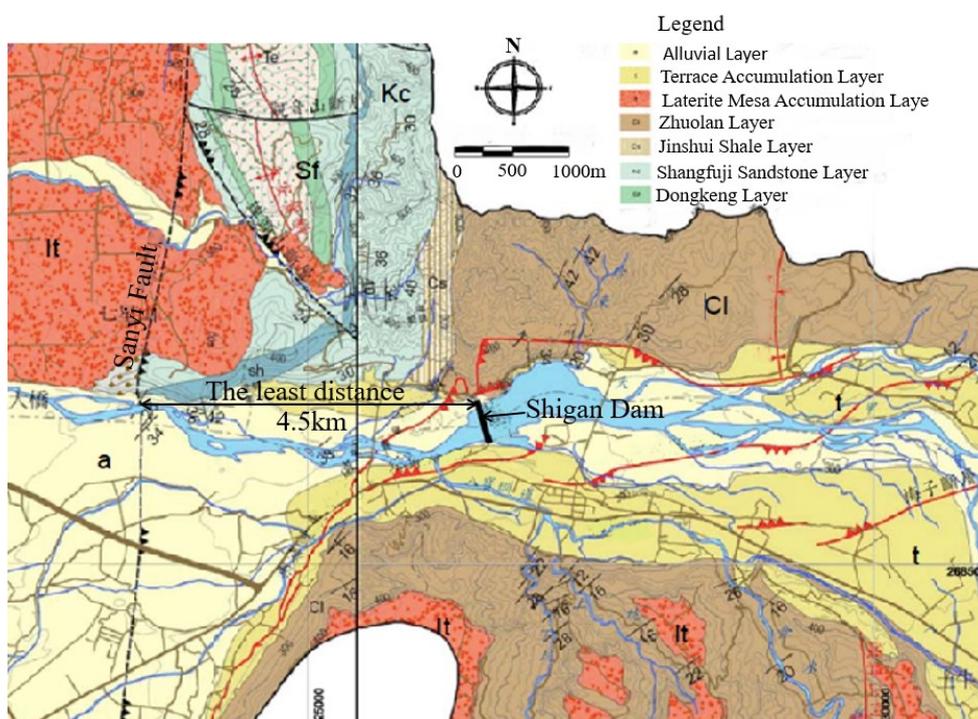
tions, the selected k_h was increased by 50% and the vertical seismic coefficient (k_v) was half of k_h ; in other words, the k_h used in the design of the Shigang Dam was 0.15 and the k_v was 0.075 (Liming Engineering Consulting Co., Ltd., 2012). In addition, the design fault selected for the Shigang Dam was the Sanyi Fault and the least distance (r_{rup}) between them was 4.5 km (Figure 7).

Figure 7. The least distance between the Shigang Dam and the Sanyi Fault (redrawn from Liming Engineering Consulting Co., Ltd., 2018).

Because the Chelongpu Fault clearly passed through the Shigang Dam and caused the fracture damage to the dam body, the design fault changed from the Sanyi Fault to the Chelongpu Fault. The least distance between the Shigang Dam and the design fault (r_{rup}) also changed from 4.5 km to 0.0 km, and the peak ground acceleration (PGA) calculated by the attenuation formula changed from 0.5 g to infinity.

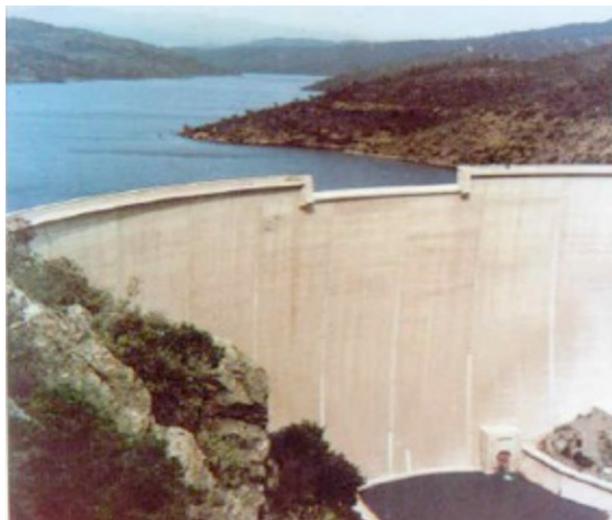
The Malpasset Dam was a concrete arch dam located on the Riviera in Southern France. Because the left abutment of the dam was higher, a large dihedral thrust block was placed below the dam to raise it to the necessary height. When the first dam filling was nearly complete (Figure 19), the Malpasset Dam failed (on December 2, 1959) after the area experienced heavy rain. Geological investigations that took place after the failure of the dam revealed that it had been built on a gneiss formation. In addition, a fault was discovered immediately downstream of the dam. Failure of the left abutment led to the ultimate failure of the dam as cracks propagated across the

Figure 19. The Malpasset Dam prior to failure (Association of State Dam Safety Officials, 1984).

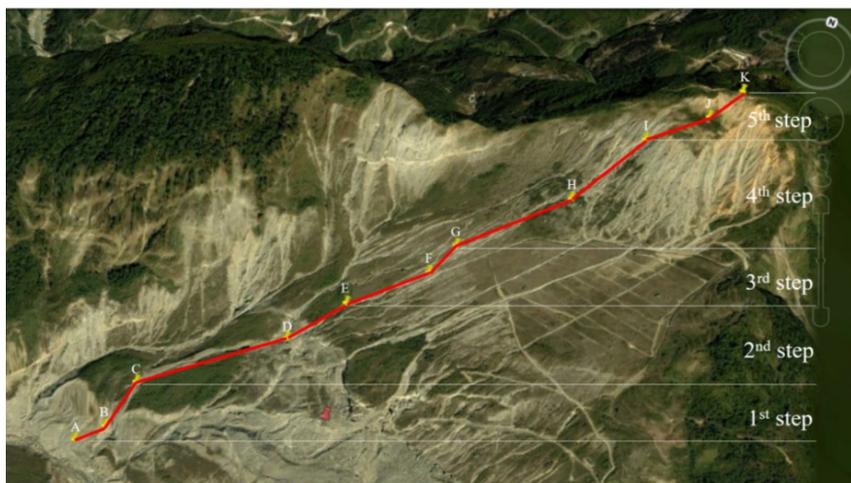
(a) Caoling landslide (921 Earthquake in 1999; Hsu, et al., 2021).

Hsu et al. (2021) demonstrated that when there are tilted shear band slopes with multiple steps on the river bank, the slope will induce delamination and sliding failure under strain softening and shear band tilting effects. They cited two examples from Taiwan

(Figure 21). The Malpasset Dam canyon wall is therefore unsound and unstable. Because a tilted slope is a shear-band displaced landform feature, it can be used as an index for the evaluation of the dam failure potential.

Figure 21. Large-scale landslides that happened on tilted multi-step shear band slopes in Taiwan (background image is from Google Earth, 2021).

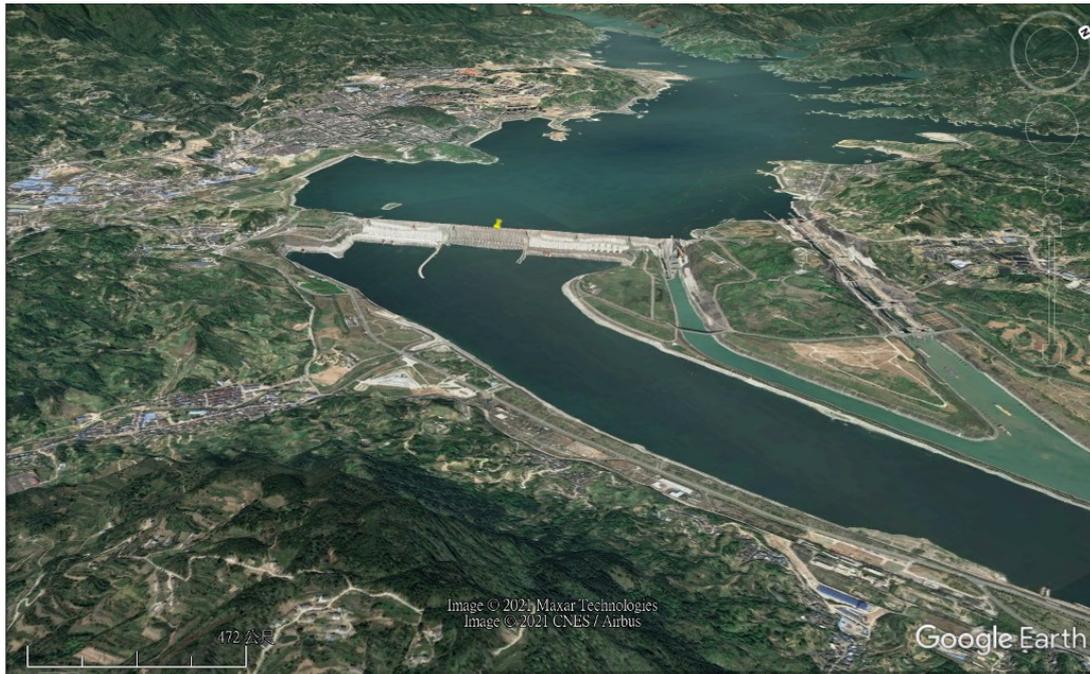
Figure 27 shows that the Three Gorges Dam is a concrete gravity dam with a length of 2335 m, a top width of

Figure 27. The Three Gorges Dam and its adjacent areas (Google Earth, 2021).
