FORMATION MECHANISMS FOR VARIOUS FAILURE IN THE REAR-LINE REGION OF THE TAICHUNG PORT DOCK CAISSON

Tse-Shan Hsu

Hung-Chia Chang

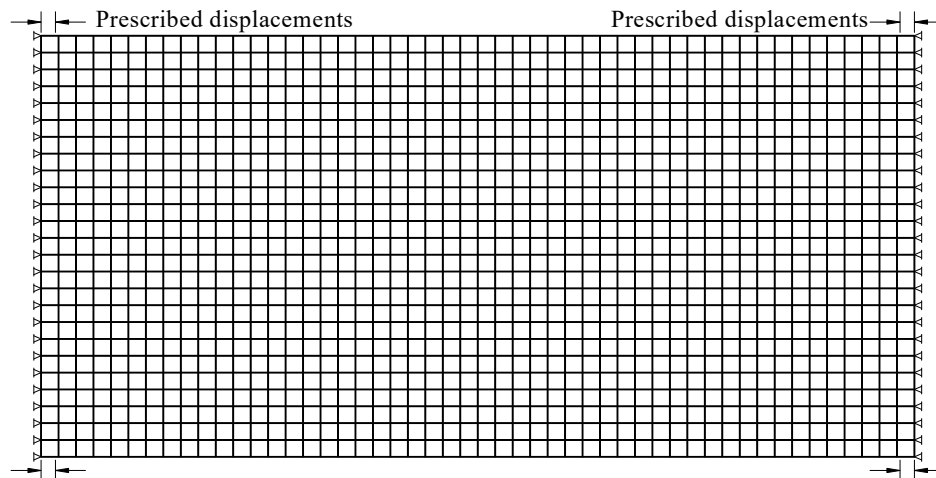
Figure 4. Initial finite element mesh and boundary conditions for numerical simulation analysis of a plate under lateral compression (Hsu, 1987).

Figure 4 shows the structural analysis model for the finite element simulation of a plate continuously subjected to lateral prescribed displacements; Figure 5 illustrates the finite element deformation mesh after the plate goes deep into the plastic range; and Figure 6 presents the distribution of excess pore water pressure contours after the formation of the shear bands in the plate.

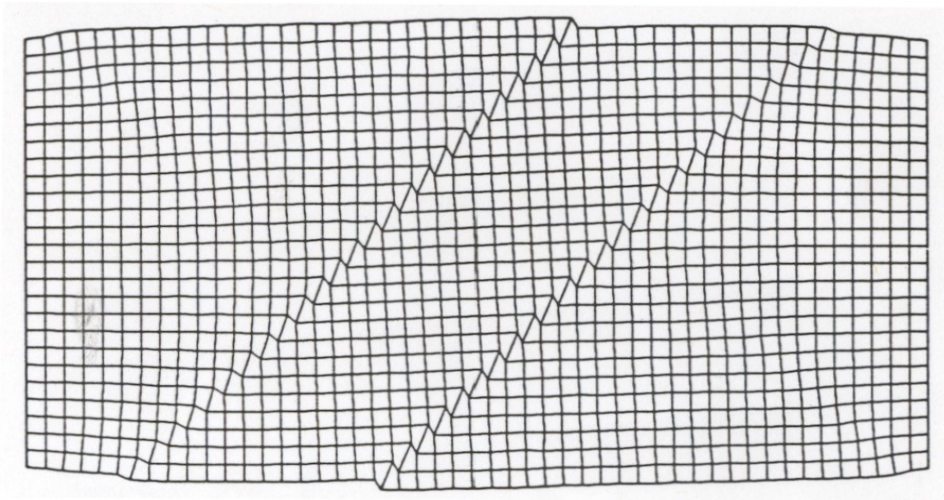
Figure 5. Finite element deformation mesh after the formation of shear bands in the plate (Hsu, 1987).

As the strain goes deep into the plastic range, Figure 5 shows that the plate loses its stability and symmetry due to plastic strain softening, and shear bands are formed as a result of

localizations of deformations. Figure 6 illustrates the distribution of excess pore water pressure contours of groundwater within the shear bands.

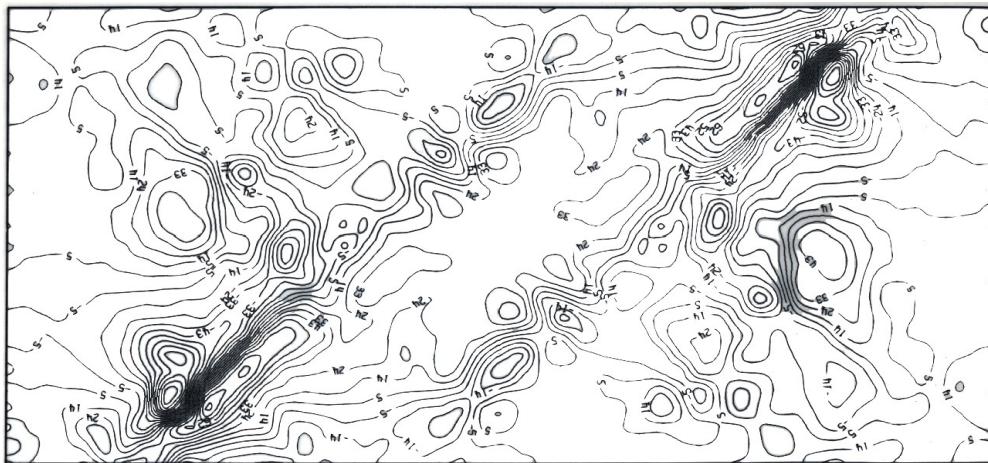
Figure 6. Distribution of excess pore water pressure contours after the formation of the shear bands in the plate (Hsu, 1987).

1. After the caisson rotates or moves seaward, it induces shear bands, as shown in Figure 3.
2. Highly concentrated excess pore water pressure appears locally in the groundwater within the shear bands, as illustrated in Figure 6.
3. The soils within the shear bands undergo brittle fracture. After the soil particles, ranging from fine to coarse, float in the groundwater, the

groundwater, along with the suspended soil particles, sprays upward through the discharge tunnel formed along the fractured pore spaces of the shear band.

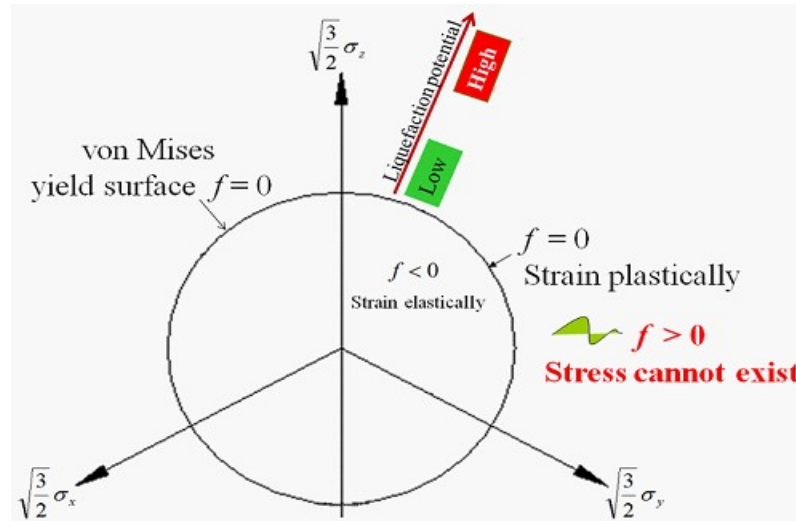
Figure 11. Stress space for the traditional definition of soil liquefaction potential, shown using the von Mises yield plane.

higher the potential for soil liquefaction (see Figure 11). Since this definition of soil liquefaction and its potential contradicts plastic mechanics principles, the entire

rear-line region of dock caisson for Taichung Port was incorrectly assessed as having soil liquefaction potential (Lai, 2007).
