THE MAJOR CAUSE OF HIGH-RISE BUILDING FAILURE DURING THE 921 JJI EARTHQUAKE

Tse-Shan Hsu

Abstract

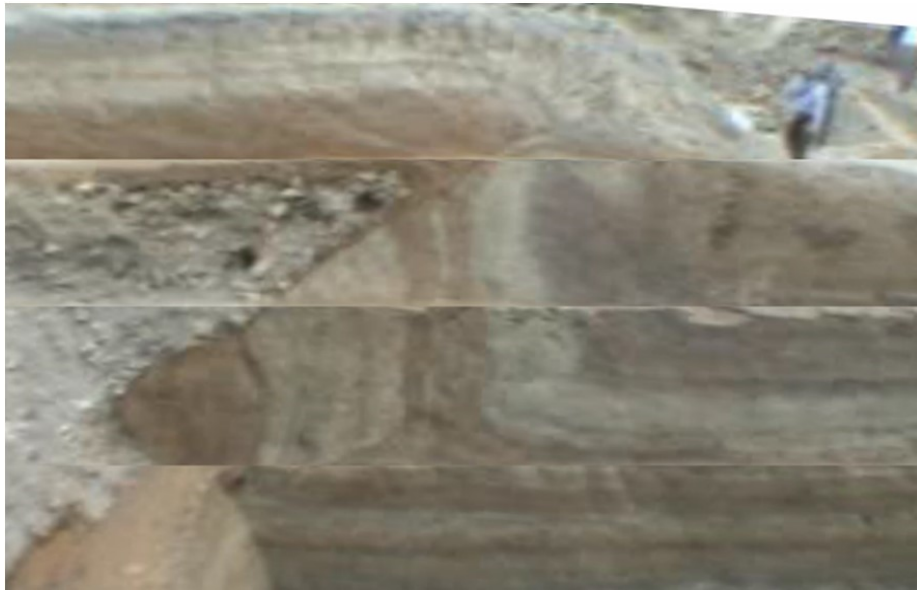
Taiwan is situated at the intersection of the Eurasian and Philippine Sea tectonic plates, where ongoing pressure from the latter can destabilize the former. As strain deepens into the plastic range, the Eurasian plate may lose stability and symmetry due to strain softening, leading to localizations of deformations and the formation of shear bands (see Figure 3).

Figure 3. Shear band observed in Zhushan, Taiwan, during the 1999 921 Jiji earthquake (Hsu, 2018).

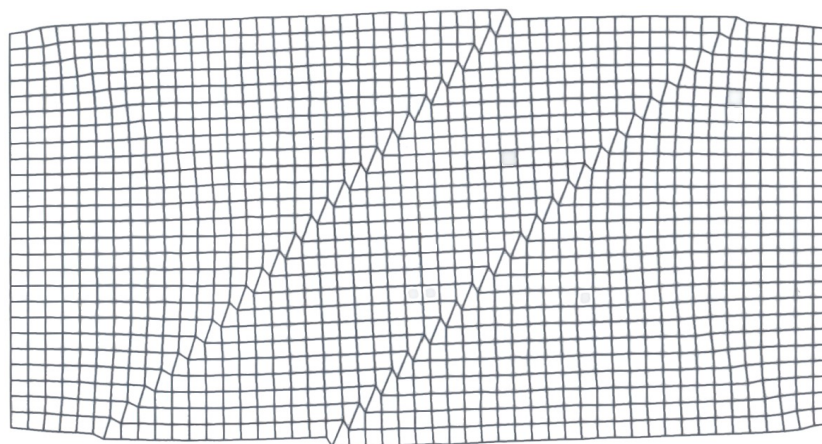
When conducting a numerical simulation analysis of the shear band shown in Figure 3 using the finite element method, the deformed mesh, including the shear band, is illustrated in

Figure 4. Deformed finite element mesh (Hsu, 1987).

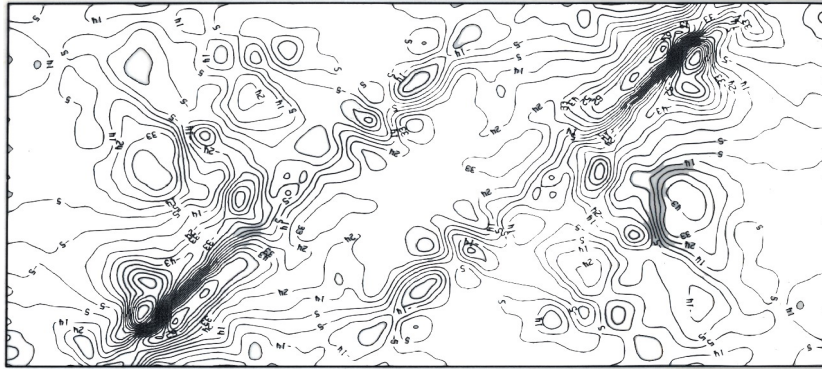
Figure 4. Additionally, Figure 5 demonstrates the presence of highly concentrated excess pore water pressure within the shear band.

Figure 5. Contours of excess pore water pressures (Hsu, 1987).

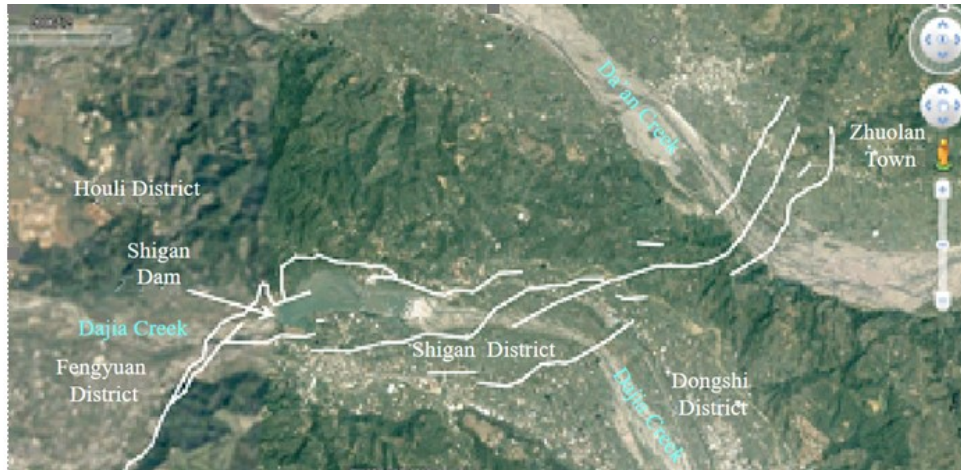
Figure 7 depicts the Chelungpu Fault zone, which triggered the earthquake. A comparison of Figures 6 and 7 reveals that the foundations of the Shigang Weir, as well as the Pifeng, Chang

Gung, Dongshi, Shihwei, and Zhuolan bridges, are embedded within the Chelungpu Fault zone. Consequently, judicial authorities classified the resulting damage as a natural disaster.

Figure 7. Brittle fracture phenomena in shear banding zones induced by plate necking in Shigang District, Taichung, Taiwan (Hsu et al., 2020).

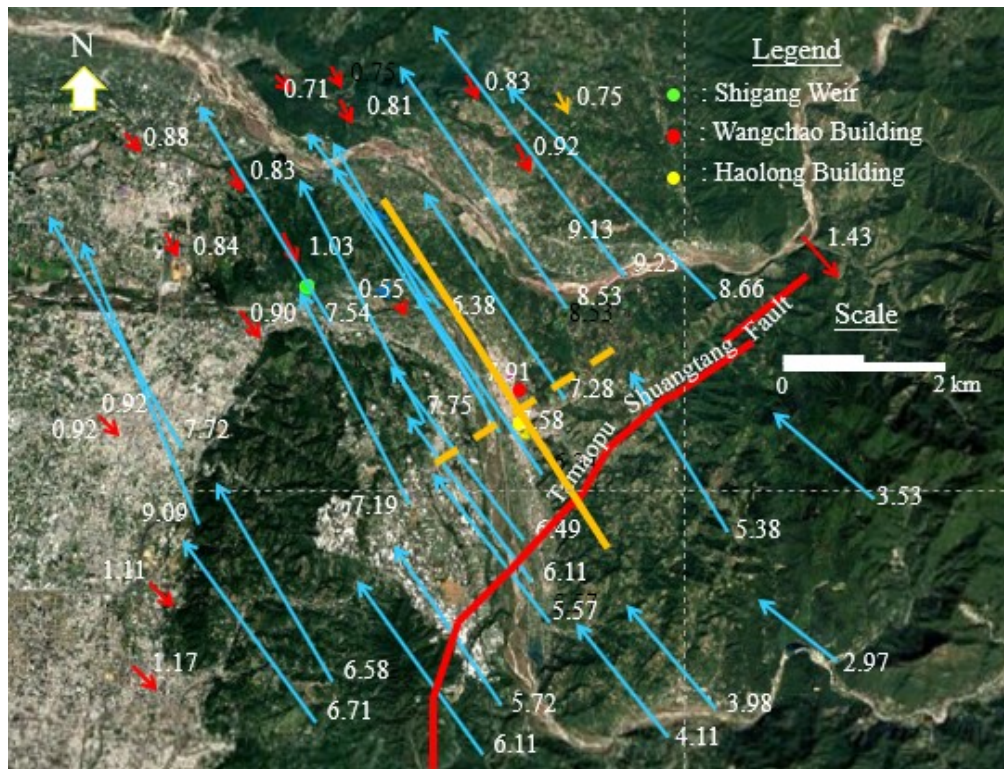
Figure 8 presents the distribution of GPS horizontal velocity vectors during the earthquake. It is evident that areas with horizontal displacements exceeding 5 meters encompass not only the Chelungpu Fault zone (as shown in Figure 7) but also shear bands and shear textures adjacent to the Damaopu-Shuangdong Fault, as depicted in Figure 8. Therefore, identifying shear bands and shear textures in the Shigang and Dongshi districts is crucial for clarifying whether the structural failure during the 921 Jiji earthquake was attributable to natural disasters.

Figure 8. Distribution map of GPS horizontal velocity vectors during the 921 Jiji earthquake (After National Land Surveying and Mapping Center, 2002; Google Earth, 2024).

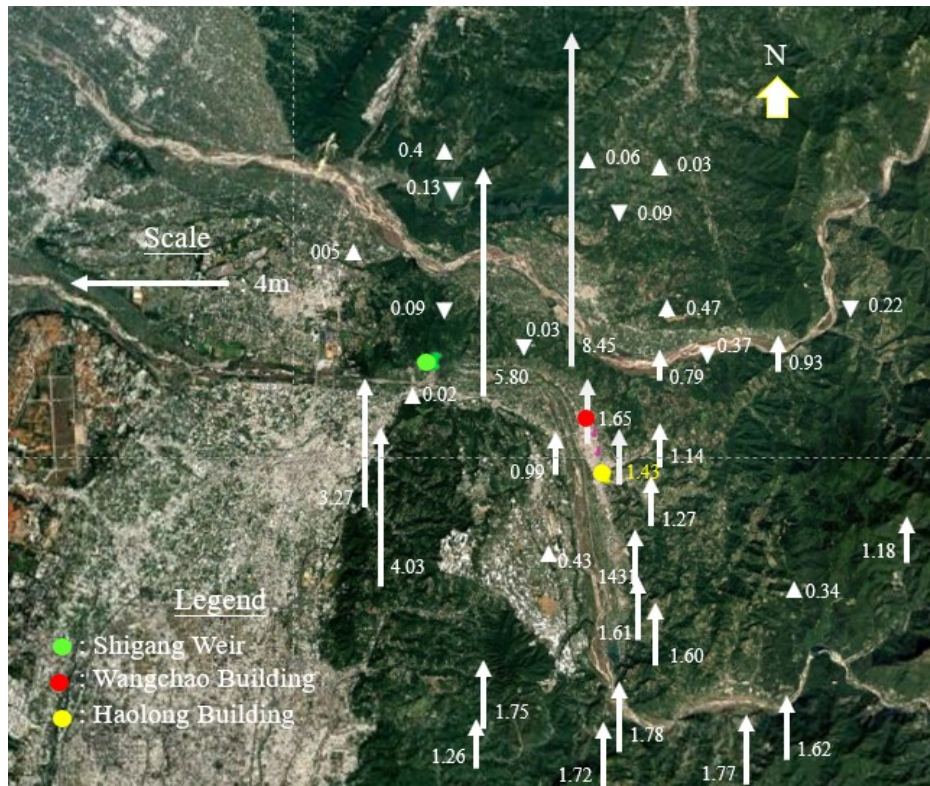
Figure 9 illustrates the distribution of GPS vertical velocity vectors recorded during the 1999 Jiji earthquake. The data indicates that the vertical displacements of the ground near the Haolong and Wangchao Buildings are 1.43 meters and 1.65 meters, respectively. In contrast, the vertical displacements of the ground to the east

Thus, during the Jiji earthquake, the eastern ground of both the Haolong and Wangchao Buildings exhibited an uplift relative to the western ground, with a maximum uplift of 0.44 meters at the Haolong Building and 0.66 meters at the Wangchao Building. This uplift phenomenon resulted in the development of shear bands and shear textures, as depicted in Figure 10.

Figure 9. Vertical GPS velocity vector map during the 921 Jiji earthquake (After National Land Surveying and Mapping Center, 2002; Google Earth, 2024).

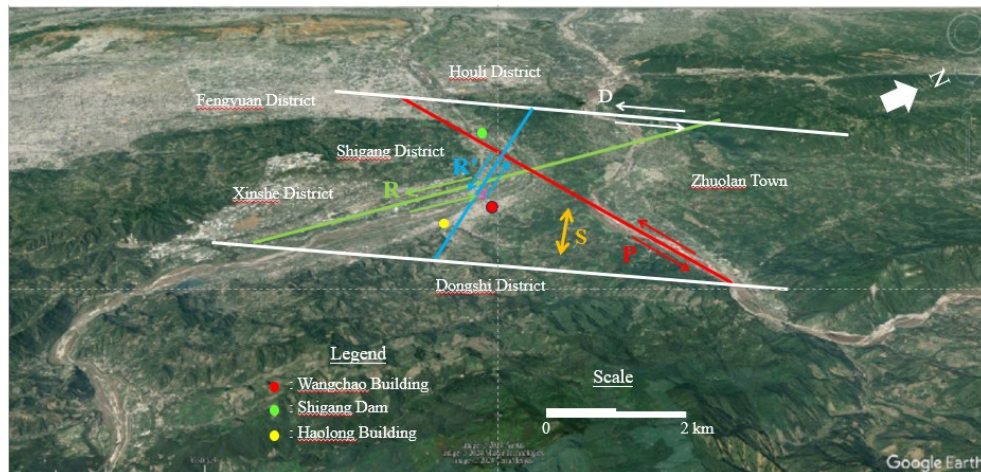
Using satellite imagery, we identify various shear textures within the overall shear band ori-

ented at N27°E, as illustrated in Figure 11. These textures include a principal displacement shear at N27°E, a thrust shear at N50°E, a Riedel shear at N8°E, a conjugate Riedel shear at N35°W, and a compression texture at N58°W.

Figure 11. Shear textures identified within the overall width of a shear band oriented at N27°E (Background image is taken from Google Earth, 2024).

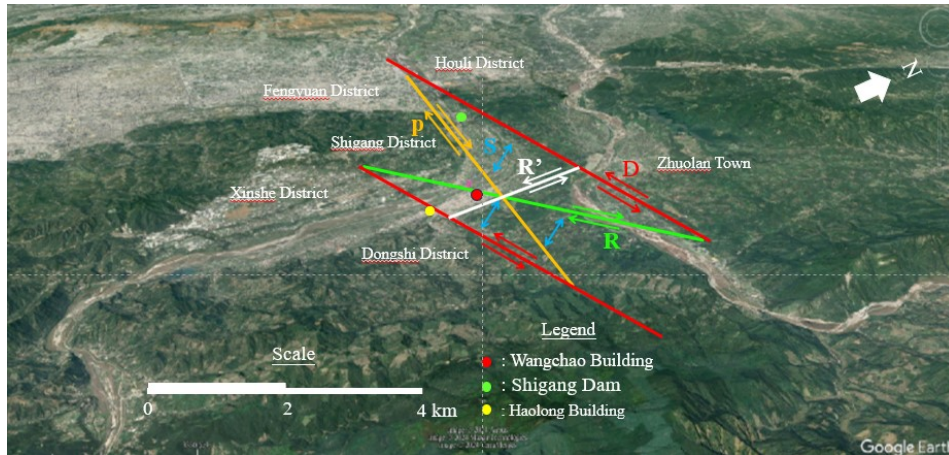
Similarly, by utilizing satellite imagery, we can identify various shear textures within the overall shear band oriented at N52°E, as depicted in Figure 12. These textures

include a principal displacement shear at N52°E, a thrust shear at N74°E, a Riedel shear at N34°E, a conjugate Riedel shear at N1°E, and a compression texture at N33°W.

Figure 12. Shear textures identified within the overall width of a shear band oriented at N52°E (Background image is taken from Google Earth, 2024).

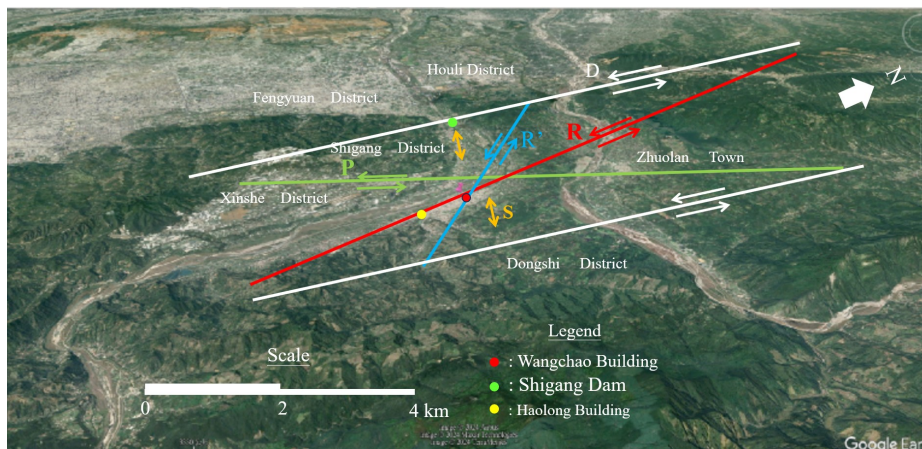
Utilizing satellite imagery along with shear texture definitions, we also identify shear textures associated with the N10°W shear band, as shown in Figure 13. These tex-

tures include a principal displacement shear at N10°W, a thrust shear at N20°E, a Riedel shear at N0°W, a conjugate Riedel shear at N35°W, and a compression texture at N80°E.

Figure 13. Shear textures identified within the overall width of a shear band oriented at N10°W (Background image is taken from Google Earth, 2024).
