A STUDY ON THE CAUSES OF HIGH-RISE BUILDING FAILURE

Dr. Tse-Shan Hsu

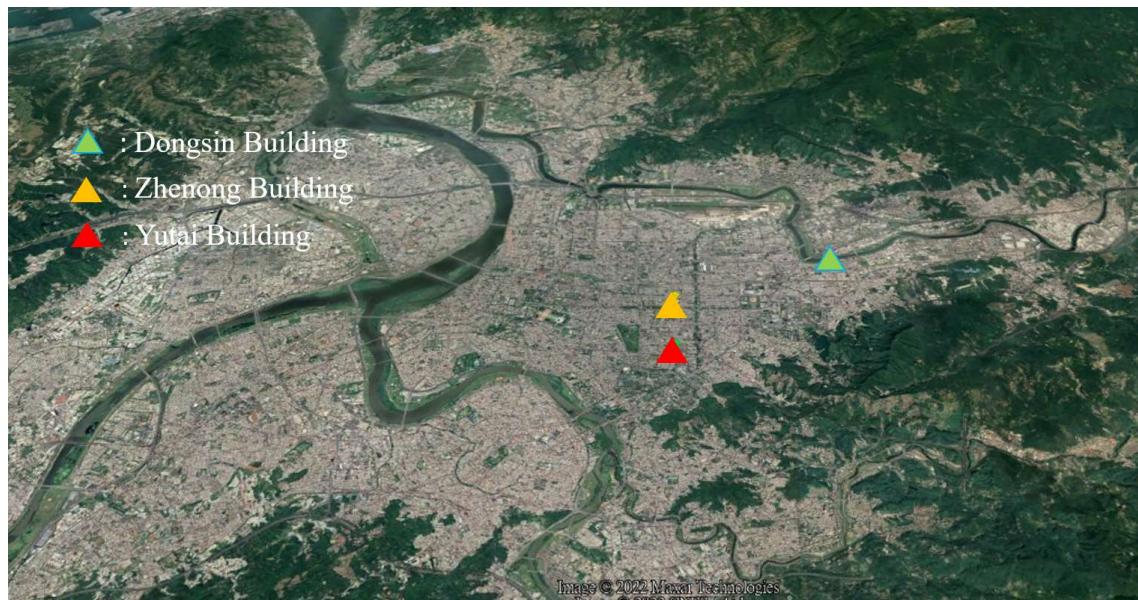
Figure 3. The three buildings damaged in the 921 Jiji earthquake in the two soft regions in Taipei (The background image is from Google Earth (2022)).

Figure 3 shows the locations of three buildings that were damaged during the 1999 Jiji (921) Earthquake, all situated within two soft-soil regions of Taipei. These damaged buildings include: (a) the Zhenong Building, which

exhibited floor cracking (Figure 4); (b) the Yutai Building, which experienced tilting and subsidence (Figure 5); and (c) the Dongshing Building, which collapsed (Figure 6) (Hsu, 2022).

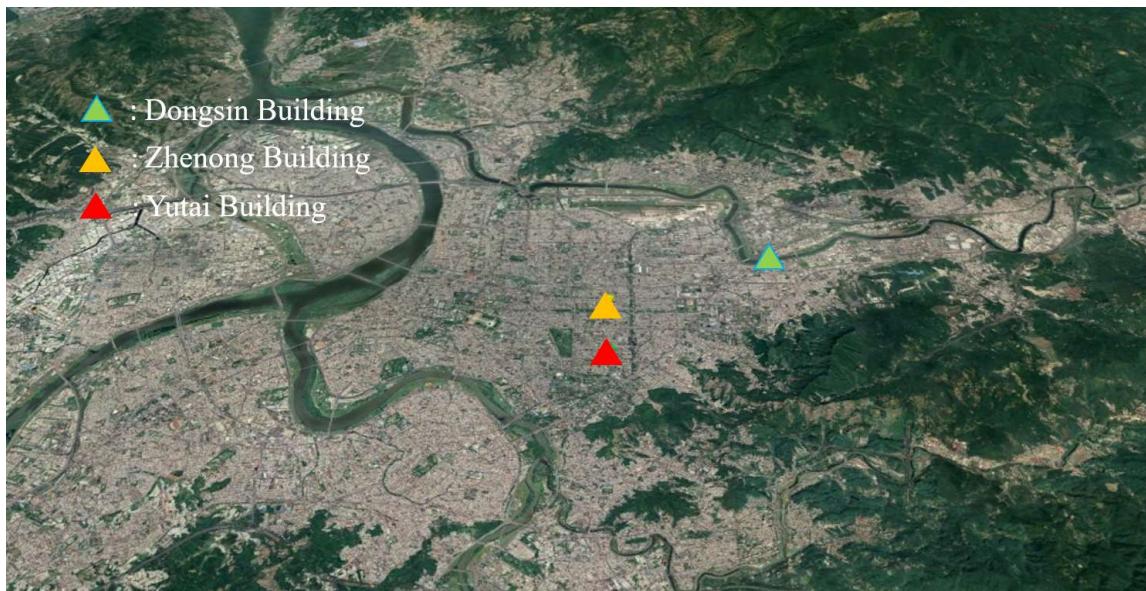
Figure 7. Geographical locations of three buildings damaged in Taipei during the 921 Earthquake. (The background image is from Google Earth (2022)).

For the three buildings located at different sites in Taipei (Figure 7), the Zhenong Building and the Yutai Building are situated in Soft Region 1, as shown in Figure 8, while the Dongsing Building is located in Soft Region 2. Figure 8 also illustrates that Soft Region 1 is subjected only to compressive forces, whereas Soft Region 2 is subjected to both compressive and torsional forces.

Because the Zhenong Building is located in Soft Region 1—an area affected solely by compression—its floor cracking suggests that the structure was in a lightly non-earthquake-resistant state. For the Yutai Building, also within Soft Region 1, the observed tilting and subsidence indicate a moderately non-earthquake-resistant state. In contrast, the collapse of the Dongsing Building, located in Soft Region 2, reflects a highly non-earthquake-resistant state.

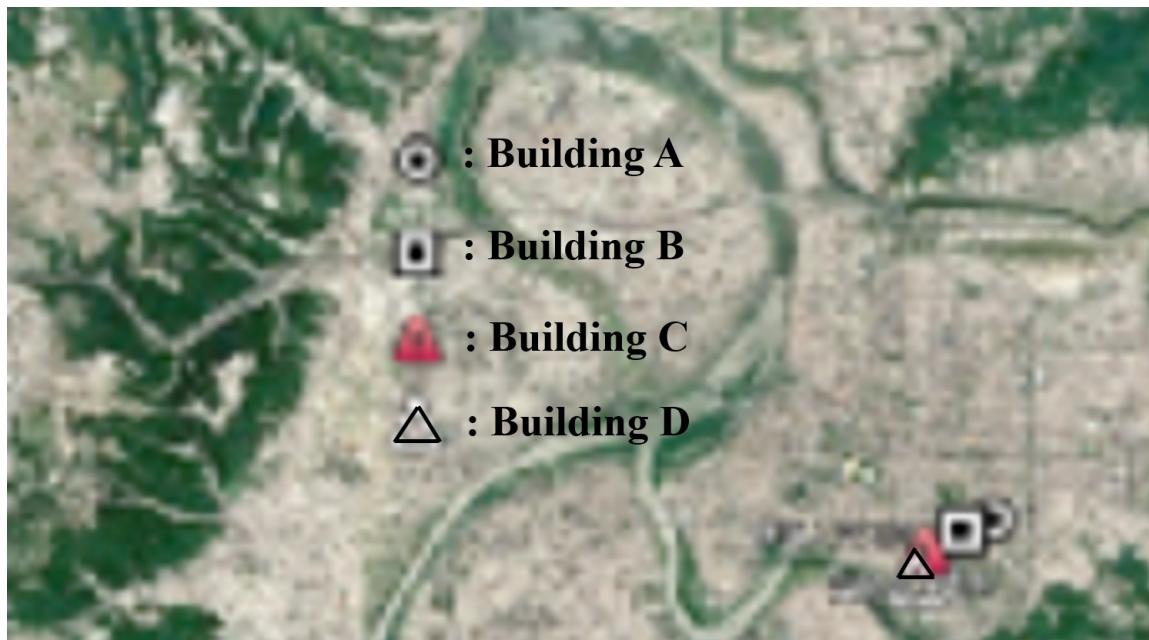
Figure 10. The four buildings selected from the soft region 1 shown in Figure 8.
(The background image is from Google Earth (2022))

Figure 8 shows that all four buildings selected for this study—Buildings

A through D—are located within Soft Region 1.

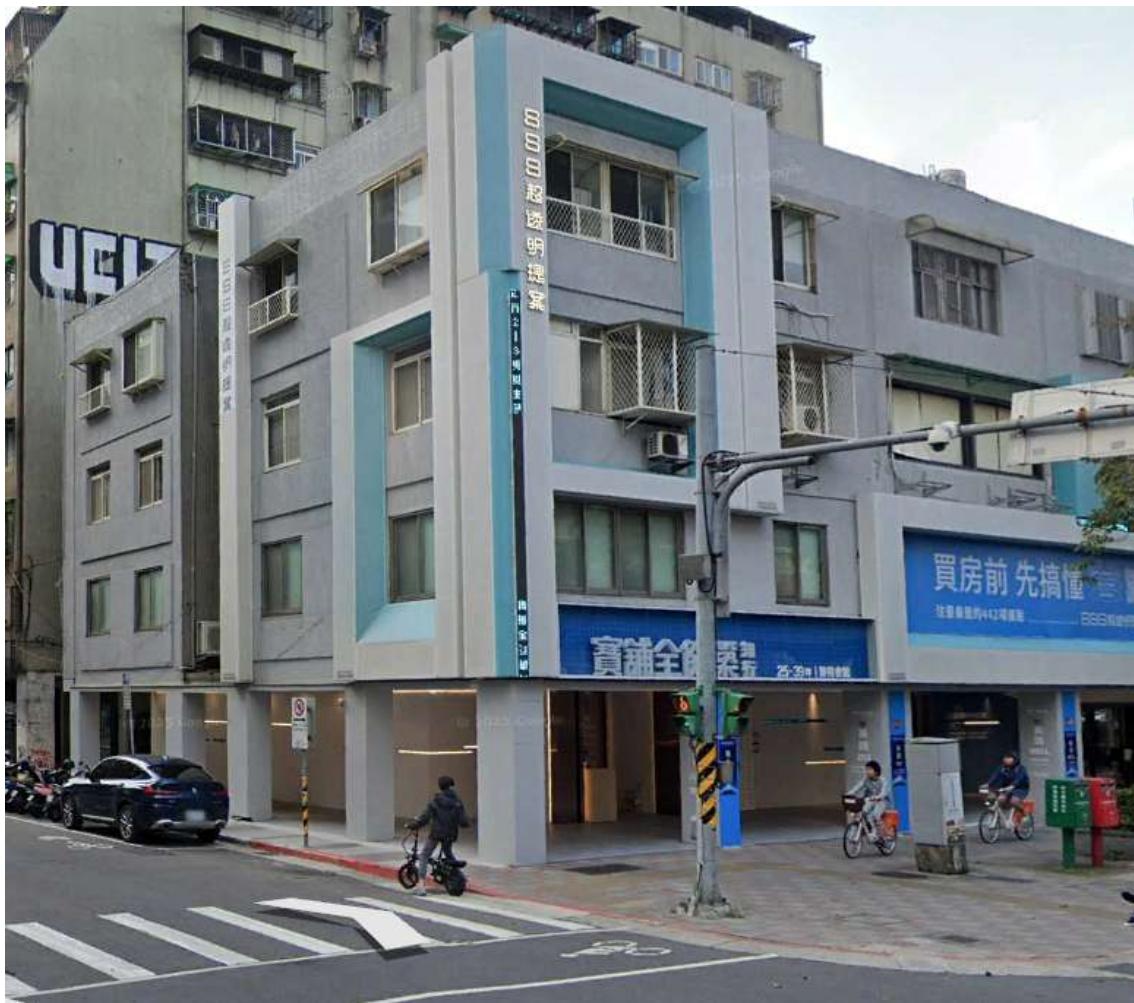
Figure 11. Building A (Google Earth (2022)).

Figures 11 to 14 show the current conditions of the four selected buildings located in Soft Region 1, as illustrated in Figure 8. Building A has 4 stories, Building B has 14 stories, Building C has 10 stories, and Building D has 16 stories.

Figure 15 shows floor cracking in Building A, indicating that it is in a slightly non-earthquake-resistant state. Figure 16 shows damage to the exterior wall tiles of Building B—including cracking, spalling, and uneven coloration—suggesting that Building B is also slightly non-earthquake-resistant. Figure 17 presents cracking of the walls and floors in Building C, likewise indicating a slightly non-earthquake-resistant condition. Figure 18 shows uneven settlement of the road adjacent to Building D and cracking of
